World Housing Encyclopedia

HOUSING REPORT

Reinforced concrete frame building with an independent vertical extension

Report #	17
Report Date	05-06-2002
Country	GREECE
Housing Type	RC Moment Frame Building
Housing Sub-Type	RC Moment Frame Building : Designed for seismic effects, with URM infills
Author(s)	Vlasis Koumousis
Reviewer(s)	Kostas Skliros

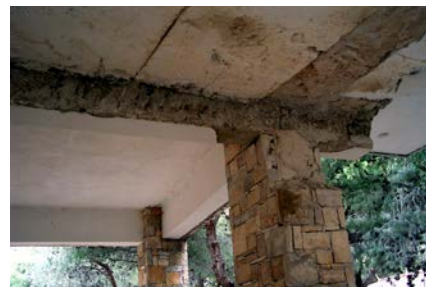
Figure 4: Critical Structural Elements: Column-Floor Slab Connection (1980 Structure)

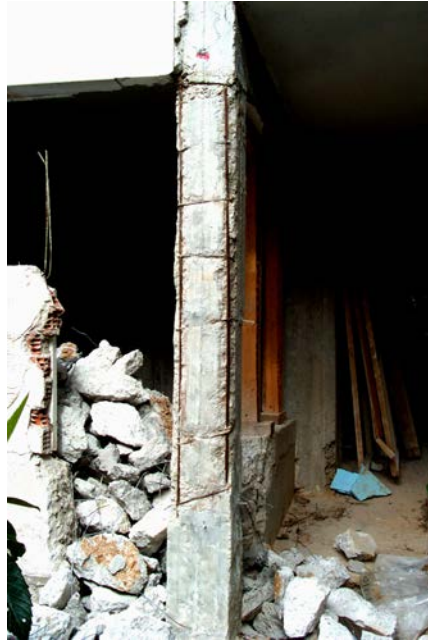
Due to the eccentric position of the elevator shaft (a "U"- shape open core) in the 1980s portion, the dynamic response of this building showed intensive torsional vibrations in the 1980 structure causing excessive displacements to the old

(1960) structure. The torsional eccentricity (distance between the centers of mass and stiffness) was equal to 7m in a building of 20 m maximum plan dimension. In the 1999 Athens earthquake, the building described in this contribution experienced severe damage caused by the tight connection of two structures with rather different dynamic properties. The damages included the extensive cracking in the exterior limestone masonry infill walls and the interior brick masonry infill walls, and the minor cracks in the flexible 1960s frame structure. More information on the 1999 Athens earthquake is available on the Internet at www.itsak.gr.

Figure 5: Typical Earthquake Damage to a Column of the Older 1960 Astructure (1999 Athens Earthquake)

Seismic Deficiency	Description of Seismic Strengthening provisions used
Minor cracks in concrete columns and shear walls	Scaled with epoxy resins following standard practice
Strengthening of the footings	Anchoring of the new reinforcement, installation of dowels in the interface, preparation of the concrete interface for improved bonding, cast in situ concrete (see Figure 6D)
Installation of new shear walls	Welding of new reinforcement to the existing reinforcement at several (3 to 5) locations within a storey-height, preparation of concrete surface for improved bonding, pouring of concrete in-situ (see Figures 6A, 6B and 6F).
Demolition and partial reconstruction of beams	Careful support (underpinning) of the adjacent structure, partial demolition of the beams, installation of additional reinforcement adequately anchored, preparation of the concrete interface, pouring the concrete.

The problems associated with the seismic performance of this building type are due to the tight connection of two structures with quite different dynamic properties. Since it is not possible to separate these two structures (i.e. the 1960 and 1980 portion of the building), the strengthening is required. The following options have been considered: a) strengthening of the 1960 frame, b) strengthening of the 1980 frame, or c) strengthening of both structures. The purpose of strengthening is to achieve an acceptable performance for the entire structure, to control the lateral displacements (drifts), and also to avoid excessive damage of the exterior and interior infill walls in future earthquakes. Strengthening of the old 1960 RC frame has appeared to be impractical and unreliable due to the poor quality of concrete and the lack of seismic detailing (inadequate amount of reinforcement, lack of stirrups, etc). Strengthening of the newer, 1980 frame, with the objective to reduce the excessive torsional effects in the structure and control the response of the old 1960 structure was considered. This option seemed to be very expensive, as it required strengthening of almost all columns and shear walls. Finally, it was decided to demolish all severely damaged infill walls and the frame at the first floor level (1960 structure), including the columns, beams and the floor slab, and to rebuild the brick infill walls at this floor level within the frames of the new structure. In addition, all cracks in the vertical elements were sealed with epoxy resins. Finally, three columns or shear walls in the new structure were strengthened to increase the torsional rigidity (locations STR 1-3 in Figures 3A, 3B and 3C). Beams at the first floor level had to be partially demolished and rebuilt with additional reinforcement (see Figures 2 and 6F). These strengthening measures were effective in ensuring the overall seismic performance of the strengthened building (including the 1960 and 1980 portion) in accordance with the requirements of the current Greek design code.

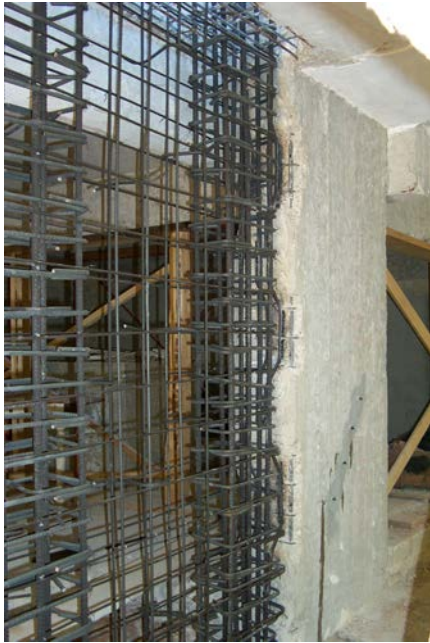
Figure 6A: Seismic-strengthening Techniques - Installation of a New Shear Wall

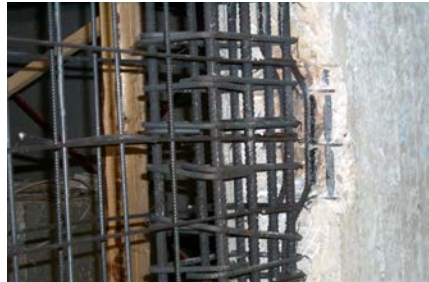
Figure 6B: Seismic Strengthening - Connection of the Old and New Concrete (Welding of Rebars)

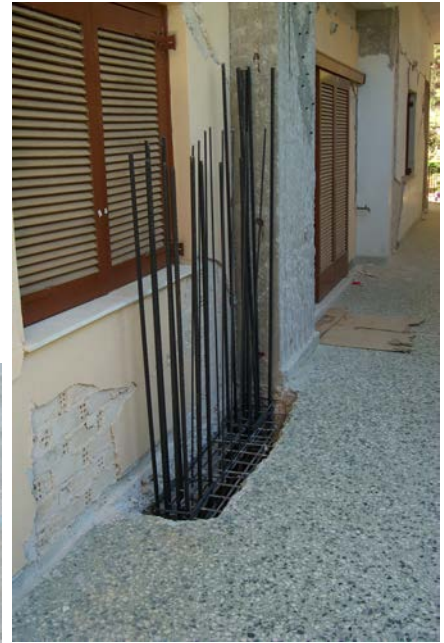
Figure 6C: Seismic Strengthening - Extension of te New Shear Wall Through the Floor Slab

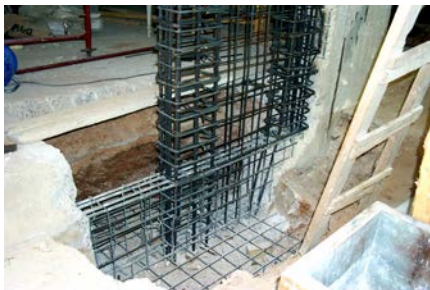
Figure 6D: Seismic Strengthening of the Footing

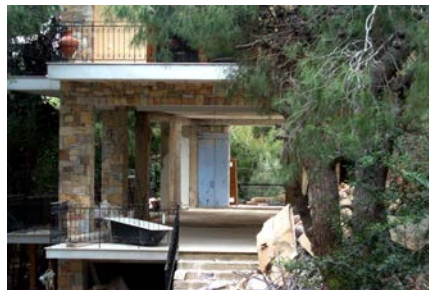
Figure 6E: Demolition of the Damaged Infill Walls at the Ground Floor Level

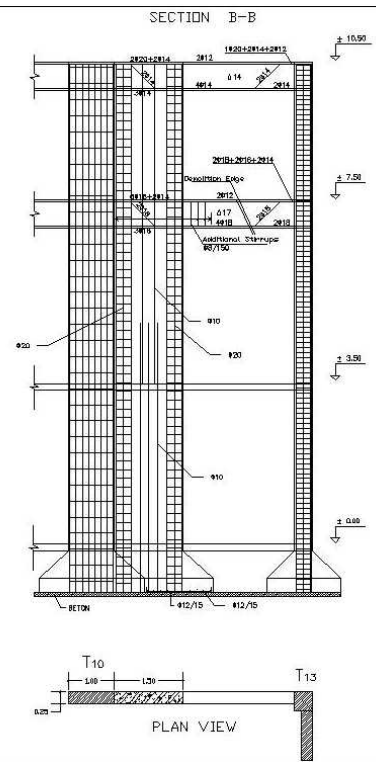
Figure 6F: Seismic Strengthening - Installation of a New Shear Wall
