World Housing Encyclopedia

HOUSING REPORT

Reinforced Concrete Moment Frame Building without Seismic Details

Report #	111
Report Date	14-09-2004
Country	USA
Housing Type	RC Moment Frame Building
Housing Sub-Type	RC Moment Frame Building : Designed for gravity loads only, with URM infills
Author(s)	Heidi Faison, Craig D. Comartin, Kenneth Elwood
Reviewer(s)	Mahmoud M. Hachem, Ayhan Irfanoglu

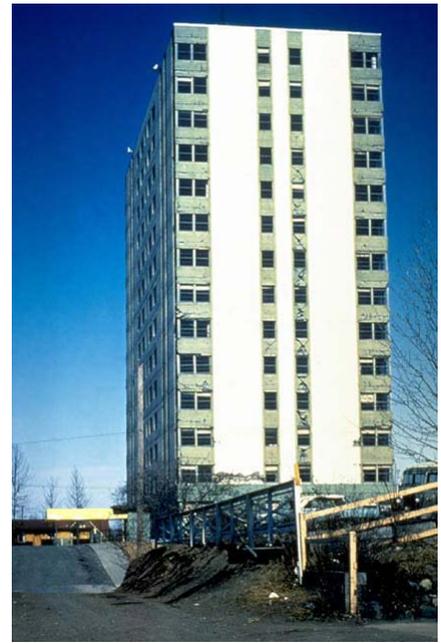
Figure 6: Overall view of the 1200 L Street Apartment building, Anchorage, Alaska after damage from the 1964 earthquake. This 14-story reinforced concrete structure has a basic lateral-resisting structural system and a series of slender walls coupled by s

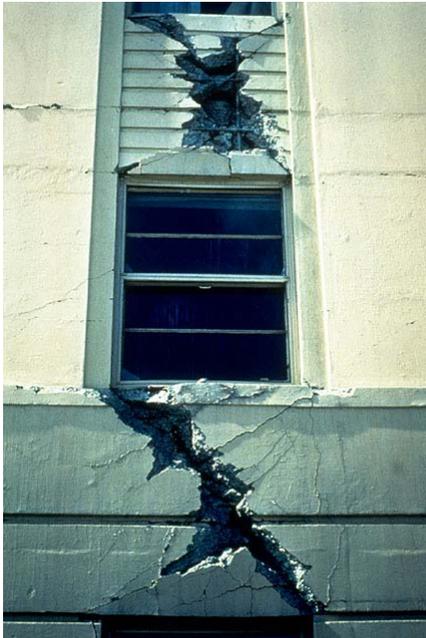
Figure 7: Close-up of characteristic X-shaped cracks and failure of coupling girders or short spandrel girders in the L street apartment building, Anchorage, Alaska. These girders were not properly designed for the shear demands. [10]

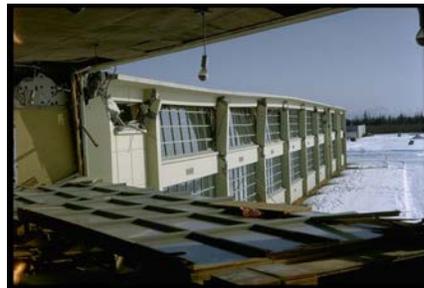
Figure 8: Damage to West Anchorage High School from the 1964 Alaska earthquake. Window wall fell inwards into the classrooms. Note sag in roof due to failure of reinforced concrete diaphragm. [9]

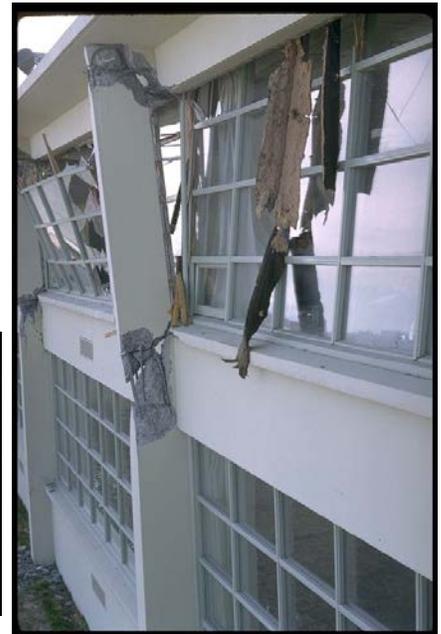
Figure 9: Detail view of damage to the column and beam joints at West Anchorage High School, Anchorage, Alaska. [9]

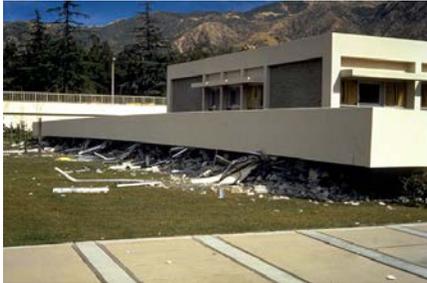
Figure 10: Olive View Hospital, Psychiatric Unit, 1971 San Fernando Earthquake. This unit was a 2-story reinforced concrete building. The structural system was a moment resisting frame. However, in the second story there were masonry walls that added sign

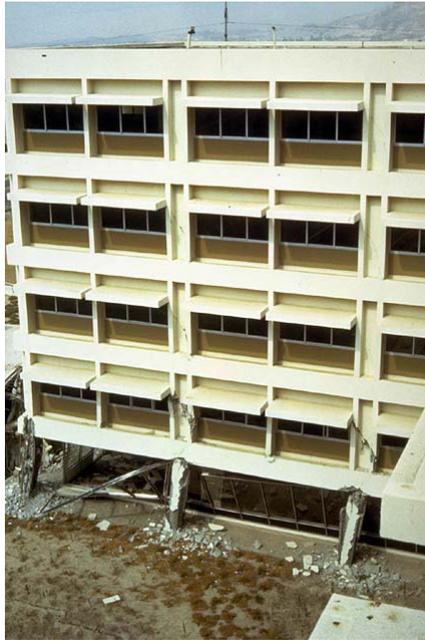
Figure 11: Olive View Hospital, Medical Treatment and Care Unit, 1971 San Fernando earthquake. View of the end of one of the four wings of this 5-story reinforced concrete building after the earthquake. Note the large distortion of the first soft story co

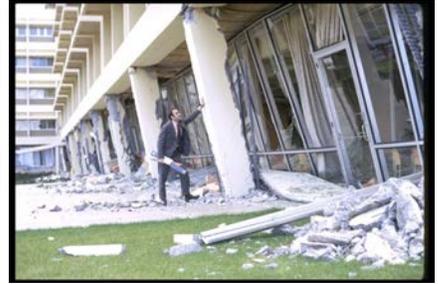
Figure 12: Damage to Olive View Hospital bottom story moment frame columns from the San Fernando earthquake. [9]

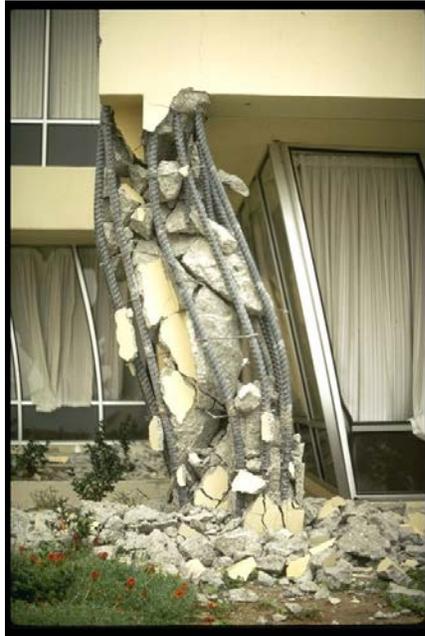
Figure 14: Example of damage to the corner columns at Olive View Hospital which was the result of poor seismic detailing. [9]

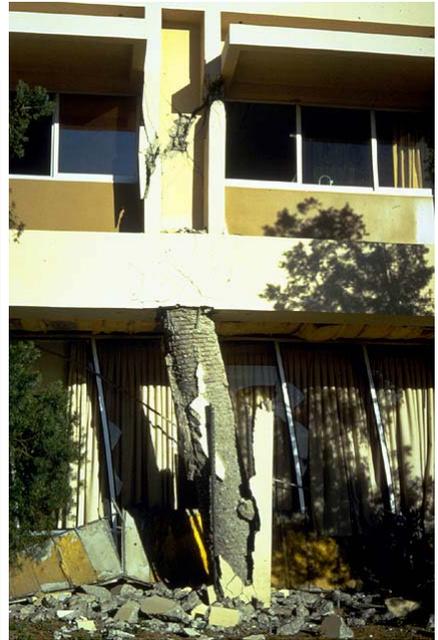
Figure 15: Detail view of the behavior of one of the first and second story columns in the Olive View Medical Treatment and Care Unit during the 1971 San Fernando Earthquake. Note the large permanent distortion of the first story column (because it was pa

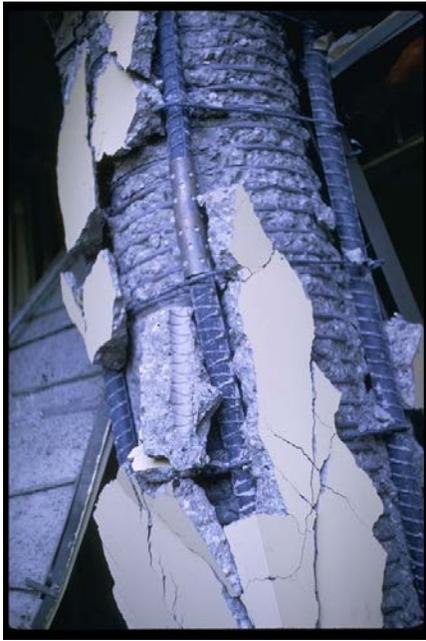
Figure 16: Detailed view of column with spiral confinement steel. The spiral confinement steel helped keep the concrete core intact. The longitudinal reinforcement is tied on the exterior of the spiral; this detail leaves the longitudinal steel vulnerable

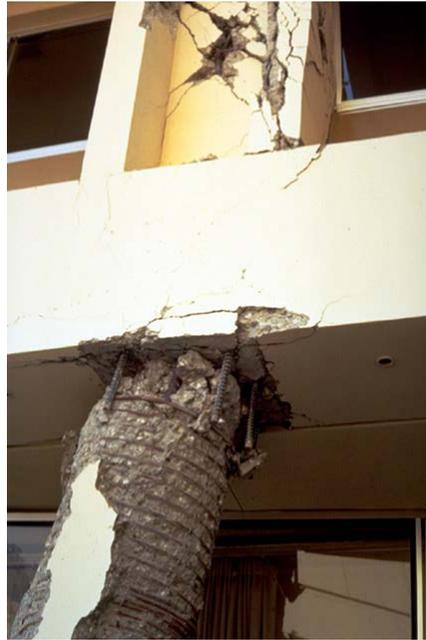
Figure 17: Olive View Hospital, 1971 San Fernando earthquake. Close-up of the top of the column illustrating how the concrete in this critical region has been disrupted (broken off) as a consequence of the premature ending of the spiral reinforcement. [10]

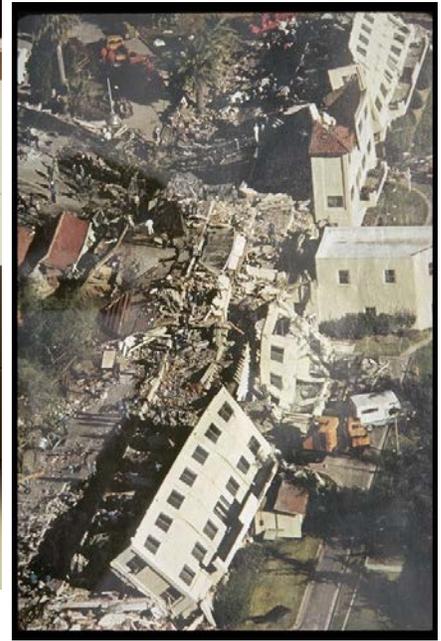
Figure 18: Collapse of the San Fernando Veterans Administration Hospital from the 1971 San Fernando earthquake. The image is from air photos taken shortly after the event. [9]

buildings accounting for ductile behavior. (b) Two example buildings damaged in the 1964 Alaska earthquake demonstrate the vulnerability of concrete structures without ductile detailing. Although they are not all moment frame buildings, they demonstrate the important lessons learned from the earthquake. The 14-story reinforced concrete L Street Apartment building in Anchorage, Alaska used a series of slender walls connected with short spandrel girders to resist lateral loads. Characteristic x-shaped shear cracks in the girders showed that the girders were not properly designed to resist shear demands (Figures 6 & 7). West Anchorage High School in Anchorage, Alaska was a 2-story concrete frame building with shear walls that showed extreme damage. Failures were present in its beam-column joints, columns, shear walls and roof diaphragm (Figures 8 & 9). (c) After the 1971 San Fernando earthquake, the engineering community realized that more seismic detailing would be necessary for concrete buildings. The damage and subsequent research from this earthquake inspired key changes to code design requirements for concrete moment frame buildings. (d) Several main buildings highlighted the vulnerability of reinforced concrete design following the current building code in the San Fernando earthquake. Olive View Medical Center experienced damage in many of its buildings. The Olive View Psychiatric Day Care Center was a two-story moment frame building whose bottom story columns failed and caused the collapse of the complete lower story (Figure 10). The Olive View Hospital experienced great damage as well (Figures 11-12). The main issues related to moment frame design from this building are in regard to column detailing. General views of the hospital building show distortions of the first story columns, which were of two designs (Figure 13). The twelve corner columns were L-shaped with six ties (No. 3's at 18 inches) spaced over the story height (Figure 14). These columns completely shattered. The other 152 columns in the building had spiral steel ties (5/8 in. at 2-1/4 in. spacing) and although they lost much of their concrete covering, they retained load-carrying capacity (Figures 15 - 17). The ability of the spirally-reinforced columns to maintain vertical load carrying capability with such large horizontal drift demonstrates the advantage of detailing concrete for ductile behavior. These spiral columns would have been helped even more by the placement of all longitudinal steel within the spirals. Figure 13 shows the detail of the spiral column with its longitudinal steel within the steel spiral yet the damage images shows some rebar on the exterior of the spirals (Figures 15 & 16). While much of the major building damage was restricted to the first floor columns, there were shear failures in some of the upper story columns. Also many of the connections were damaged. Another concrete frame structure with non-ductile design was the San Fernando Veterans Administration Hospital, which was built in 1925. It consisted of concrete frames, concrete floors and hollow tile walls. This building suffered complete collapse (Figure 18).

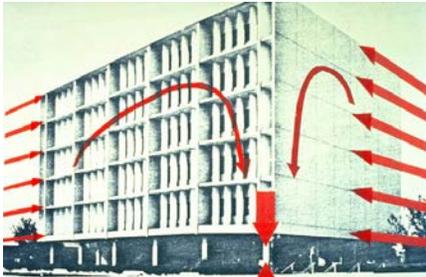
Figure 19: During the 1979 Imperial Valley earthquake, the 6-story reinforced concrete Imperial County Services Building developed significant inertia forces simultaneously in the two main directions (illustrated in red). As a result, the corner columns o

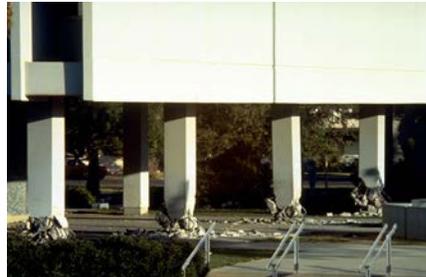
Figure 20: View of the 1979 Imperial Valley earthquake damage in the first story columns located in the east end of the Imperial County Services building. Note the explosive type of failure just above the ground and the offset between the columns and the

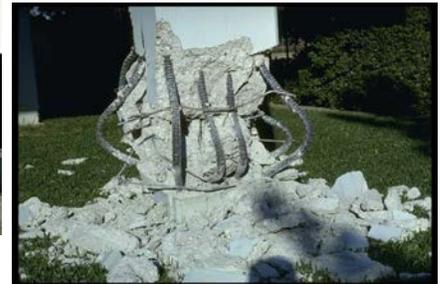
Figure 21: Close-up of the failure at the bottom of a column of the Imperial County Services building. The failure occurred in the zone of the column where there was not adequate confinement of the concrete and no shear reinforcing steel. [9]

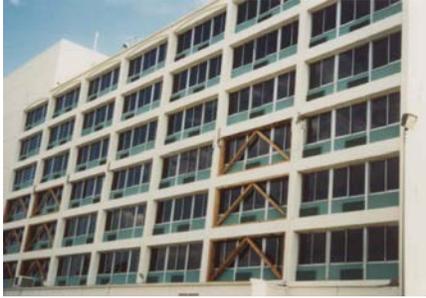
Figure 22: View of Holiday Inn, Van Nuys, CA with damage from the 1994 Northridge earthquake. The lateral system consists of reinforced concrete perimeter moment frames. Column damage required the placement of temporary shoring where the vertical load ca

Many of these strengthening techniques have been applied to institutional buildings (i.e. universities) throughout California. The Holiday Inn in Van Nuys, CA which was damaged in the 1994 Northridge earthquake was retrofitted after the earthquake to repair the structure and improve its future earthquake performance. The method used for this structure was to insert new lateral load resisting elements to take the full seismic loads. New moment frames were added to the exterior of the building that were integrated with the existing frames (Figures 30 - 33). Although several of the buildings explained and documented in this report are hotels and office buildings, they have many similarities with non-ductile concrete apartment housing construction. Hotels, offices and typical housing structures have similar low story heights to maximize the number of floors throughout the height of the building. All of these uses also require the placement of many windows and openings throughout the structure. Large apartment buildings, offices and hotels may have a soft story at the lower level if there is a ground floor lobby or commercial space. Because of these similarities in building form, the seismic performance of these buildings is comparable. The hospitals used in this report document the reasons why the codes were changed so drastically in the 1970's. The failures in these hospitals also demonstrate deficiencies in design that commonly are seen in all moment frame buildings built before 1976.

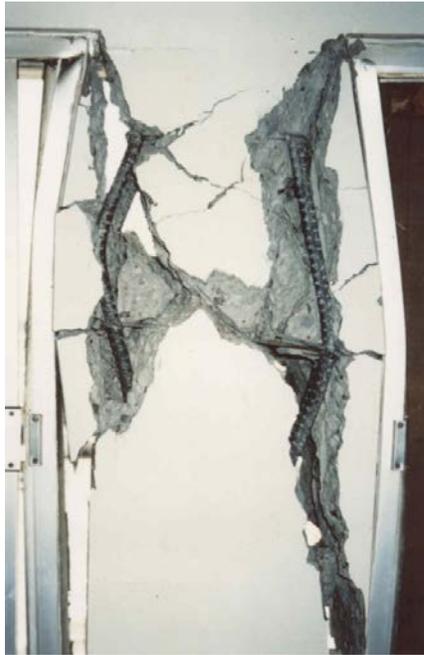
Figure 23: Damage to the Holiday Inn, Van Nuys primarily consisted of shear failure of the columns and subsequent buckling of column vertical reinforcing between the ties where added confinement provided by the concrete cover was no longer available due t

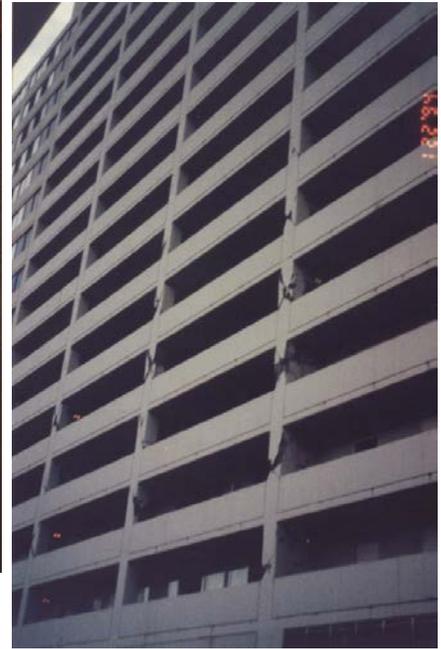
Figure 24: Damage from the 1994 Northridge earthquake to the perimeter moment frames of the Champaign Tower in Santa Monica, CA. [5]

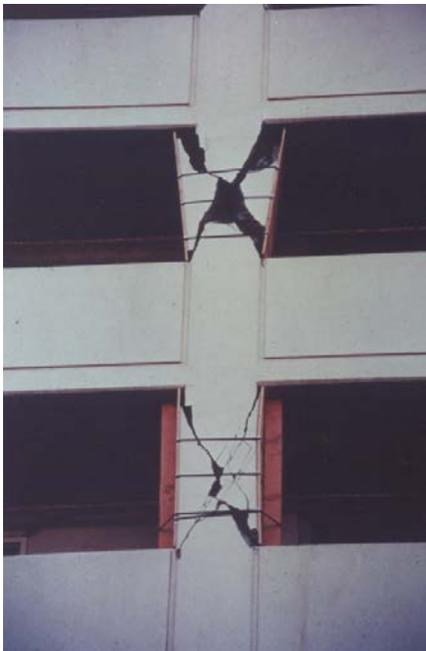
Figure 25: Balcony parapets induced short-column effects in the Champaign Tower moment frames. Typical X-shaped shear cracking from the short-column behavior is shown. [5]

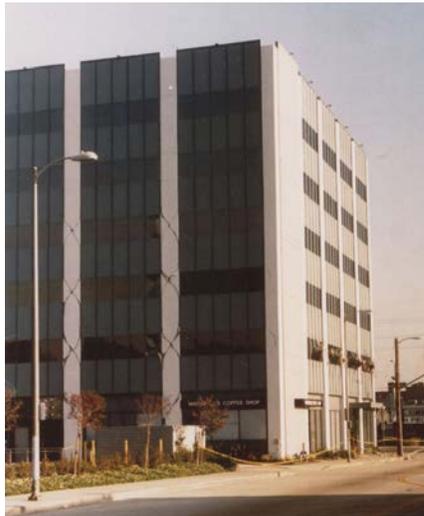
Figure 26: Damage to the L-shaped Barrington Medical Building, West Los Angeles, CA. Shear cracking in the perimeter frames undermined the column strength enough at some levels that the windows buckled due to a decreased column/story height. [5]

resisted by a combination of the interior column-slab frames and the exterior column-spandrel beam frames (Figures 1 - 3). Damage primarily consisted of shear failure of the columns and subsequent buckling of column vertical reinforcing between the ties where added confinement provided by the concrete cover was no longer available due to spalling (Figures 22 & 23). Minor to moderate shear cracks were observed in many beam-column joints at the lower stories. Several spandrel beams showed minor spalling as well as flexural cracks at the bottom of the beams, suggesting possible yielding of the bottom reinforcement. The building was red-tagged after the event and temporary shoring was placed in some bays where the vertical load carrying capacity was compromised. The Champaign Tower in Santa Monica, CA was a 15-story concrete building with nonductile moment frames in one-direction and shear walls in the other. Balcony parapets shortened the column spans, which induced short column effects on many columns in the lower stories as shown by the X-shaped shear cracking (Figures 24 & 25). Extensive coupling beam shear failures were evident in the building direction that had shear walls to resist the seismic loads. The Barrington Medical building was a 6-story, L-shaped reinforced concrete building built in the late 1960's. The lateral system included perimeter frames, shear walls along the interior core and shear walls at the perimeter. Shear cracking in the perimeter frame columns comprised most of the structural earthquake damage and undermined the column strength enough at some levels that the windows buckled due to a decreased column/story height (Figure 26).
