World Housing Encyclopedia

HOUSING REPORT

Reinforced Adobe

| Report # | 107 |

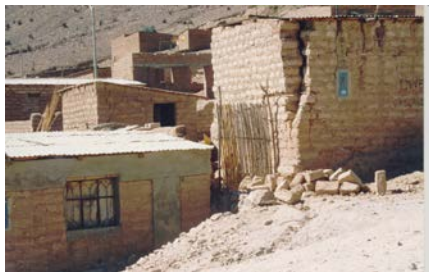
Existing adobe houses were reinforced by adding wire mesh nailed to the walls and covered with mortar in 1998. The June 23, 2001 Mw=8.4 Atico earthquake produced no damage to the reinforced adobe houses, while neighboring houses had severe cracks or collapsed. The 2007 August 15 earthquake in Pisco also affected many adobe houses, but five reinforced adobe houses in Ica province remained undamaged.

Fig. 16: Inspection after 2001 Earthquake in Moquegua: reinforced house without damage and neighboring unreinforced house with severe damage,

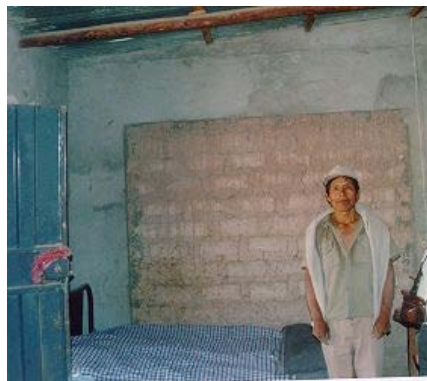
Fig. 17: Interior of adobe house of Fig 16, with the owner, Mr. Fanegas.

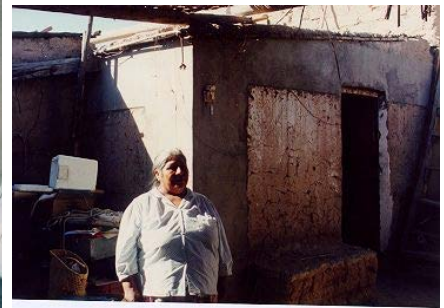
Fig. 18: Adobe house reinforced with strips of wire mesh, undamaged after 2001 earthquake in Moquegua.

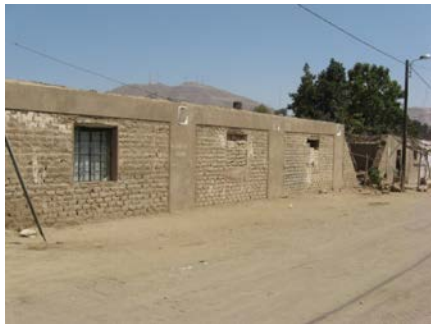
Fig. 19: House in Ica after the 2007 earthquake, reinforced walls undamaged.

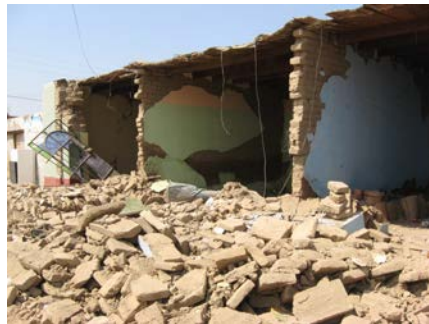
Fig. 20: Collapsed houses in the same block as the reinforced house of Fig. 19, after the 2007 earthquake in Ica.

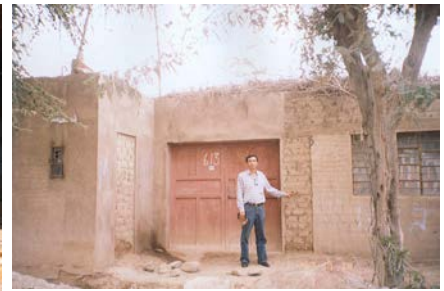
Figure 21: Demonstration house with partial reinforcement in Parcona, Ica. This is the station of the Peruvian Geophysical Institute, in which a peak acceleration of 0.49g was recorded.

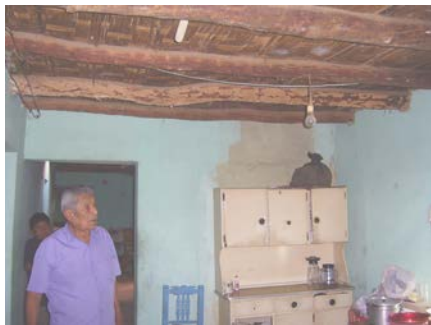
Figure 22: House reinforced in 1998 in Ica; after the 2007 earthquake. Owner Mr. Legua receives visitors showing undamaged adobe walls.

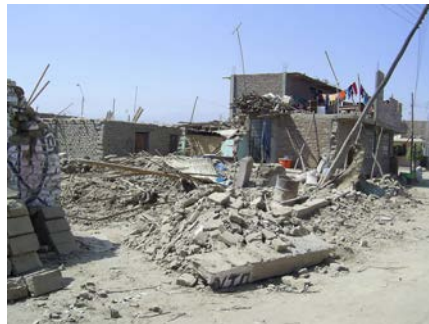
Fig. 23: Houses next to the one shown in Fig. 22, with heavy damage, Ica, 2007.

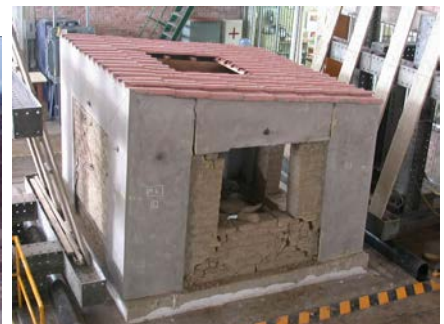
Fig. 32: Model tested in PUCP shaking table, with some damage under severe earthquake.
