# World Housing Encyclopedia

## HOUSING REPORT

### Unreinforced stone wall rural housing (lower and middle income)

<b>Report #</b>	121
<b>Report Date</b>	26-05-2007
<b>Country</b>	ITALY
<b>Housing Type</b>	Stone Masonry House
<b>Housing Sub-Type</b>	Stone Masonry House : Rubble stone without/with mud/lime/cement mortar
<b>Author(s)</b>	Riccardo Vetturini, Fabrizio Mollailoli, Paolo Bazzurro
<b>Reviewer(s)</b>	Svetlana N. Brzev

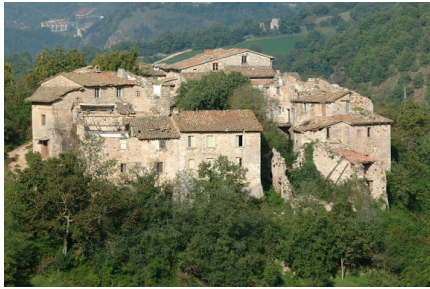
Figure 1: UMI 11 Le Cese overall view of the downhill elevation. UMI 11 is the structure immediately facing the hillside to the left of the photo. UMI 9, to the right of UMI 11, almost completely collapsed in the 1997 Umbria-Marche earthquake.

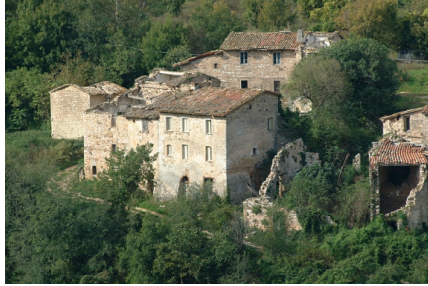
Figure 2: UMI 11 Le Cese overall view of the downhill elevation. The roof structure on the far side of the building (over the older portion) has completely collapsed.

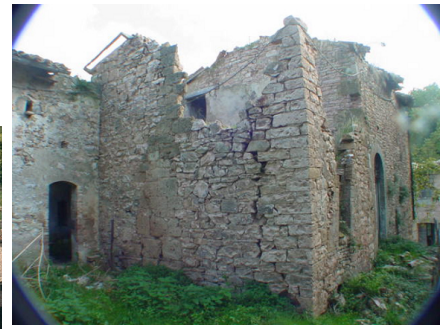
Figure 3: UMI 11 Le Cese view from the uphill side, where there are only two stories above grade. The residence sustained major damage to the stone masonry walls on this elevation in the 1997 Umbria-Marche earthquake. The roof completely collapsed as well.

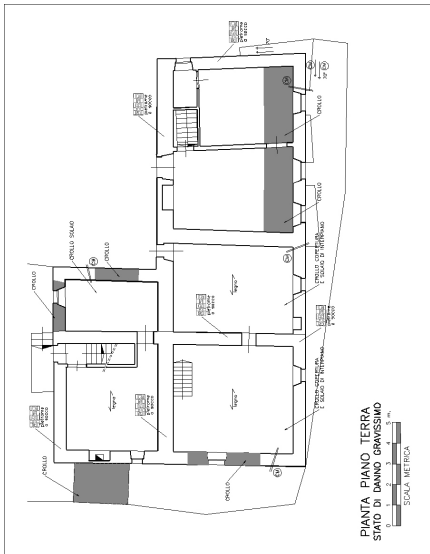
Figure 8: First-floor (ground-level) plan illustrating extent of earthquake damage.
