HOUSING REPORT

Adobe with sawn timber roof framing and corrugated iron sheeting

Report #	136
Report Date	26-05-2007
Country	GUATEMALA
Housing Type	Adobe / Earthen House
Housing Sub-Type	Adobe / Earthen House : Rammed earth/Pise construction
Author(s)	Matthew A. French
Reviewer(s)	Andrew W. Charleson

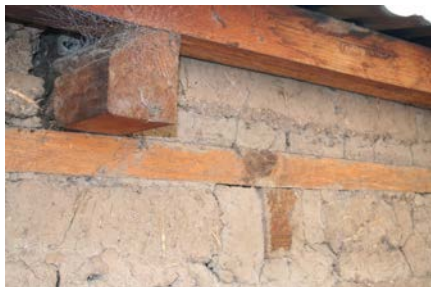
Figure 1: Connection of roof framing to wall incorporating a timber ring beam.

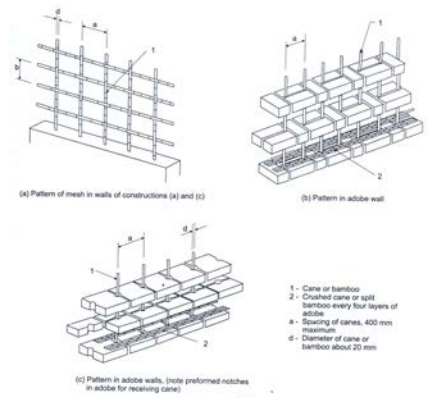
Figure 6: Bamboo reinforcing system. IAEE Guidelines, 2004, p.73.

Seismic Deficiency	Description of Seismic Strengthening provisions used
Walls: Adobe as a material has limited tension strength. Inadequate connections to return walls and lack of face load strength for long walls reduces strength	1. Bamboo: Several researchers have been involved with using internal horizontal and vertical bamboo, in a similar fashion to reinforced concrete masonry walls. 2. Timber ring beam: This helps to hold the walls together and facilitate transfer of loads from the roof to the walls. 3. 'Improved Adobe' has long been promoted to make adobe buildings more robust under seismic activity. The 'system' does not utilise another material, but focuses on the design and planning of adobe buildings by limiting opening sizes, plan dimensions, wall lengths and heights, and roof weight.
Roof: The roof will not work as a diaphragm to help transfer lateral loads to the ground.	A timber ring beam helps to hold the walls together and prevent them falling inwards. Galvanised sheet metal as is used here reduced roof loads, which minimises injury, if collapse occurs.

The bamboo strengthening scheme is not used in Guatemala, but is presented in this report as an option for making adobe buildings safer generally.

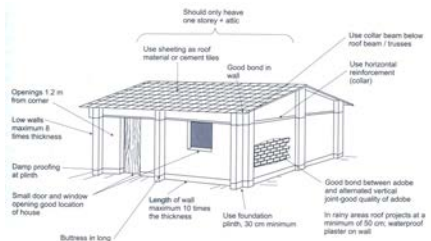
Figure 7: 'Improved Adobe' principles. IAEE Guidelines, 2004, p.75.

Bamboo: Yes, it has been implemented in Peru with successful structural results but unsuccessful local adoption of the concept. The system is not used in Guatemala. Timber ring beam: These are common now, but often limited finances ensure they are out of reach for many in Guatemala. 'Improved Adobe': Some of the principles, such as small openings and walls, are used but others such as buttresses are not evident.

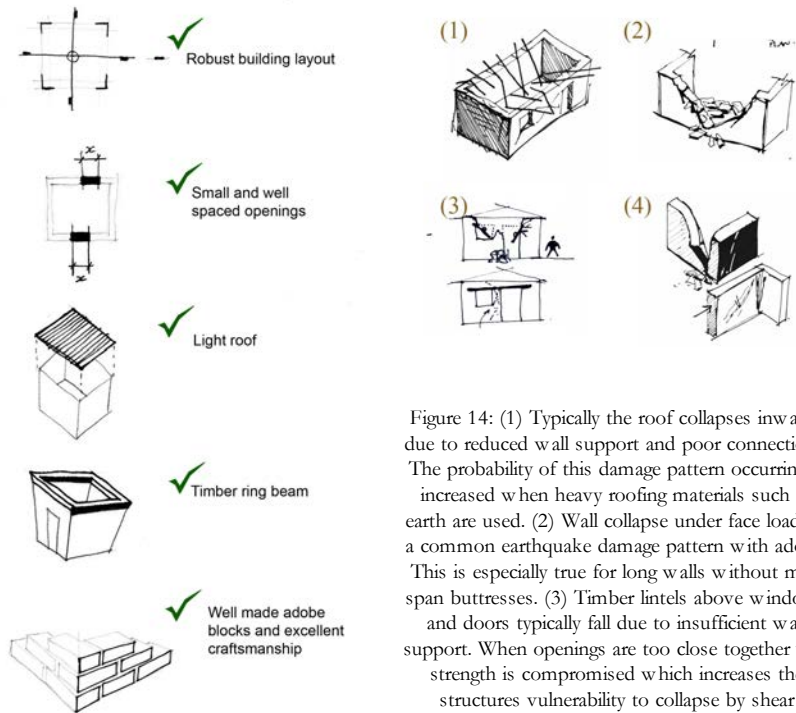
Figure 13: Seismic features of this building.

Structural Element	Seismic Deficiency	Earthquake Resilient Features	Earthquake Damage Patterns
Wall	The adobe walls are too thin and brittle to resist lateral in plane and face loads. Adobe is strong in compression, but very weak in tension.	Lintels have suitable anchorage back into the walls.	45° shear cracking under in-plane lateral loads occurs. This cracking increases vulnerability for wall collapse under face loads.
Frame (columns, beams)			
Roof and floors	The roof is too flexible and insufficiently connected to the walls to enable it to work as a rigid diaphragm.	The roof is light-weight minimising risk of injury.	The roof fails to hold the top of the walls in place. Wall displacement becomes too large and dislodges roof support, which in turn leads to roof collapse.
Other
