GEM Building Taxonomy Report

Scawthorn Japan - 7

Scawthorn

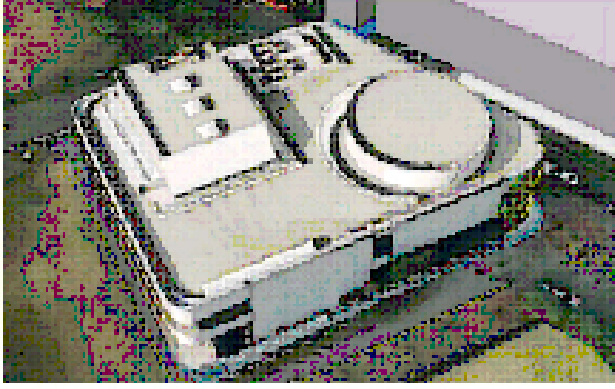
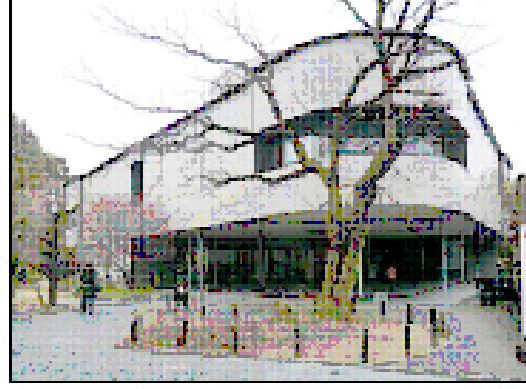
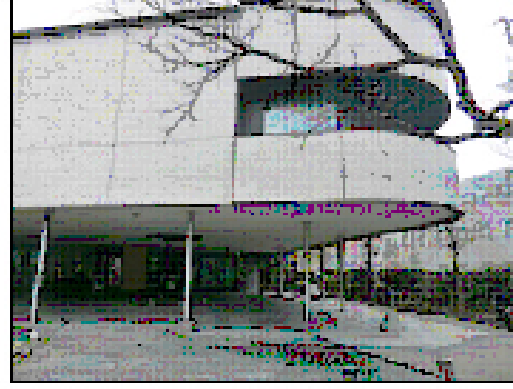
Soft storey

Change in vertical structure

Modern office building yet extreme opening on ground floor with extreme overhang - would appear to have major torsional problem
