## **GEM Building Taxonomy Report**

GR\_PIz\_Campos\_1 Mercedes Feriche

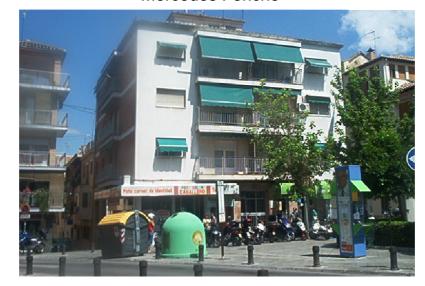
Vertical structural irregularity - secondary: Pounding potential Roof covering: Clay or concrete tile Roof system type: Concrete, unknown

It's a typical residential building before seismic design codes
