GEM Building Taxonomy Report

Reinforced concrete building Downtowner Hotel, Seattle
Svetlana Brzev

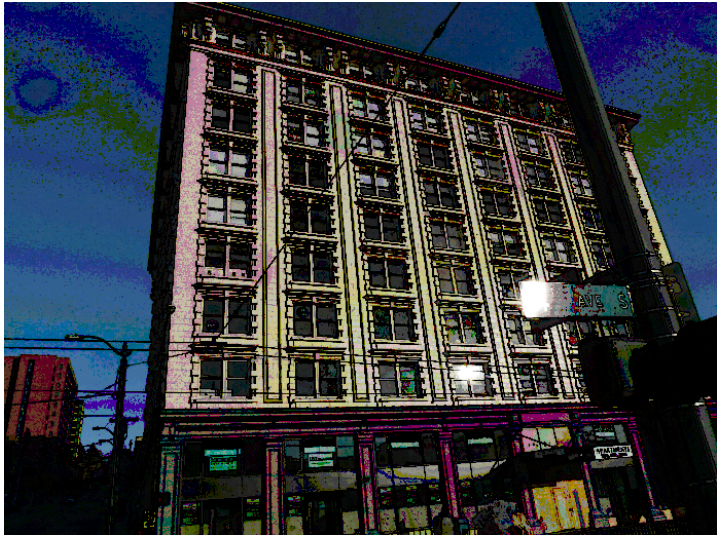
This is a 100 year old reinforced concrete building which is currently undergoing a retrofit. It used to be a hotel and it is being converted into social housing.
