World Housing Encyclopedia

HOUSING REPORT Reinforced concrete cast-in situ shear wall buildings ("OD"-type, with "fagure" plan)

Report #	78
Report Date	05-06-2002
Country	ROMANIA
Housing Type	RC Structural Wall Building
Housing Sub-Type	RC Structural Wall Building : Moment frame with in-situ shear walls
Author(s)	Maria D. Bostenaru, Ilie Sandu
Reviewer(s)	Vanja Alendar

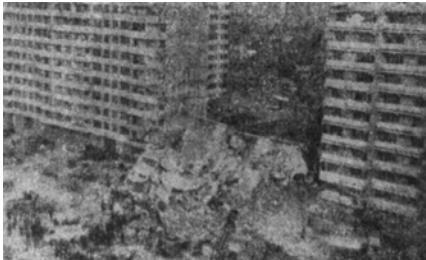
Figure 5A: Collapse of OD16 Building in the 1977 Vrancea Earthquake

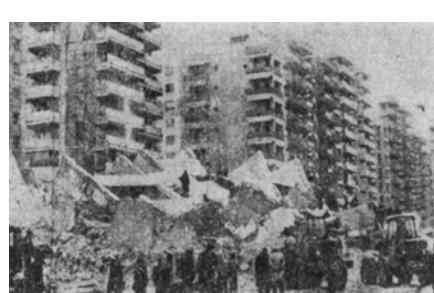
Figure 5B: Building Collapse in the 1977 Vrancea Earthquake (OD16 Building)

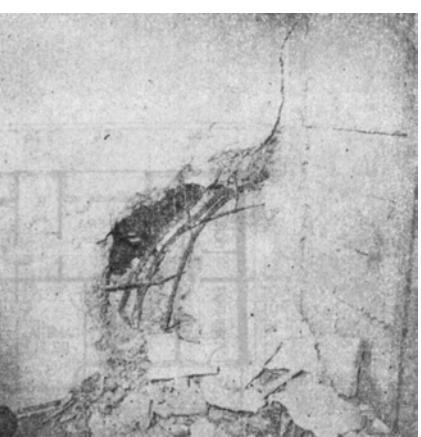
Structural Element	Seismic Deficiency	Earthquake Resilient Features	Earthquake Damage Patterns
Shear Walls	 Inadequate (too small) wall thickness of 140 mm; - Inadequate wall density in the longitudinal direction (one shear wall only); - Significantly different wall density in the two principal directions (i.e. larger wall density in the transverse direction); - Lack of ductility and inadequate amount of reinforcement (especially in the transverse direction); 	- Large stiffness, resulting in small displacements and minimized damage to nonstructural elements;	- Damage was more pronounced in the longitudinal wall (vertical and inclined cracks); - Cracking in the transverse walls was more pronounced at the low er levels where extensive "X" cracks developed in the piers between the door openings); - Brittle failure of wall end zones with spalling and bursting of the concrete at the base and buckling of reinforcement bars; - see Figures 5C and 5D

Figure 5C: Typical Earthquake Damage in RC Shear Walls (1977 Vrancea Earthquake)

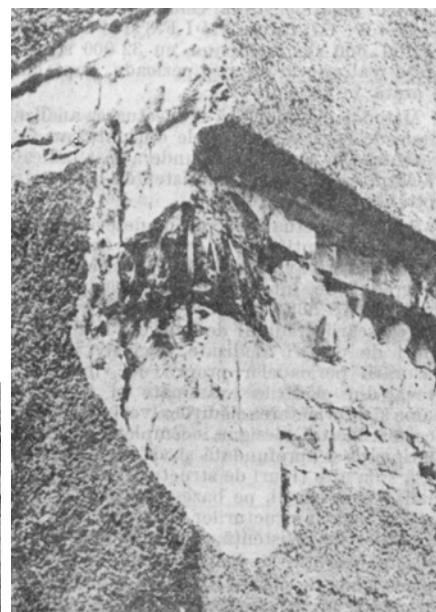
""Bulbs"- Boundary Elements'- boundary elements	- Inadequate cross-sectional dimensions (too small); - Inadequate reinforcement (10-12 mm dia longitudinal bars, very scarce ties (300 mm spacing on centre)	- Bulbs can be considered as a provision against the brittle failure; these boundary elements carry large compressive forces induced by overturning moments acting on the w alls.	- Brittle failure with concrete spalling and crushing at the base and buckling of the reinforcement (OD16 building) - Crushing of concrete and reinforcement buckling at the first floor level (OD1 example) - see Figure 5E
Lintels	- Too small depth (around 500 mm) due to the reduced floor height (2.60 - 2.70 m)	- Energy dissipation	- Extensive cracking
Other	- Actual gravity loads were larger as compared to the design loads due to finishing works and some flow er pots at the balconies construction deficiencies: variation in concrete strength, honeycombing of concrete (especially in boundary elements); - inadequate construction of seismic joints (Figure 5D)

Figure 5D: Typical Earthquake Damage in RC

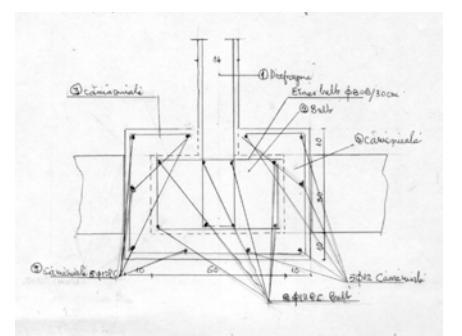
Figure 6: Illustration of Seismic Strengthening Techniques-Retrofit of Boundary Elements (bulbs)

Seismic Deficiency Description of Seismic Strengthening provisions used Shear walls: Cast in-situ RC jacketing of the boundary elements-bulbs (see Figure 6). A special care is taken to ensure the adequate bond inadequate wall between the new and existing concrete. - Jacketing with glass fibre woven fabric and epoxy resins in the severely damaged thickness and areas reinforcement Cracks in shear walls Small cracks - injecting the cracks with epoxy grout; Large cracks - filling the cracks with epoxy mortar (paste); and lintels Small cracks in shear Crack injections with epoxy resins. This was the most widely used method to repair the damages after the 1977 earthquake. The domestic resin DINOX 10L was used per the INCERC technology (C. 183-77). The injection is applied by cleaning the walls and lintels surface, making the injection holes and applying the resin.
