## **GEM Building Taxonomy Report**

Scawthorn Japan - 10

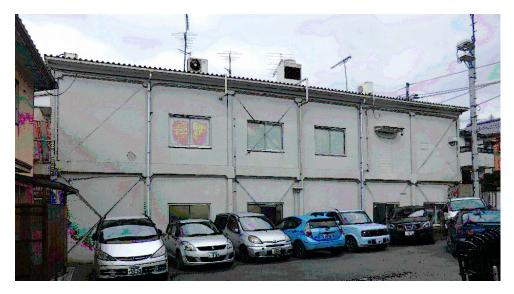
Rod bracing indicates metal framing.
