# GEM Building Taxonomy Report

Tarque\_Masonry\_Confined

Nicola Tarque

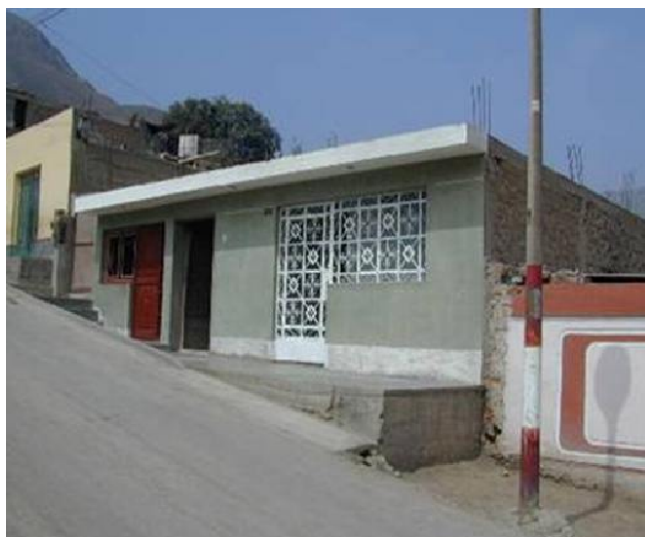
Economical confined masonry building placed at the sub-urban areas of Lima. Look at the steel reinforcement left above for a second floor (overlapping)
