World Housing Encyclopedia

HOUSING REPORT Street front building with arcade at the first floor (pre-1970's construction)

Report #	61
Report Date	05-06-2002
Country	TAIWAN
Housing Type	RC Moment Frame Building
Housing Sub-Type	RC Moment Frame Building : Designed for gravity loads only, with URM infills
Author(s)	George C. Yao, M. S. Sheu
Reviewer(s)	Craig D. Comartin

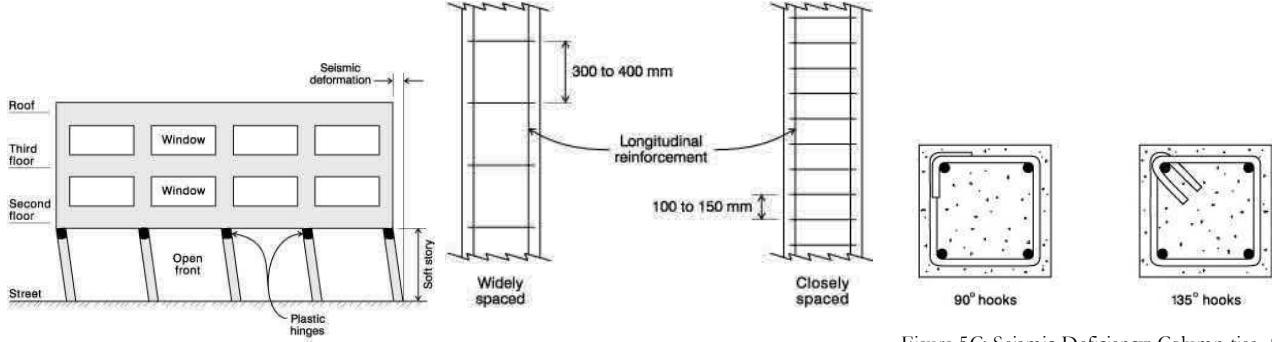
Structural Element	Seismic Deficiency	Earthquake Resilient Features	Earthquake Damage Patterns
Wall	-Unreinforced brick masonry walls are laid out in one direction only, resulting in the increased vulnerability in the other direction due to the absence of vertical elements of lateral-load resisting system, as illustrated in Figure 2A.		In a major earthquake (of intensity similar to or larger than the design level earthquake), collapse of buildings is expected to take place due to the lack of structural strength in the w eak direction.
Frame (columns, beams)	- Column reinforcement is usually spliced at the top of the slab where the column bending moments are the largest (see Figure 4). As a result of this poor construction practice, seismic capacity of the columns is largely reduced. Majority of the buildings that collapsed in the Chi-Chi earthquake were constructed this way Lack of the 135 degree stirrup hook was another major defect in building construction (see Figure 5b) Widely spaced column ties, usually spaced at 300 mm on centre which is less than the current code requirement for ductile columns that prescribes 100 mm c/c tie spacing for columns end zones. (see Figure 5a)		Collapsed columns

Figure 5B: Seismic Deficiency - Widely spaced hoop reinforcement (Source: EERI 2001)

Figure 5C: Seismic Deficiency: Column ties -90 degree hooks were used instead of 135 degree hooks (Source: EERI 2001)

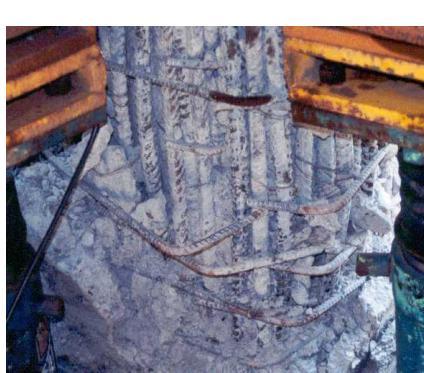
Figure 6B: Earthquake Damage - Opening of 90 degree column hooks in the 1999 Chi Chi earthquake (Source: EERI 2001)

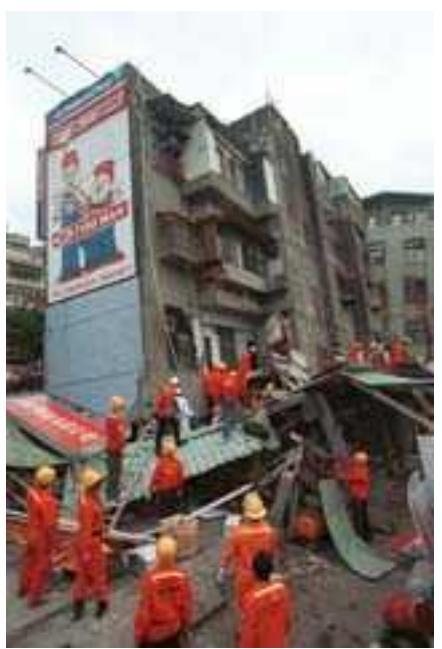
Figure 6C: Earthquake Damage - Collapse ofa 5story building in the March 31, 2002 Taipei earthquake

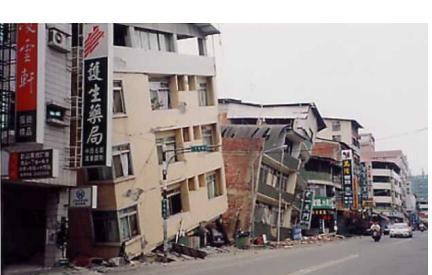
No major deficiencies		
	The open front at the bottom story is the most obvious configuration irregularity characteristic for this construction type. This feature creates undesirable soft-story and torsional effects, as illustrated in Figure 5A (Source: EERI 2001).		Extensive damage and building collapses have been due to the large demands on the bottom story columns caused by soft story and torsional effects (see Figure 6A)

Although many buildings of this construction type sustained significant damage in the 1999 Chi Chi earthquake, most of them performed satisfactorily. Earthquake damages are illustrated in Figure 6A. The main causes for damage observed after the earthquake are (EERI, 2001): 1) Poor configuration attributable to the open front combined with inadequate column lateral reinforcement (ties). The large displacement demands from the soft-story and torsional effects often damaged the plastic hinge regions of the columns at the open front. All damaged columns were observed to have non-ductile confinement reinforcement details consisting of widely spaced horizontal hoops, more than 300 mm apart, and 90 degree hooks. Usually, the lack of confinement reinforcement in the plastic hinge regions resulted in brittle failure. In some cases, hinge rotation caused buildings to permanently lean out of plumb. In other cases, buildings with no signs of earthquake damage remained standing next to the seemingly identical buildings that sustained the total collapse of entire bottom stories. 2) There was also widespread damage to the unreinforced brick partitions and perimeter walls. Although partitions are usually considered nonstructural elements, the collapse of or damage to unreinforced brick partitions represents a significant falling hazards, and it forced many people out of their homes. 3) Performance of this construction type in the earthquake was significantly influenced by the infill wall layout. Because brick infills significantly influence the structural characteristics and yet are not considered in the design, the seismic performance of this building type is highly unpredictable. A five-story building of this construction type (constructed in the early 1970's) collapsed in the March 31, 2002 Taipei earthquake. The bottom two stories were flattened in the earthquake. Fortunately no one died in this building owing to the quick response of the rescue team established after the 1999 Chi-Chi earthquake in central Taiwan. According to a local newspaper, a garage shop purchased several units at the first floor. The first floor walls were torn down to satisfy the spatial needs of a garage. As a result, a weak story formed and the building leaned forward and collapsed in the first few seconds in the earthquake.

Figure 6A: A Photograph Illustrating Typical Earthquake Damage (1999 Chi Chi earthquake)
