World Housing Encyclopedia

HOUSING REPORT

Gravity Concrete Frame Buildings (Predating Seismic Codes)

Report #	11
Report Date	05-06-2002
Country	COLOMBIA
Housing Type	RC Moment Frame Building
Housing Sub-Type	RC Moment Frame Building : Designed for gravity loads only, with URM infills
Author(s)	Luis G. Mejia
Reviewer(s)	Sergio Alcocer

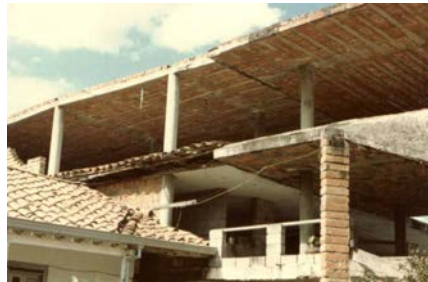
Figure 1: Typical Building

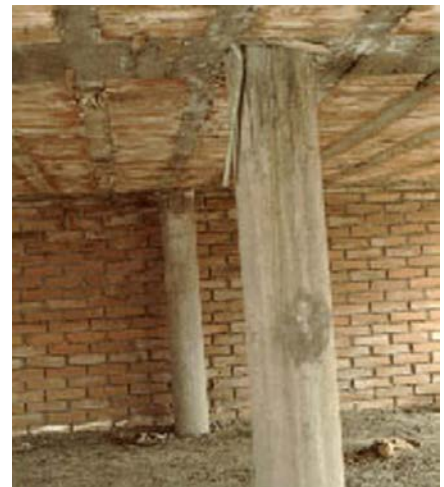
Figure 5A: Poor Construction Practices: Beams constructed in one direction only

Typical seismic deficiencies related to this type of construction, mainly due to poor construction practices and workmanship, are illustrated in the FIGURES 5A, 5B, 5C, 5D and 5E.

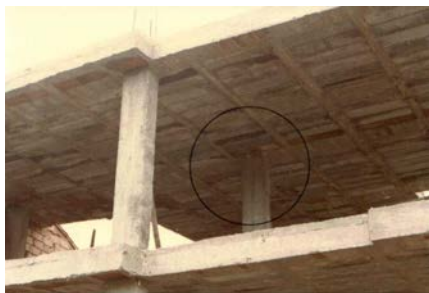
Figure 5B: Poor Construction Practice: Beams constructed in one direction only

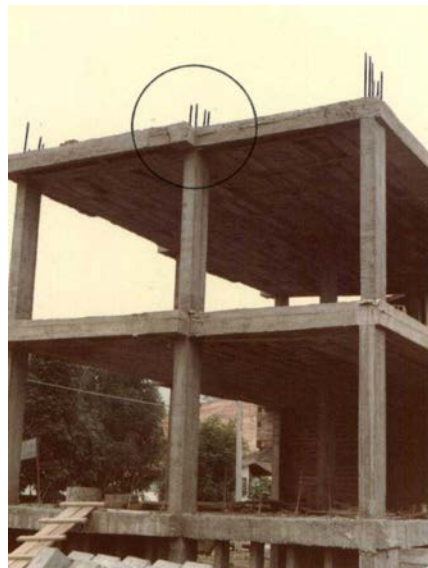
Figure 5C: Poor Construction Practice: Inadequate splice length and location (100% splices at the column base)

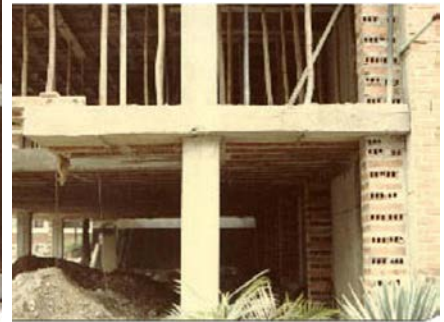
Figure 5D: Poor Design: Combination of Concrete Frames and Unreinforced Masonry Walls or Pilasters

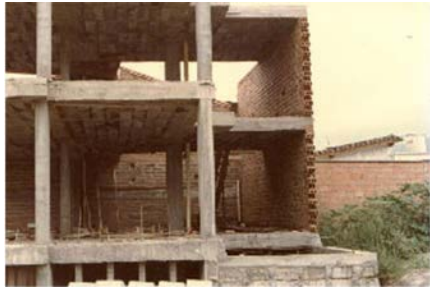
Figure 5E: Poor Design: Combination of Concrete Frames and Unreinforced Masonry Walls or Pilasters

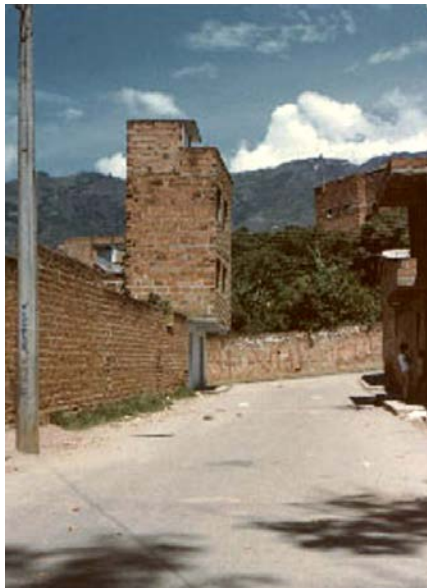
Figure 5F: Playing with the laws of equilibrium

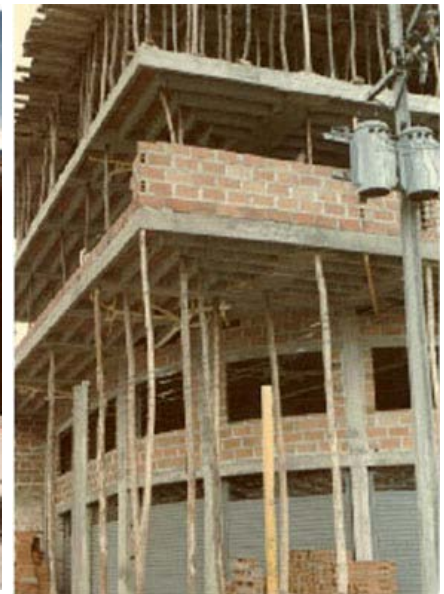
Figure 5G: Playing with the laws of equilibrium

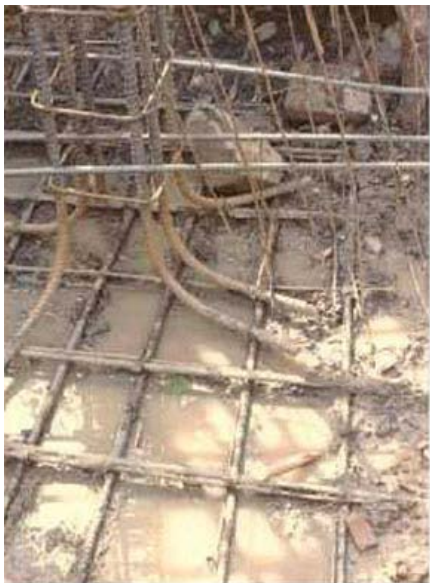
Figure 5H: Poor Workmanship: Dirty groundwork and inappropriate column and beams

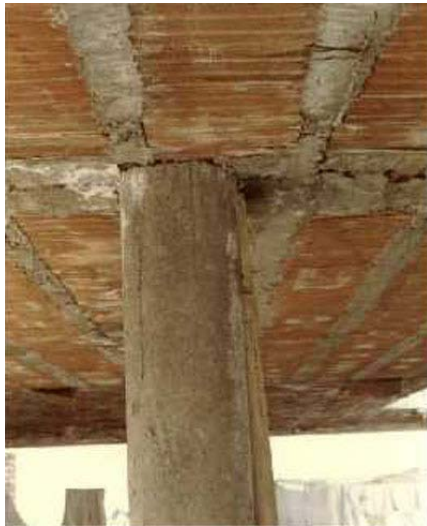
Figure 5I: Poor Construction Practice: Drains running across the girders. Stirrups are removed to allow for the pipeline passage

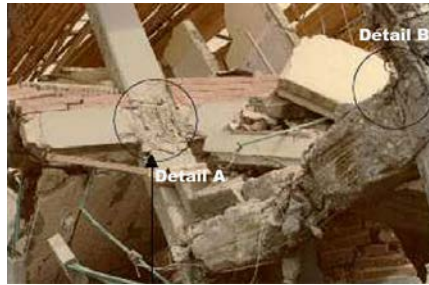
Figure 6B: Earthquake Damage: Reinforcement splices in the joint zone (Detail A)

Most buildings of this type collapsed, killing the inhabitants, especially in the areas with pronounced soil amplification. Typical patterns of earthquake damage are illustrated in FIGURES 6A, 6B, 6C, 6D, and 6E. The figures confirm the importance of good construction practice and its impact on seismic performance.

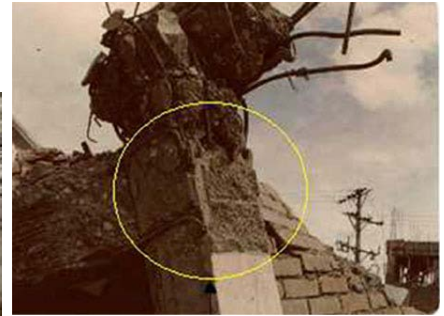
Figure 6C: Earthquake Damage: Anchorage of beam reinforcement in the column cover area (It would be correct to anchor the reinforcement inside the joint.) Detail B

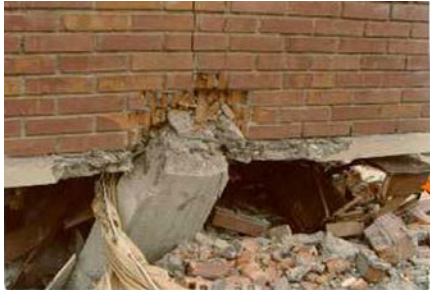
Figure 6D: Earthquake Damage: Inadequate longitudinal and transverse reinforcement (Note the collapsed first story)

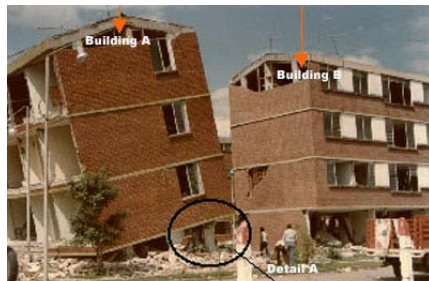
Figure 6E: Collapsed building: Detail A shows too widely spaced stirrups

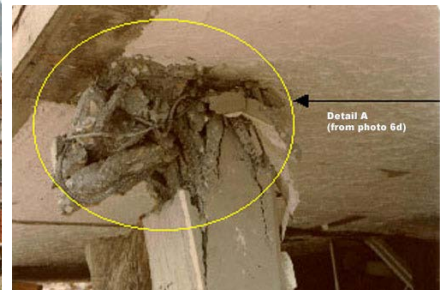
Figure 6F: Collapsed building: Detail A shows too widely spaced stirrups

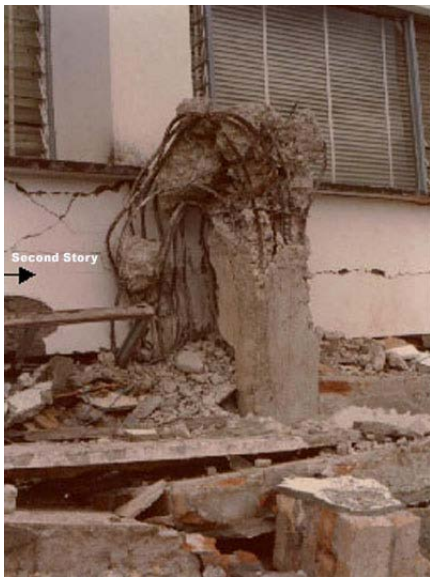
Figure 6G: Collapsed 3-story building. (Note the total lateral drift between the 2nd and 3rd floor.)

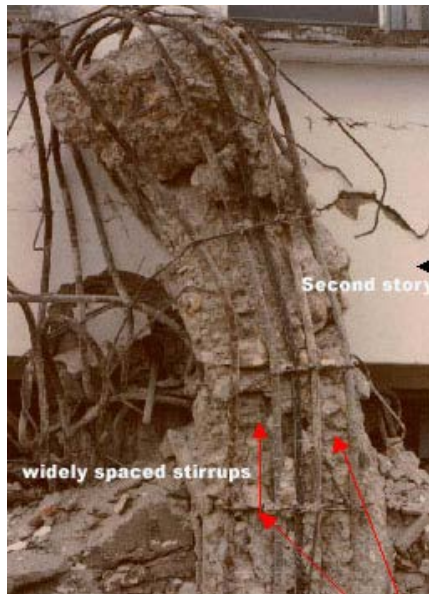
Figure 6H: First-story column collapse due to the widely spaced stirrups and poor quality of aggregate

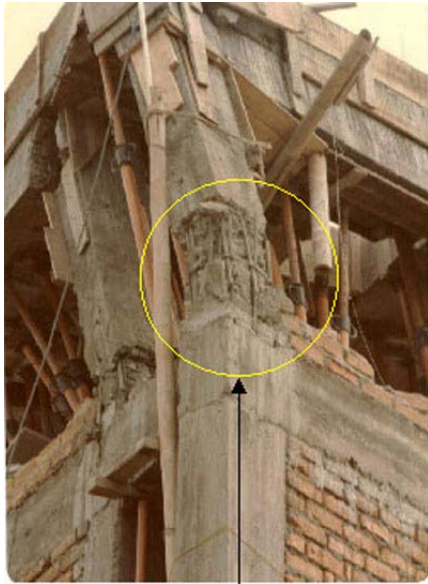
Figure 6J: Earthquake Damage: Inadequate Columns Splices

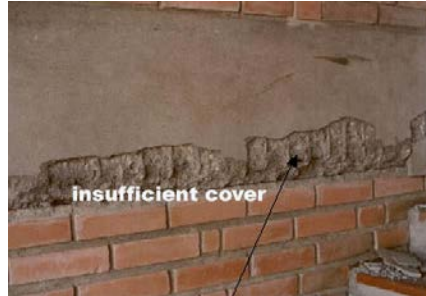
Figure 6K: Earthquake Damage: Inadequate Concrete Cover

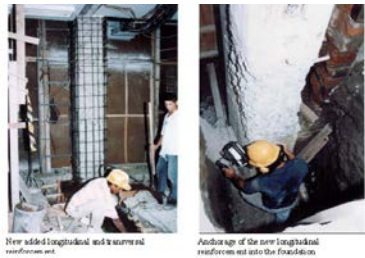
Figure 7D: Seismic Strengthening Techniques: Field Implementation

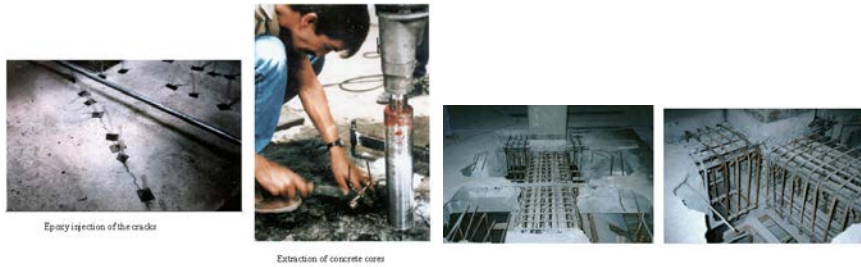
Figure 7E: Seismic Strengthening Techniques: Field Implementation
