World Housing Encyclopedia

HOUSING REPORT

Rubble stone masonry walls with timber frame and timber roof

Report #	18
Report Date	06-05-2002
Country	INDIA
Housing Type	Stone Masonry House
Housing Sub-Type	Stone Masonry House : Rubble stone without/with mud/lime/cement mortar
Author(s)	Svetlana N. Brzev, Marjorie Greene, Ravi Sinha
Reviewer(s)	Ravi Sinha

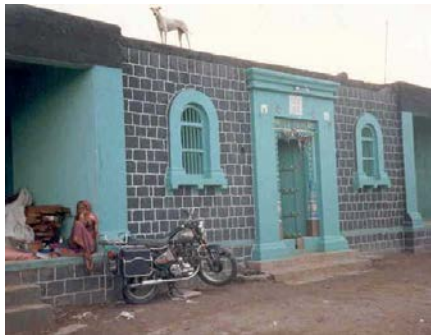
Figure 1: Typical Building

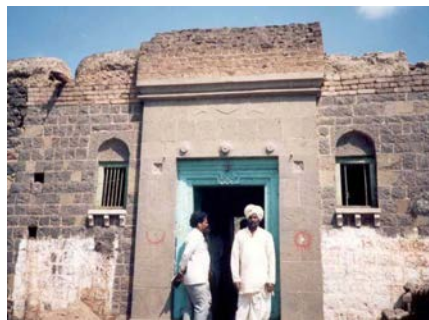
Figure 1A: Typical Building

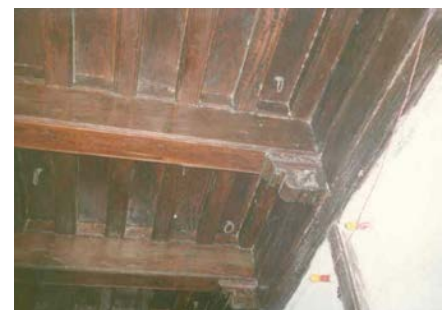
Figure 4B: Critical Structural Details - Good Quality Timber Roof Structure

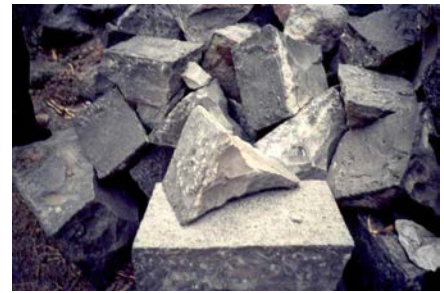
Figure 4E: A Typical Wedged-Shape Stone Used for the Exterior Wall Wythe

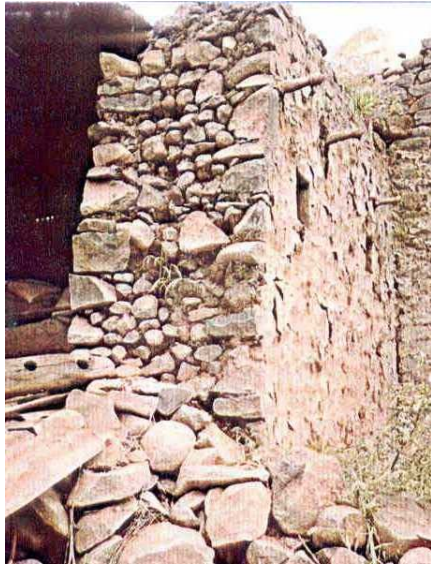
Figure 5: Key Seismic Deficiency - Extremely Thick Stone Walls

Structural Element	Seismic Deficiency	Earthquake Resilient Features	Earthquake Damage Patterns
Wall	-Extremely large thickness; -Absence of through-stones; -Unshaped boulders used in construction; -Absence of header stones at corners and junctions; -Vertical separation joints at wall corners and junctions.		-Delamination and failure of inner and outer wall wythes; -Separation of walls at the corners; -Out-of-plane collapse of the walls.
Frame (columns, beams)	-Ambiguous system of vertical load transfer: transverse timber beams supported simultaneously by timber posts and stone masonry walls; - Inadequate post-to-beam connection; -Poor quality of timber frame construction; - Poor maintenance of timber elements	Provided that post-to-beam connections in timber frames are adequate, the frames could serve as restraint and prevent the inwards collapse of the walls (an observation made after the 1993 Maharashtra earthquake).	lateral swaying of the frames due to poor post-to-beam connections (mainly deteriorated due to aging and insect attacks).

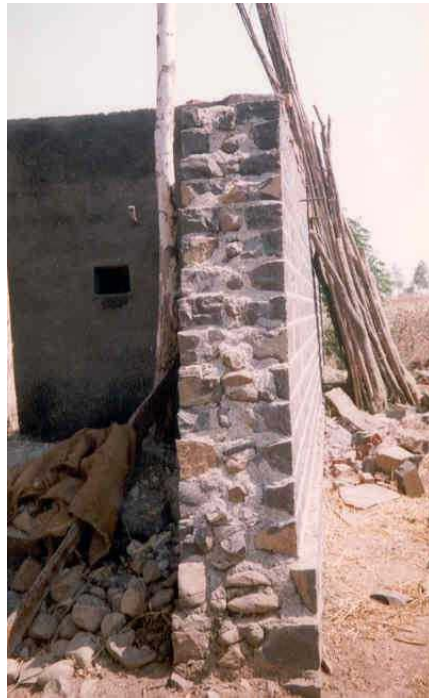
Figure 5A: Seismic Resilient Feature - Well Constructed Stone Wall

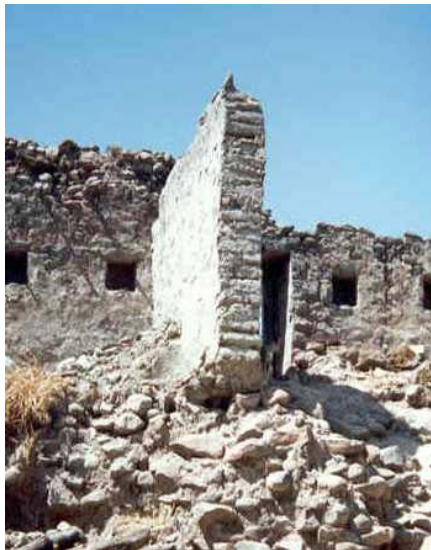
Figure 5C: Structural Deficiency - Absence of Foundations

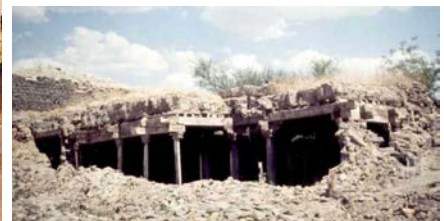
Figure 5E: Seismic Deficiency - Excessive Mud Overlay Atop the Roof

Roof and floors	Excessive weight of mud overlay atop the roof, thickness ranging from 50 to 80 cm.		-Collapse of roofs due to excessive weight and loss of stability in the frames.

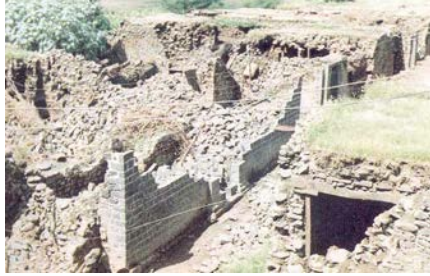
Figure 6A: Massive Collapse of Stone Masonry Buildings in the 1993 Killari Earthquake (Yelvat Village, Source: GSI 1996)

Buildings of this construction type suffered substantial damage in the 1993 Maharashtra earthquake. Close to 30,000 houses of this type collapsed, and other 200,000 houses were damaged. Typical patterns of earthquake damage and failures reported in the 1993 earthquake were: delamination and failure of stone masonry walls (out-of-plane) separation of the walls at corners and junctions lateral swaying of timber frames due to heavy roof weight and inadequate post-to-beam connections.

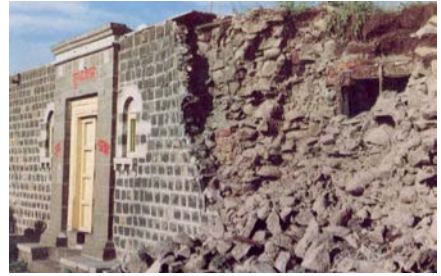
Figure 6B: Typical Earthquake Damage - Partial Collapse of the Exterior Wall in the 1993 Killari earthquake (Salegaon Village, Source: GSI 1996)

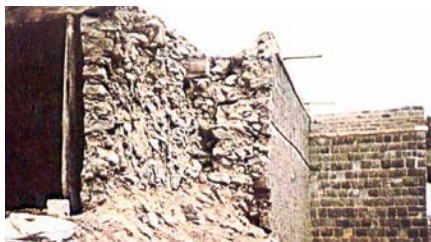
Figure 6C: Typical Earthquake Damage - Delamination of the Exterior Wall Wythe (the interior wythe remained undamaged due to restraint provided by timber posts), 1993 Killari Earthquake

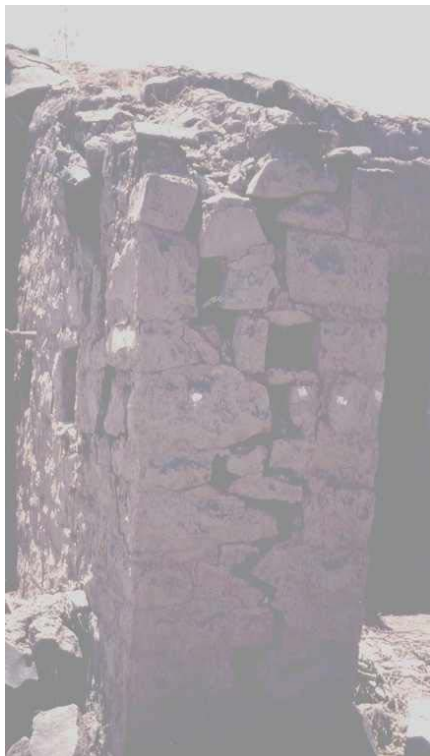
Figure 6D: Typical Earthquake Damage - Delamination of Stone Wall Wythes due to the Absence of Through Stones (1993 Killari earthquake)

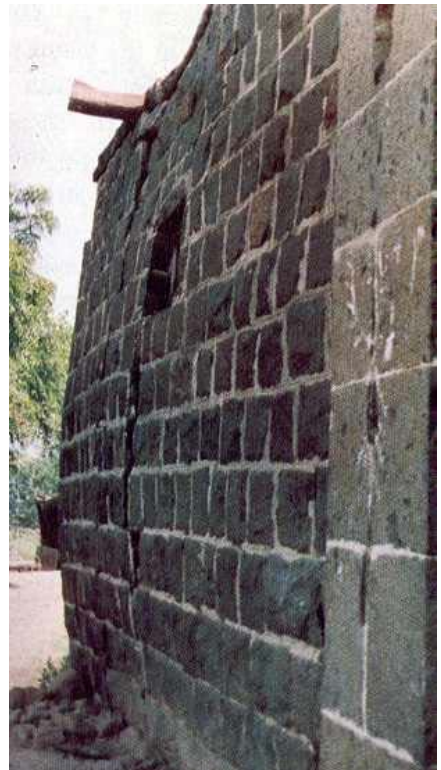
Figure 6E: Typical Earthquake Damage - Building and Cracking of a Thick Stone Wall in the 1993 Killari Earthquake (Source: GSI 1996)

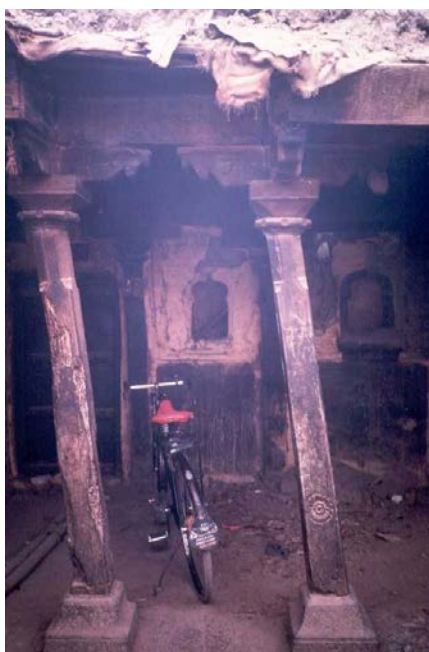
Figure 7: Seismic Strengthening Technologies for Stone Masonry Buildings (Source: GOM 1998)

Seismic Deficiency	Description of Seismic Strengthening provisions used
Heavy roof	removal of mud overlay atop the roof; simple construction.
Deficient timber frame connections	Bracing of frame (knee-brace/diagonal brace) to strengthen post-to-beam connections using timber or steel elements; simple construction; some materials (e.g. rolled steel sections) may not be locally available; timber braces considered to be more appropriate.
Thick multi-wythe walls without through-stones	Installation of through-stones; requires training of local artisans (new skills); must be performed very carefully;
Separation joint at wall corners	Strengthening of wall corners using wire mesh and cement overlay; welded wire mesh usually not available locally in rural areas.
Lack of integrity of load-bearing structure to lateral loads	Installation of concrete ring beam (band) at the lintel/roof level
Delamination of exterior wall wythe	Pointing of exterior walls in cement mortar

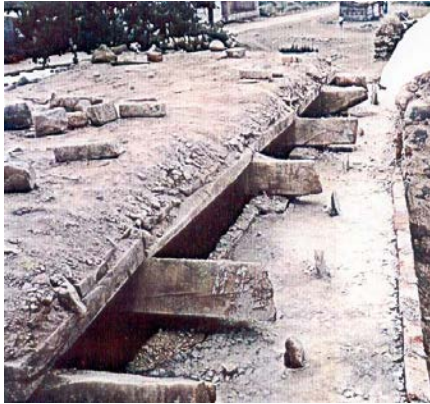
Figure 7C: Seismic Strengthening - Installation of a Bandage at the Lintel Level (an alternative to the installation of RC band) Source: GOM 1998

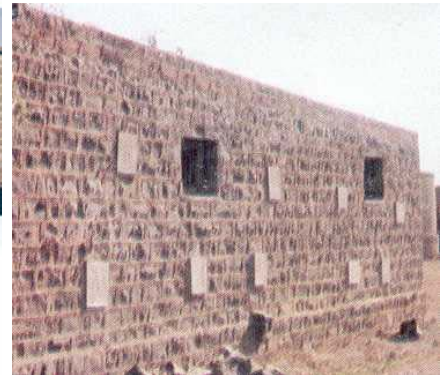
Figure 7H: Seismic Strengthening - An Example of a Retrofitted Building (note through-stones and RC lintel band)
