World Housing Encyclopedia

HOUSING REPORT

Stone masonry apartment building

Report #	75
Report Date	05-06-2002
Country	ALGERIA
Housing Type	Stone Masonry House
Housing Sub-Type	Stone Masonry House : Rubble stone without/with mud/lime/cement mortar
Author(s)	Mohammed Farsi, Farah Lazzali, Yamina Ait-M
Reviewer(s)	Marjana Lutman

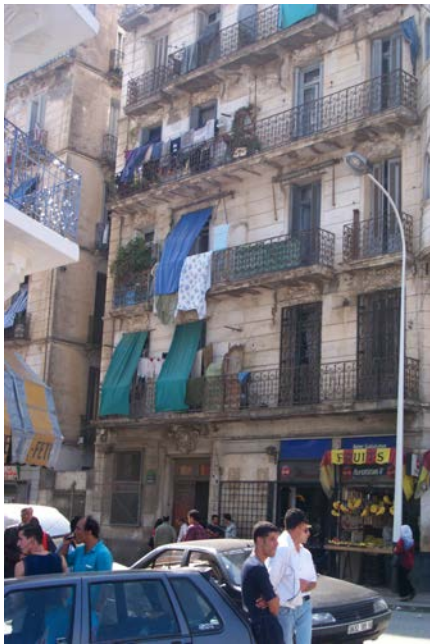
Figure 1: Typical Building

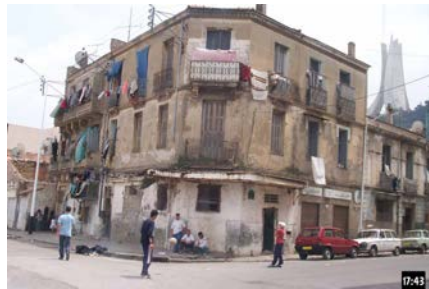
Figure 1B: A typical old stone masonry building in Algiers city

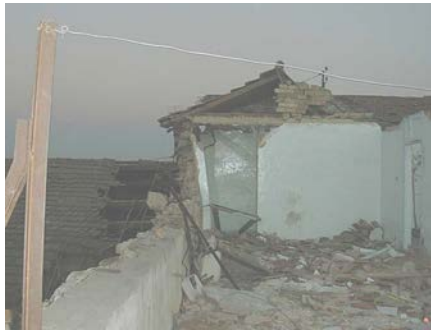
Figure 5A: Typical Earthquake Damage: Partial Roof Collapse (1999 Ain-Temouchent Earthquake)

Buildings of this type were affected by the May 21, 2003 earthquake with the epicenter close to Zemmouri. The earthquake was of magnitude $M_w = 6.8$ and the intensity was IX-X (MMI scale). In general damage patterns vary from diagonal "X"-cracks to total wall collapse, and partial to total collapse of the roofs/slabs. Earthquake, Total Number of Apartment Buildings (all types), Damage level (MSK scale) 1 2 3 4 5 1980 El-Asnam, 4844 439 1304 1351 863 887 1989 Tipaza, 4511 1480 1102 223 426 1280 1994 Mascara, 1874 470 302 351 212 539 1999 Ain-Témouchent, 3398 1062 606 684 528 518.

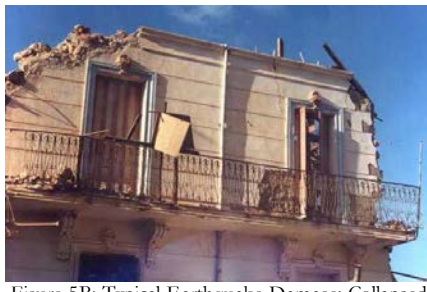
Figure 5B: Typical Earthquake Damage: Collapsed Roof of a Masonry Building (1989 Tipaza Earthquake)

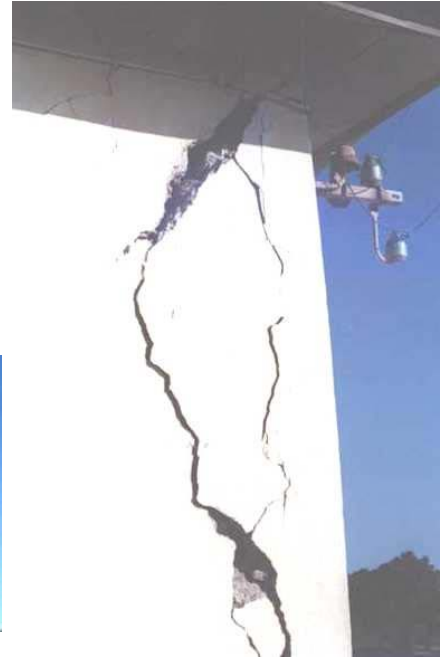
Figure 5C: Typical Earthquake Damage: Cracking in the Wall Corners

Structural Element	Seismic Deficiency	Earthquake Resilient Features	Earthquake Damage Patterns
Wall	Poor mortar strength; walls not tied together		X-cracks and total collapse in some cases; very low seismic resistance
Frame (columns, beams)			
Roof and floors	Not monolithic; not rigid in-plane		
Other

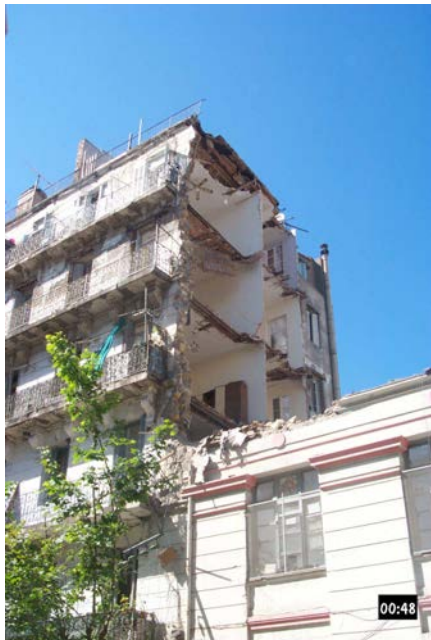
Figure 5D: Damage to a stone masonry building in Algiers in the May 21, 2003 earthquake

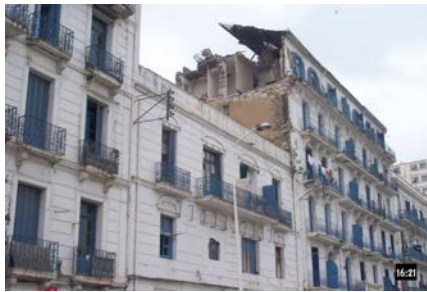
Figure 5E: Collapse of a roof and a side wall in a multi-storey stone masonry building in Algiers city in the May 21, 2003 earthquake

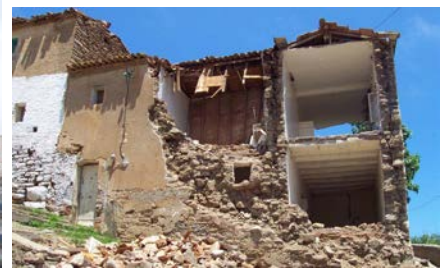
Figure 5F: Totally collapsed stone masonry building in Delys (Boumerdes) in the May 21, 2003 earthquake

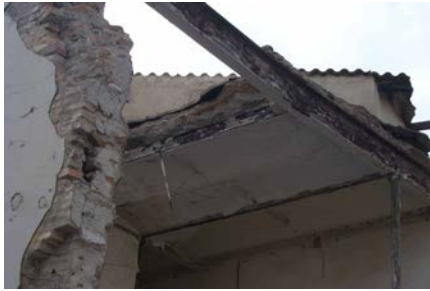
Figure 5G: Collapse of the vaulted brick and steel floor system in the May 21, 2003 earthquake (EI Harrach district, Algiers)

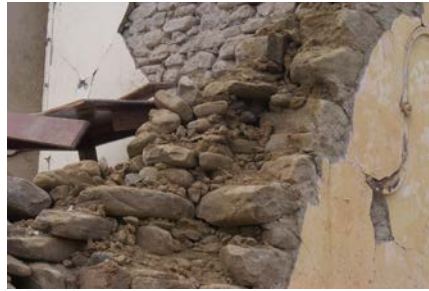
Figure 5I: Collapse of a rubble stone masonry wall made of river stones and mud mortar in the May 21, 2003 earthquake (Sidi Daoud, Boumerdes)

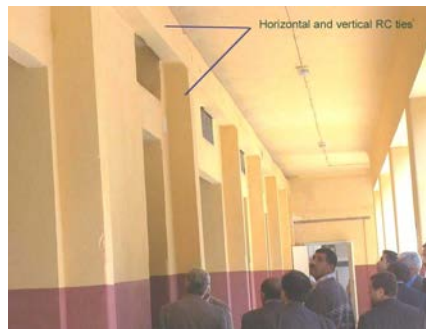
Figure 6B: Seismic Strengthening Techniques: An Example of a Strengthened Building with Vertical and Horizontal RC Ties at the First Floor Level

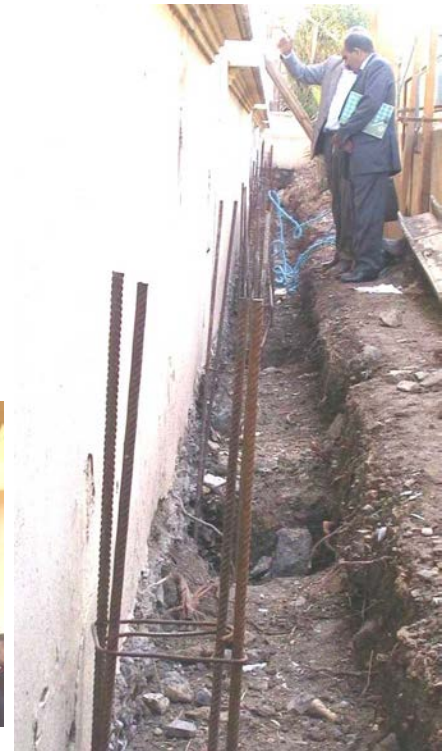
Figure 6C: Seismic Strengthening Techniques: Construction of RC Ties
