World Housing Encyclopedia

HOUSING REPORT

Low-strength dressed stone masonry buildings

| Country | INDIA |

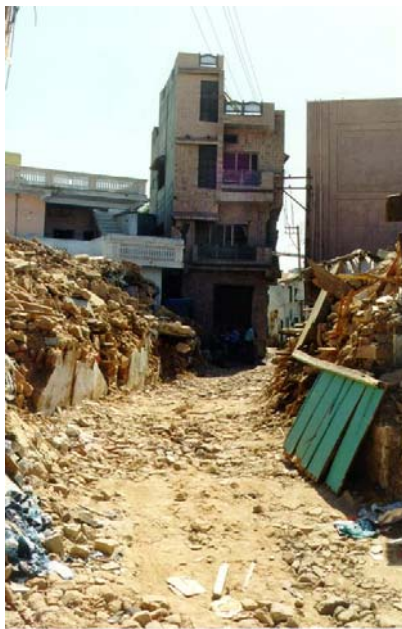
Figure 1: Typical Suburban Building

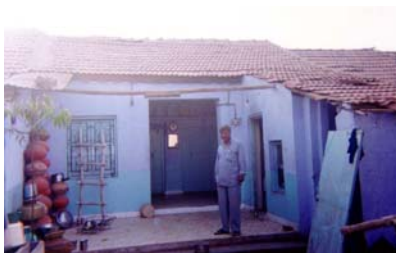
Figure 2: Typical Rural Building

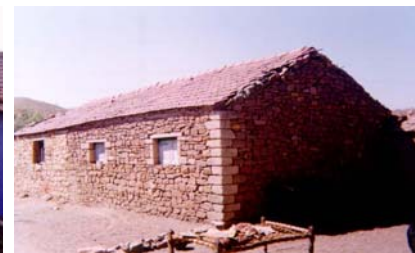
Figure 3: Key Load-Bearing Elements

The vertical load-resisting system is stone masonry walls. The gravity load-bearing system consists of the walls which carry the floor and roof loads. The walls, in turn, transmit the loads to the foundations, which consist of strip footings, which vary in depth from 0.5m to 2.0 m (depending on the number of stories and the local soil conditions). Most rural houses have gable end timber roof truss with conventional or Mangalore type clay tiles as roofing resting on bamboo or timber

The lateral load-resisting system is stone masonry walls. This housing type is characterized with rather poor lateral load resistance. Lateral loads are resisted by the stone masonry walls; however, due to the low strength of walls in these constructions (due to use of low-strength mortar and absence of earthquake-resistant features), the walls are vulnerable to earthquake effects. In single-storey constructions, the roof may consist of wall-supported flexible truss, which is not effective in distributing the storey-level inertia forces to the different resisting elements. In these constructions, openings are often found near the corners which further weaken their resistance to lateral loads.

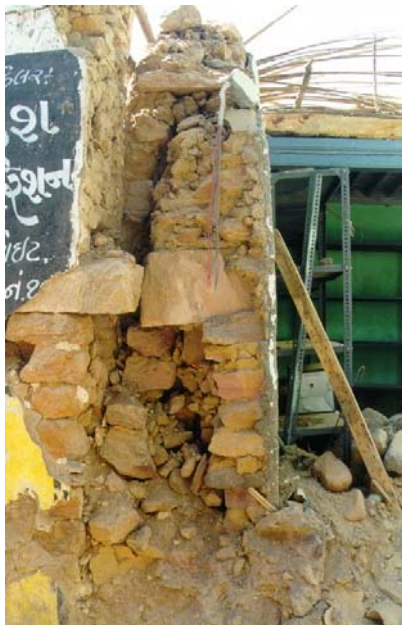
Figure 5: Key details: multi-wythe wall construction

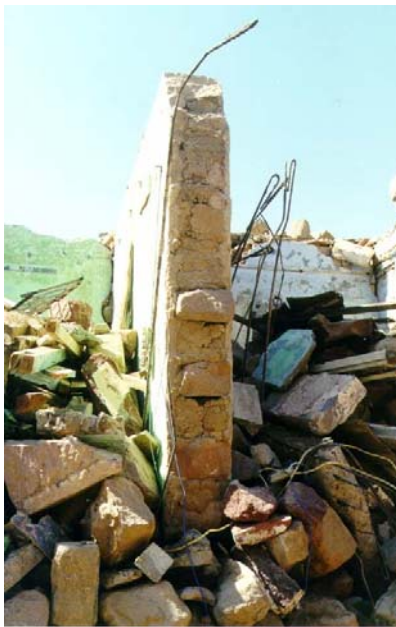
Figure 6: Key details: section through a single-wythe wall

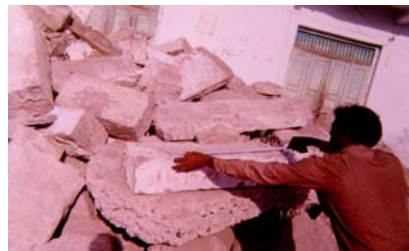
Figure 7: Key details: stone lintels

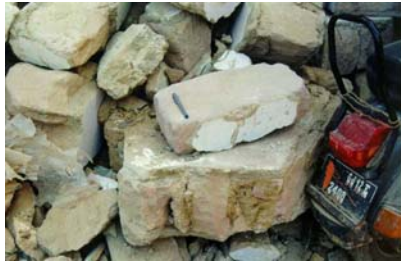
Figure 8: Key details: size of stones used in construction

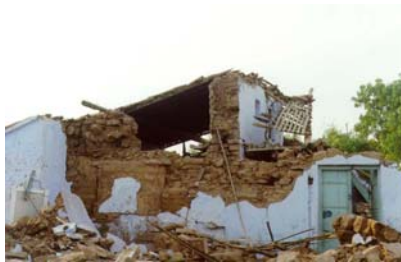
Figure 11: Seismic deficiencies: collapse of stone masonry building due to inadequate wall connections (2001 Bhuj earthquake)

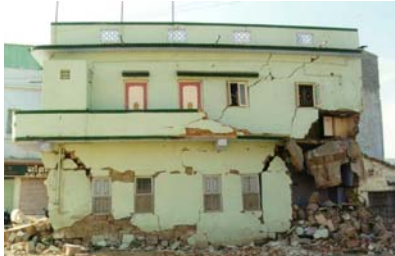
Figure 12: Seismic deficiencies: in-plane shear wall failure (2001 Bhuj earthquake)

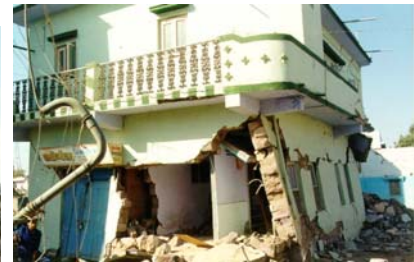
Figure 13: Seismic deficiencies: improper wall-concrete floor slab connection resulting in the out-of-plane wall

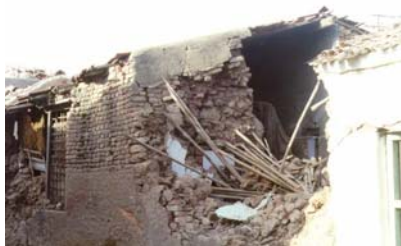
Figure 14: Seismic deficiencies: separation of wall wythes due to absence of through-stones (2001 Bhuj earthquake)

| Seismic Deficiency | Description of Seismic Strengthening provisions used |
|---|--|
| Inadequate lateral load resistance of masonry walls due to the absence of through stones in the walls | Lateral strength of masonry units can be increased by inserting new walls in one or both directions; through-stones can also be added to tie the wythes. |

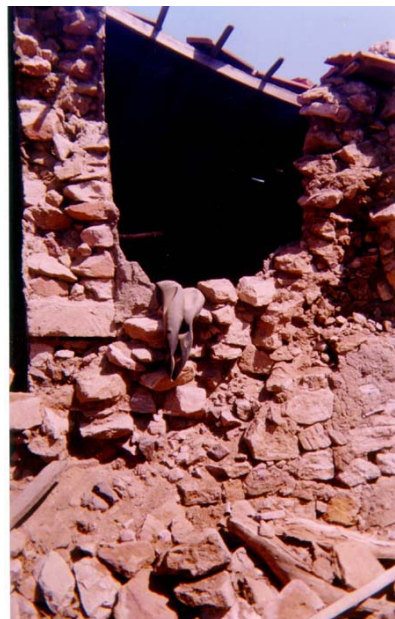
Figure 15: Seismic deficiencies: poor mortar strength in stone masonry walls resulting in the wall collapse (2001 Bhuj Earthquake)

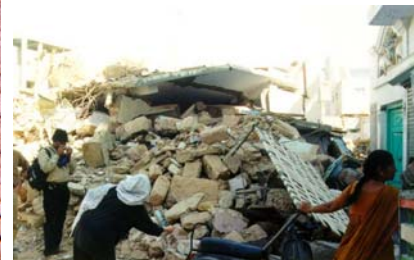
Figure 16: Earthquake damage: complete collapse of a stone masonry building due to inadequate mortar strength (2001 Bhuj Earthquake)

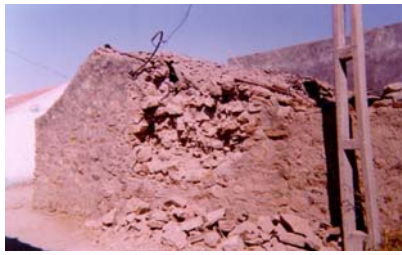
Figure 17: Earthquake damage: out-of-plane wall corner failure (2001 Bhuj Earthquake)

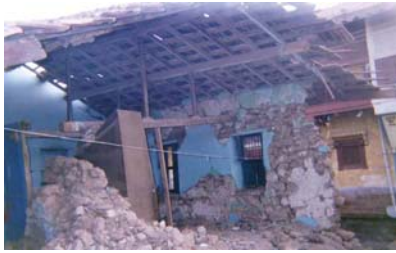
Figure 18: Building Collapse due to Lack of Earthquake Resistant Features (2001 Bhuj Earthquake)

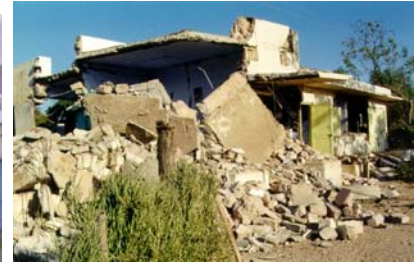
Figure 19: Building Collapse due to the Torsional Motion of Reinforced Concrete (RCC) Roof Slab (2001 Bhuj Earthquake)
