# World Housing Encyclopedia

# Block of flats with 11 floors out of cast-in-situ concrete, gliding frameworks

Report #	87
Report Date	30-11-2002
Country	ROMANIA
Housing Type	RC Structural Wall Building
Housing Sub-Type	RC Structural Wall Building : Moment frame with in-situ shear walls
Author(s)	Maria D. Bostenaru
Reviewer(s)	Dina D'Ayala

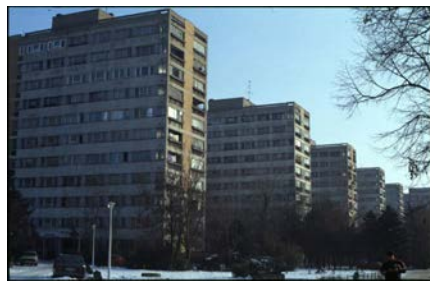
Figure 2: Assembly of buildings of this type

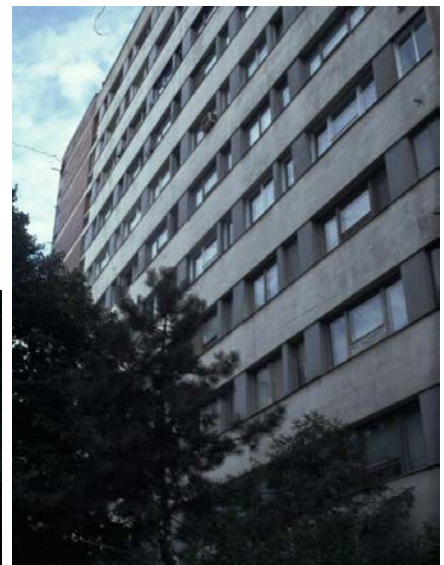
Figure 3: View of the main south facade of a typical building.

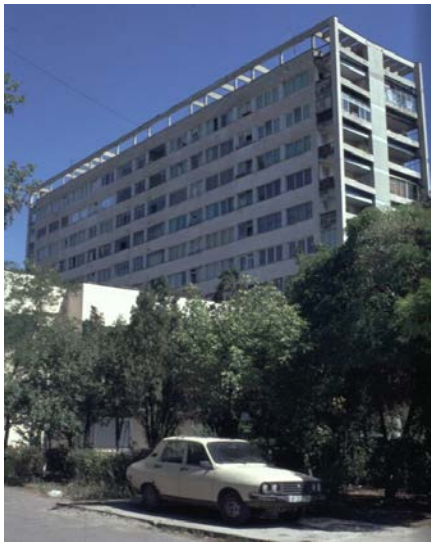
Figure 10: View of a building with increased length, due to the presence of two staircase. Figure 10: The layout of the individual flats except a single room flat in the middle, and the typical structure are the same.

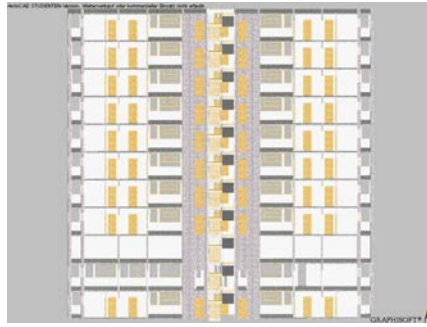
Figure 14: Longitudinal 3D section. Note that in the first and second upper floors the non structural walls respectively the openings have been omitted.

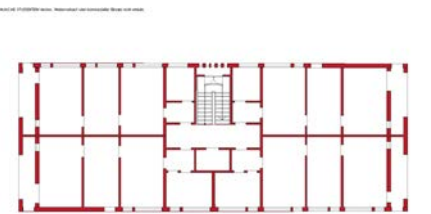
Figure 26: Layout of load bearing walls and their openings in a current floor

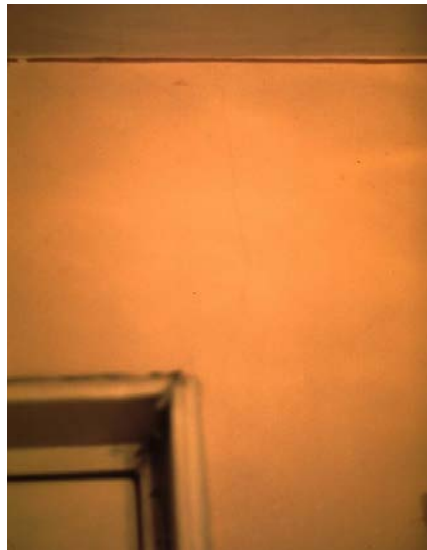
Figure 35: Vertical rift in shear wall going out from door opening corner

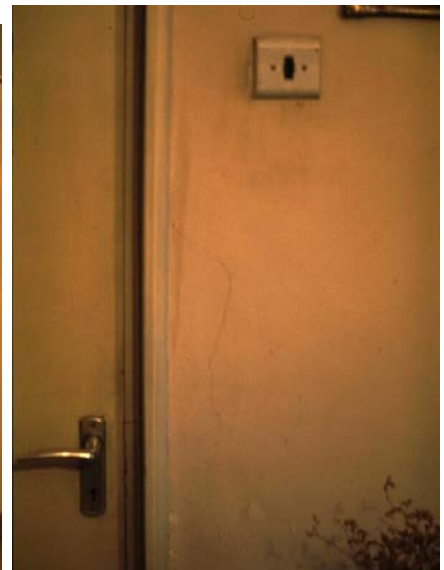
Figure 36: Vertical rift near door.

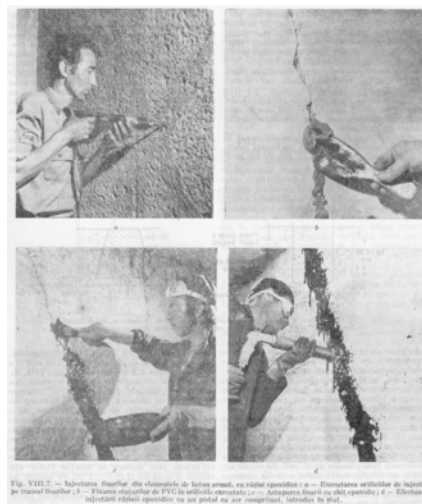
Figure 37: Epoxy resin injections (after Balan, P. 416)

Seismic Deficiency	Description of Seismic Strengthening provisions used
Small cracks in structural walls and lintels	Epoxy resins injections and plating with Rooving layers ("Folie") 1. Dismantling the plastering; 2. Mechanical execution of 2cm wide holes (4 in a square metre); 3. injections of the cracks with epoxy resin; 4. Plating of the elements with Rooving-type weaving; 5. Plastering with M50-T mortar. More details can be seen at INCERC.

According to tests done at the Aristotle University of Thessaloniki (as quoted by G. Bourlotos in his study work; original source Dritsos P. 190) epoxy resin injections fully establish the properties the structural wall had before the measure.
