# World Housing Encyclopedia

## HOUSING REPORT

### Rural mud house with pitched roof

<b>Report #</b>	23
<b>Report Date</b>	06-05-2002
<b>Country</b>	INDIA
<b>Housing Type</b>	Adobe / Earthen House
<b>Housing Sub-Type</b>	Adobe / Earthen House : Mud walls
<b>Author(s)</b>	Amit Kumar
<b>Reviewer(s)</b>	Ravi Sinha

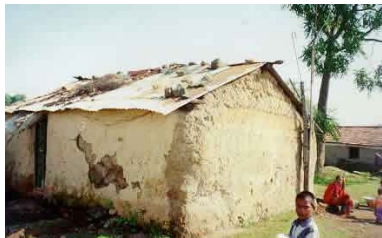
Figure 1: Typical Building

This is a typical rural construction found throughout India, except in the high rainfall areas in the northeastern part of the country. It is a single-family house, mainly occupied by the poorer segment of the population. The main load-bearing system consists of mud walls, which carry the roof load. In some cases wooden posts are provided at the wall corners and at intermediate locations. The wooden posts and walls are not structurally integrated, and therefore the loads are shared by the walls and the frame. There are very few openings (doors and windows) in these buildings. In rural areas there are usually no windows at all. In general, this type of construction is built by the owners

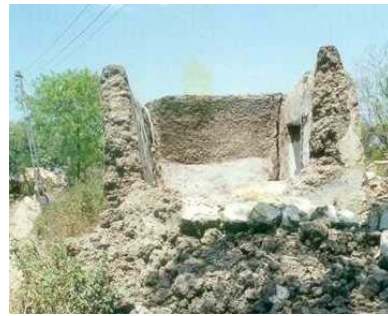
Figure 4: Critical Structural Details: Wall Section (Source: Sudhir K. Jain)

The building is constructed with the help of masons. Generally no technical and engineering input is used during the construction process. Foundation: Trench of about 2.5 feet is excavated along the walls. Stone blocks are rammed with mud into the trench to form consolidated foundation. Timber posts, if used, are erected during the ramming of stones. The load-bearing wall is erected above the ground level. The stone walls are sometimes constructed up to 2 feet above ground level, and the mud wall is extended above this level. Wall construction: The wall is made up of mixed mud with wheat husks and water (mud-polymer composite). Generally the wheat husk is mixed and kept for about a week to give it a homogenous texture. The mud mortar is placed and rammed to make it compacted. The wall is erected up to about 2.5 feet in each lift and allowed to dry for one or two days before the next lift. Roofing: Roof truss is either made up of bamboo, wood or built up steel section. The spacing between purlines and rafters are generally not regular. Generally old conventional typical house is covered with heavy clay tiles. The cladding material may not be firmly anchored to the trusses and wall. Openings : Generally mud wall buildings are provided with very few large openings. The construction of this type of housing takes place incrementally over time. Typically, the building is originally not designed for its final constructed size. The building byelaws in rural areas are not yet enforced. It requires proper enforcement to the rural and urban areas.

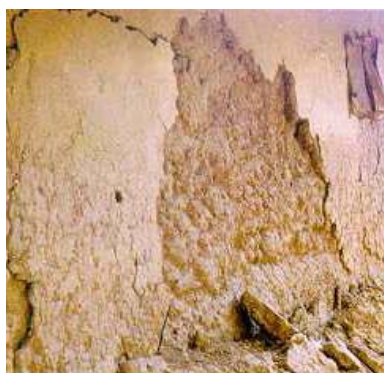
Figure 6: Typical Earthquake Damage

Jabalpur earthquake of May 22, 1997 seriously affected the life and damaged properties in the epicentral area. It is estimated that about 33,000 buildings in the urban areas and 24,000 buildings in the rural areas were partially damaged or completely destroyed. A typical earthquake damage is shown on Figure 6 (Source: BMTPC Publication, 1997, Part-1, Earthen Houses With Clay Tile Roofing Guidelines for Damage Assessment and Post-Earthquake Action).

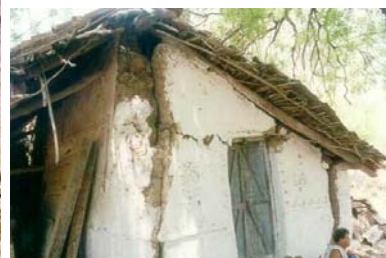
Figure 6A: Typical Earthquake Damage - Cracking and Separation of Walls in the 1997 Jabalpur Earthquake (Source: Sudhir K. Jain, IIT Kanpur)

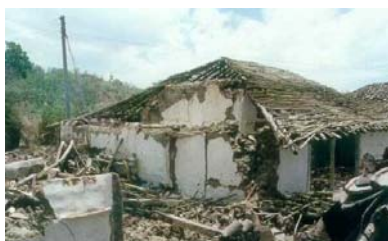
Figure 6B: Typical Earthquake Damage - Collapse of roof in the 1997 Jabalpur Earthquake (Source: Sudhir K. Jain, IIT Kanpur)

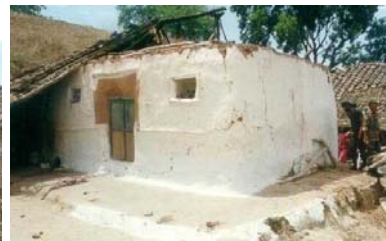
Figure 6D: Typical Earthquake Damage - Cracking of Walls in the 1997 Jabalpur Earthquake (Source: Sudhir K. Jain, IIT Kanpur)

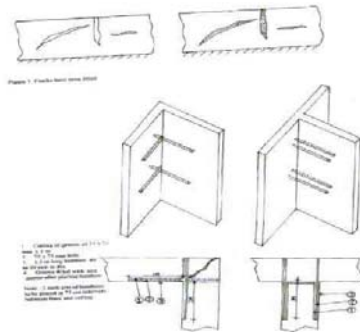
Figure 7A: Strengthening measures suggested in IAEE Manual

Seismic Deficiency	Description of Seismic Strengthening provisions used
No connection between adjacent walls	Provision of wooden bracing at regular interval in walls
Poor connection between roofing elements	Strengthening of roofing elements through bracings Securely tying of rafters to roof truss after removal of all tiles and purlins at the roof level
Large Opening	Reducing the openings and provide additional strength to openings (Refer figure 7A)
Wall	Filling of cracks with good fiber-reinforced mortar.
Wall	Stitching of corner cracks with bamboo ties at 75 cm c/c.

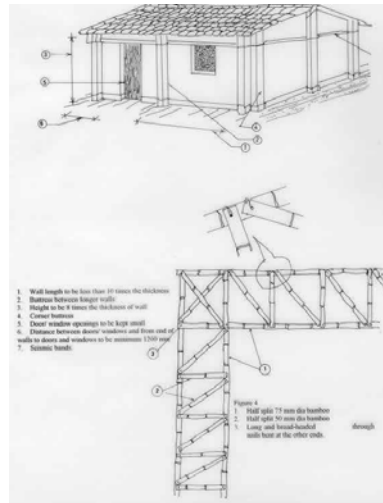
Figure 7B: Strengthening measures suggested in IAEE Manual

Seismic Deficiency	Description of Seismic Strengthening provisions used
Wall span	Provide additional support if span exceeds 5 m.
Planning	Place roof truss and rafters in a symmetric or regular arrangement.
Wall	Reduce height of wall to ensure height/thickness ratio less than 8.
Wall	Provide bamboo seismic bands at lintel and roof level.
