Earthquake-Resistant Construction of Adobe Buildings: A Tutorial

Marcial Blondet
Pontificia Universidad Catolica del Peru

Published as a contribution to the
EERI/IAEE World Housing Encyclopedia, www.world-housing.net

March 2003

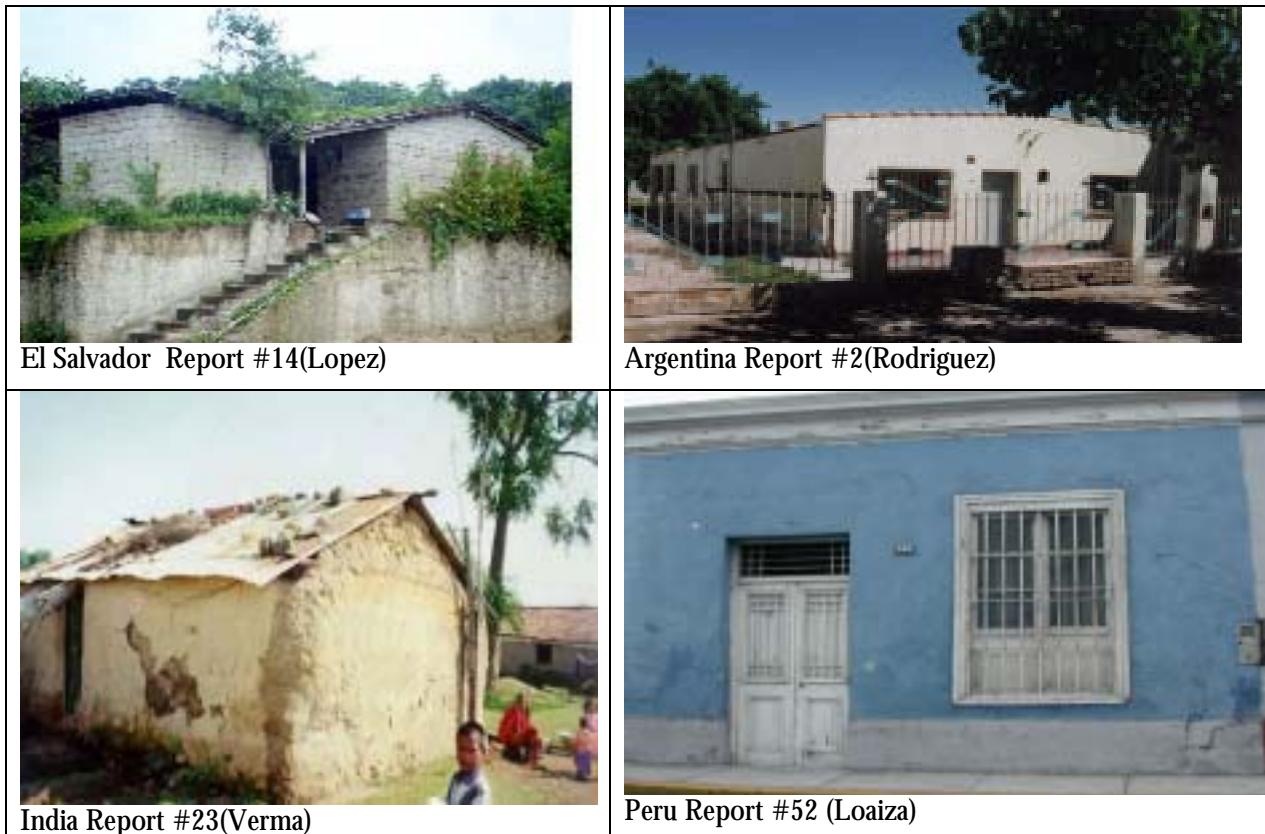
Figure 3 – Several of the Typical Adobe Houses Described in the EERI/IAEE World Housing Encyclopedia. (www.world-housing.net)

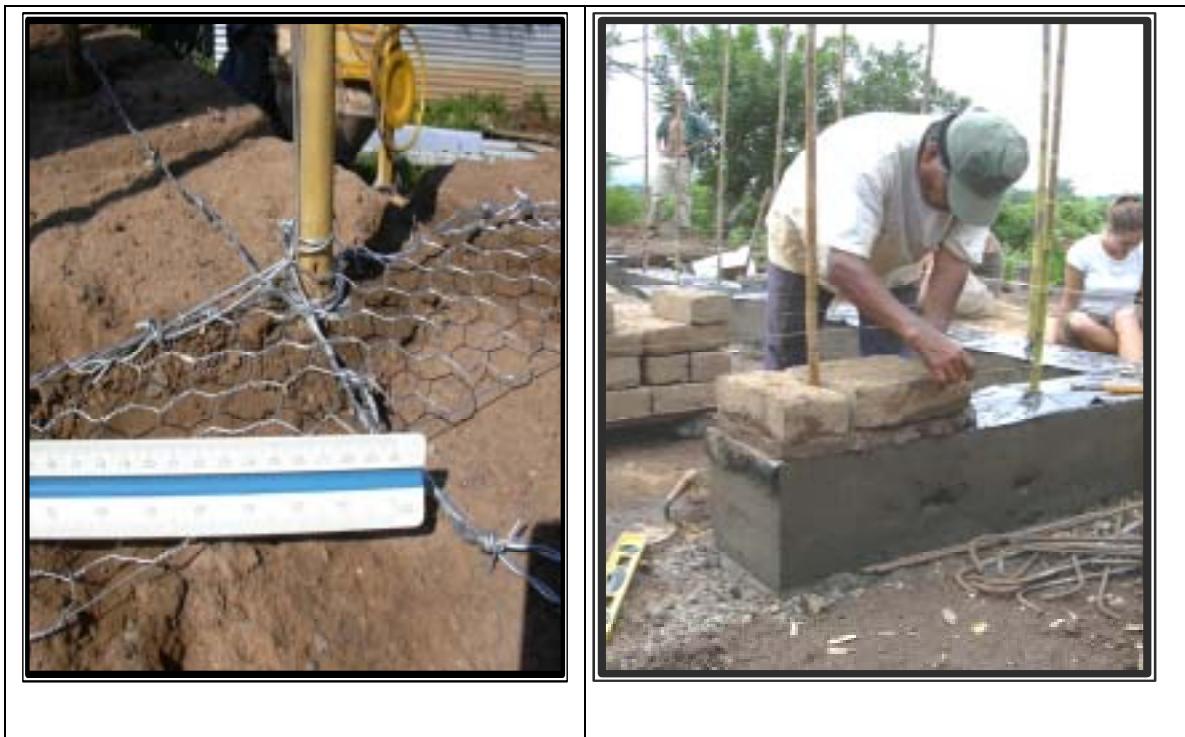
Figure 12 – Construction of Cane Reinforcement In El Salvador (Dowling, 2002)

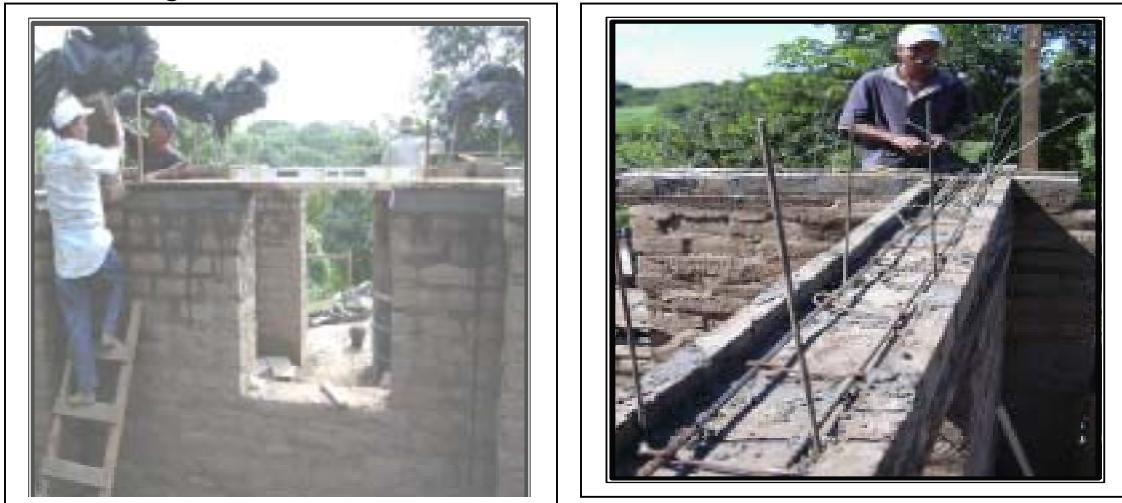
Figure 16- Reinforced Concrete Lintel Ring Beam Construction in El Salvador (Dowling 2002)

A ring beam (also known as a crown, collar, bond or tie beam or seismic band) that ties the walls in a box-like structure is one of the most essential components of earthquake resistance for load-bearing masonry construction. To ensure good seismic performance of an adobe building, a ring beam needs to be provided continuously like a loop or a belt. The ring beam must be strong, continuous and well tied to the walls and it must receive and support the roof. The ring beam can either be made of concrete or timber.

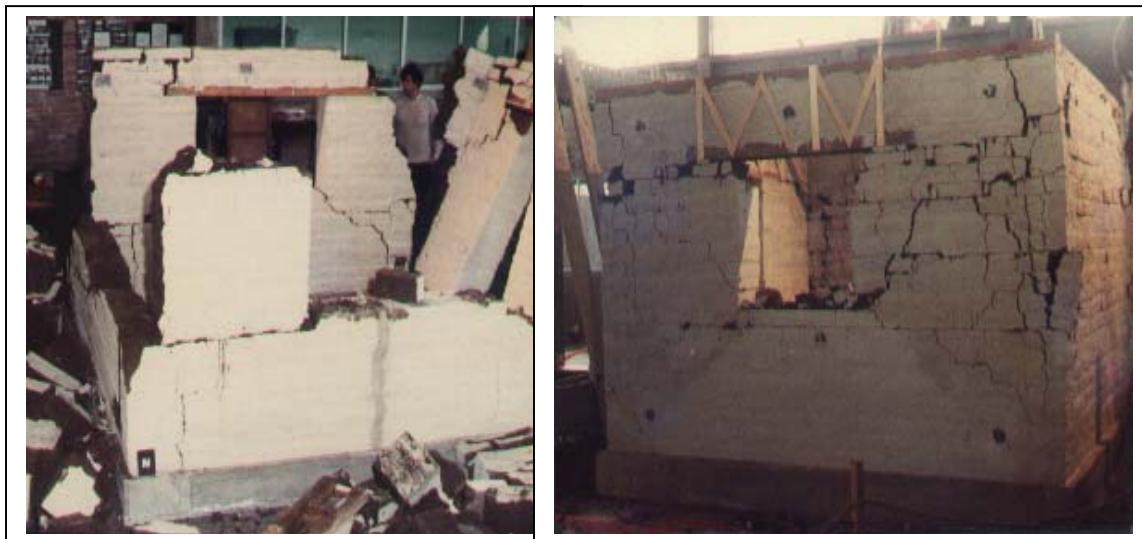
FIGURE 18 – Seismic Performance of an Unreinforced Adobe Building (Left) and a Strengthened Adobe Building with Internal Cane Reinforcement and Ring Beam (Right) (Blondet et al, 2002)

In addition to the ring beam, the use of truss-like timber ties between the lintel and ring beam proved to be effective, based on the tests performed at the PUCP, Peru (Blondet, 2002). The performance of an unreinforced adobe building model and a model with vertical and horizontal cane reinforcement, ring beam and truss-like ties is illustrated below.

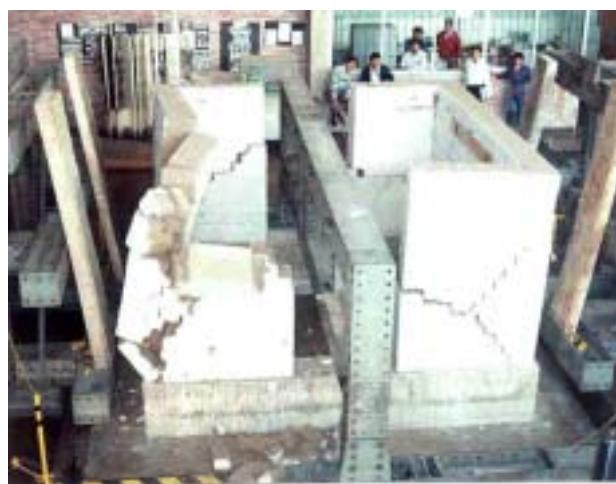
Figure 20 – Dynamic Testing of "U" Shaped Walls (Zegarra et al, 1997)

Simple techniques to reinforce existing adobe houses were tested at PUCP. The proposed external reinforcement was developed to delay the collapse of the structure during a severe earthquake. Different reinforcement materials were tested, like wooden boards, $\frac{1}{2}$ -inch rope, chicken wire mesh, and welded mesh. Seismic simulation tests were performed on "U"-shaped walls, with and without reinforcement, as shown in Figure 20.

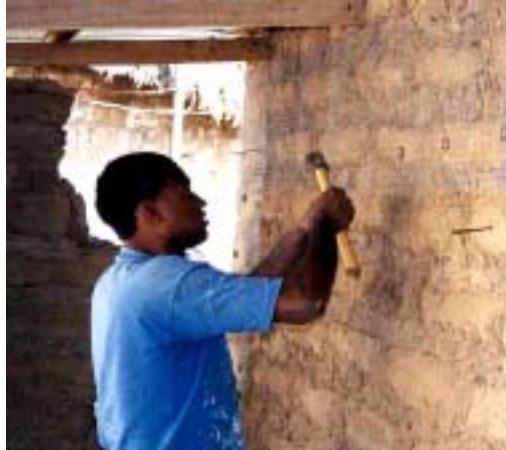
Figure 21 – Placing The Welded Mesh On Traditional Adobe Wall (Zegarra et al, 1997).

The dynamic tests demonstrated that the best solution for existing adobe houses is reinforcement consisting of welded mesh (1 mm wires spaced at $\frac{3}{4}$ inches) nailed with metallic bottle caps against the adobe as shown in Figure 21. The mesh is placed in horizontal and vertical strips simulating beams and columns, and is covered with cement and sand mortar. This solution proved to be highly effective in delaying the collapse of the structure.

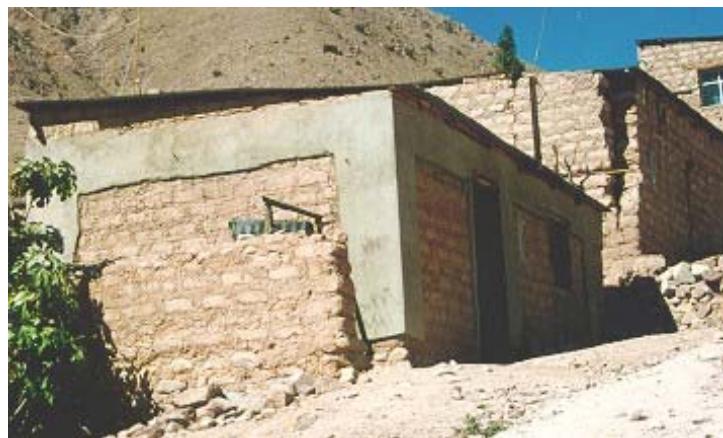
Figure 22 – A House with External Welded Mesh Reinforcement Remained undamaged (front) whereas a House Without Reinforcement (shown at the back) was Severely Affected by the 2001 Arequipa Earthquake, Peru (Zegarra et al, 2001)

During the Arequipa earthquake in Peru (2001), existing adobe houses that had been externally reinforced with welded mesh covered by cement-sand mortar as part of a prototype reinforcement program, withstood the seismic event without any damage, whereas houses with no reinforcement collapsed or were severely damaged, as can be seen in the figure below.
