SEISMIC STRENGTHENING OF EARTHEN HOUSES USING STRAPS CUT FROM USED CAR TIRES: A CONSTRUCTION GUIDE

Andrew Charleson

First Edition, September 2011

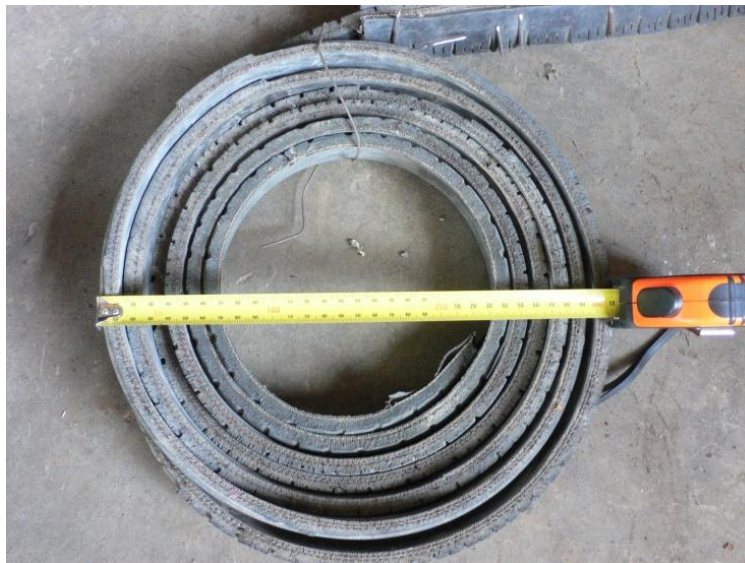
Figure 1.2 A tire strap approximately 6 m long ready to be applied to a house.

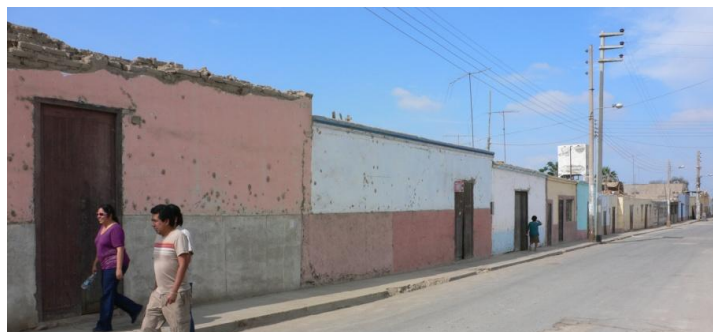
Figure 1.7 Adobe houses built up against each other

Development of this system to date has concentrated on ‘stand alone’ houses. In reality, many houses share party-walls with others or have their walls built directly against those of other houses (Figure 1.7).

Further research is required to determine the best strategy for protecting houses in these situations. In the interim, horizontal straps should wrap around party-walls or two walls built against each other. In this case where two walls are being confined, both horizontal and

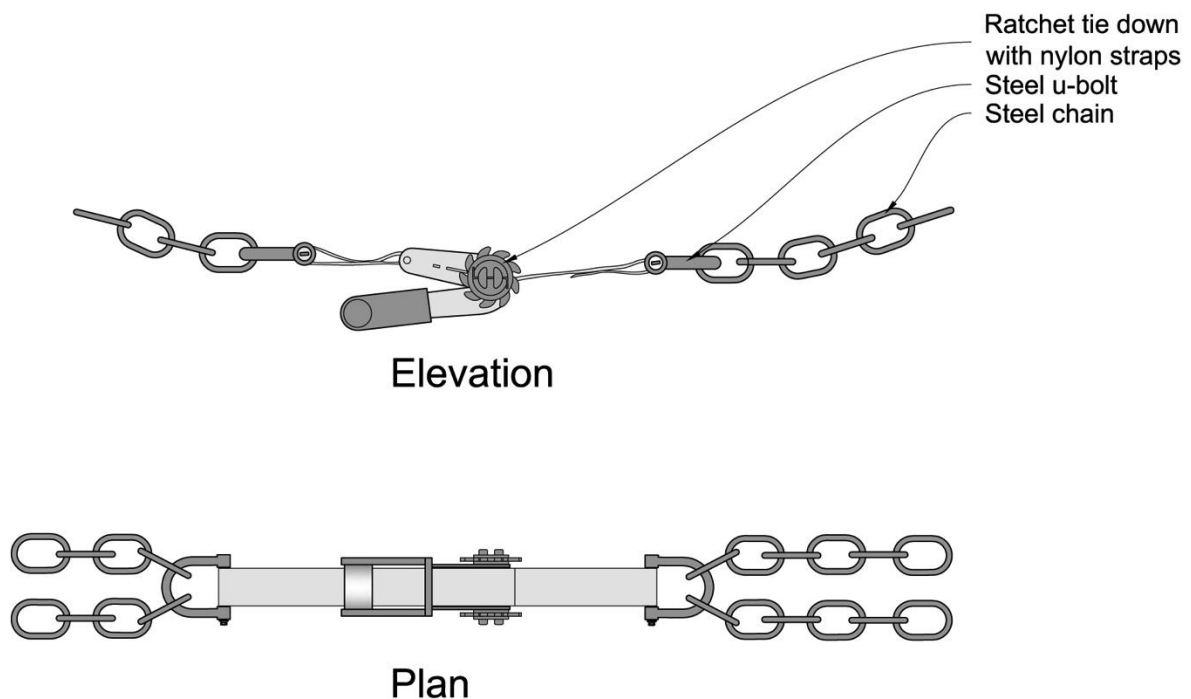
Figure 2.1 Elevation and plan of a simple ratchet device and attachments used to lightly tension straps during installation.

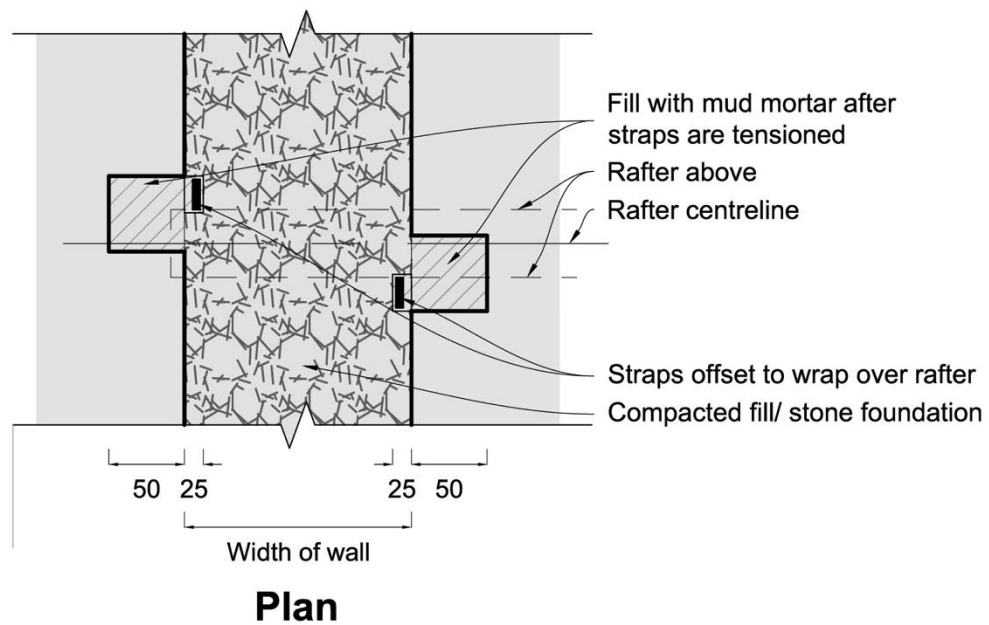
Figure 3.3 A plan view of a length of the foundation showing the position of off-set straps under a rafter and how they are set into the width of the wall.

initially be positioned on the centerlines of as many rafters as possible, and then one strap of each pair of straps be off-set by 100 mm in plan. The off-set enables each strap to pass vertically up the wall and to pass over the rafter (Figures 3.2 and 3.3).

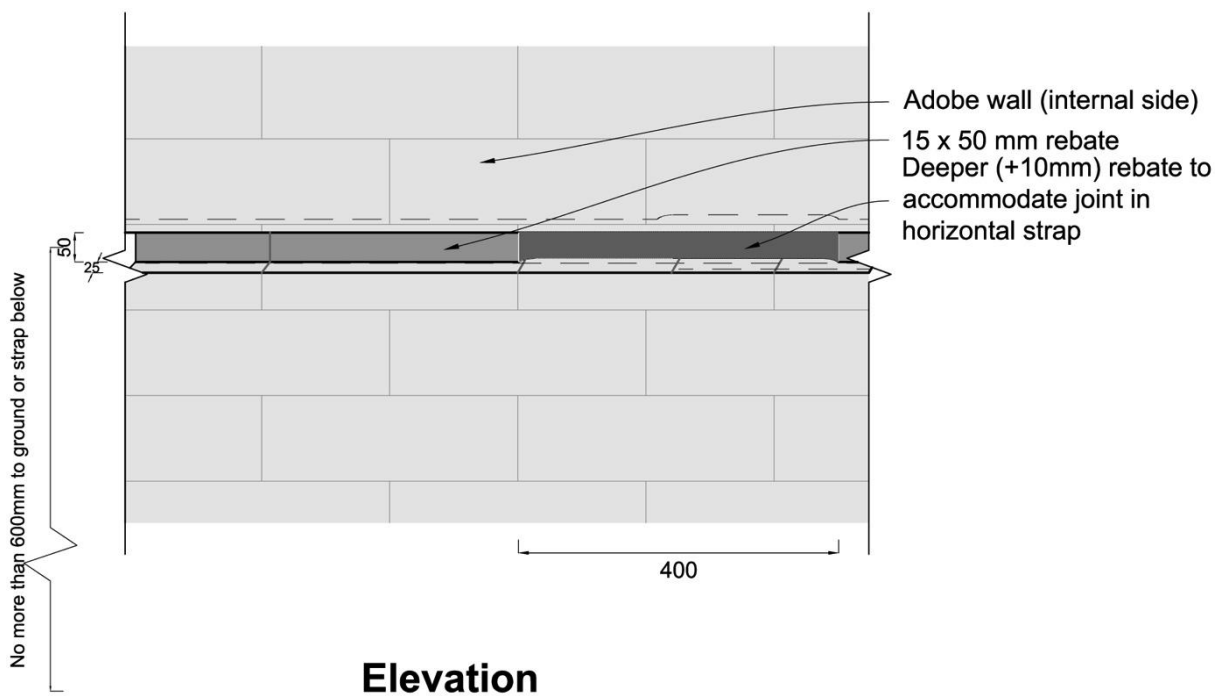
Figure 3.10 Horizontal straps wrap around the corner of an internal wall. Note the deepened length of rebate to accommodate the nailed joint of the strap. The position of the deepening should allow for easy strap tensioning of the joint, avoid clashing with a vertical strap running at right angles and be on the inside face of a wall to reduce the risk of corrosion.

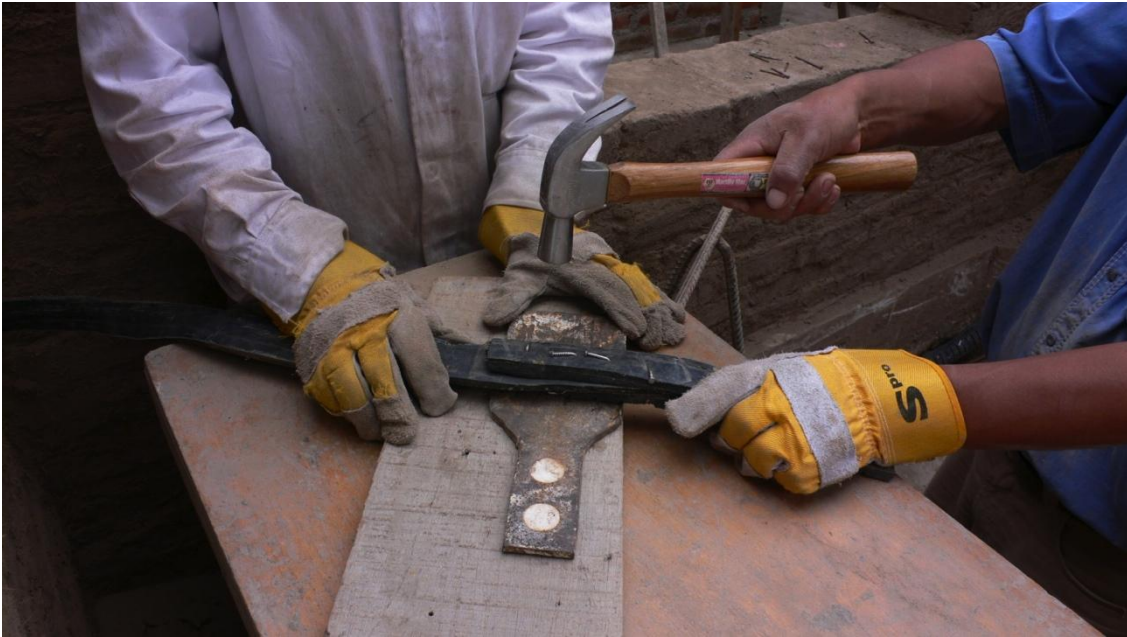
Figure 4.5 A firm support and a steel plate assist the nailing and nail bending process.

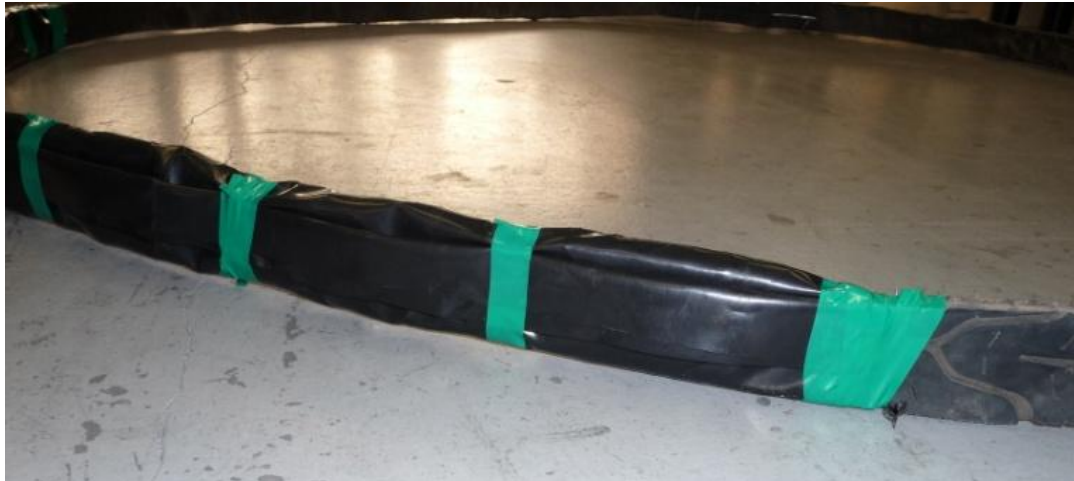
Figure 4.7 A strap with a length of PVC sheet to provide water protection to the strap below ground level and up to the height where the strap is protected by mud mortar and painted surfaces.

to 4.5). For moist or wet climates a pvc sheath is placed around the strap where it passes through and up each side of the foundation (Figures 4.6 to 4.7).

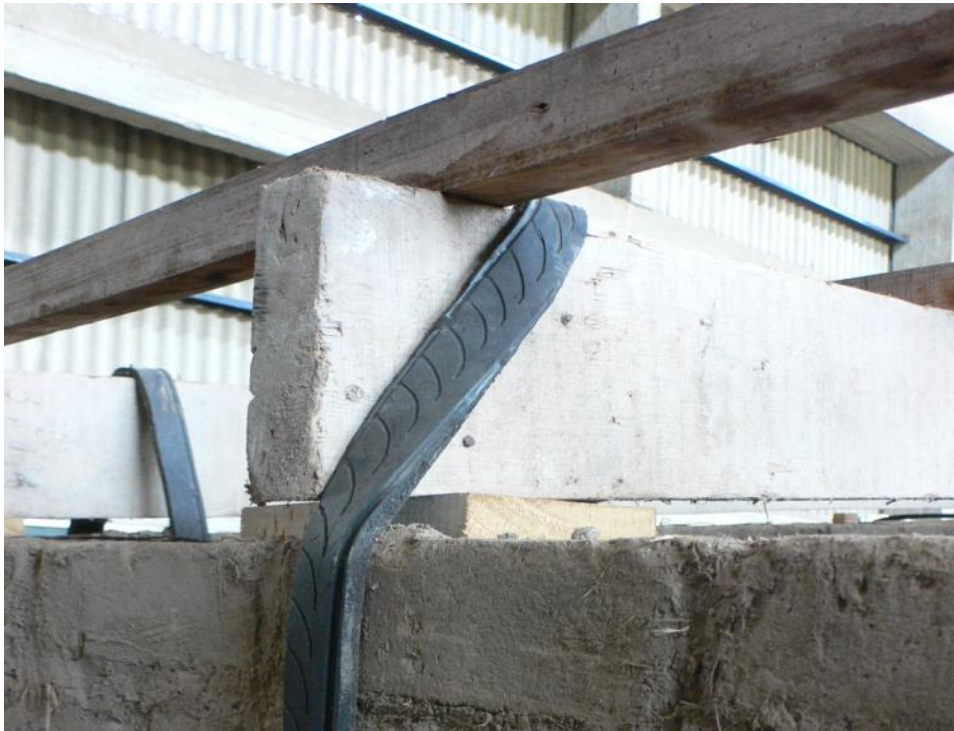
Figure 4.10 A strap wrapping over a rafter. In this trial house the straps were not placed in wall rebates and the rafters were not notched.

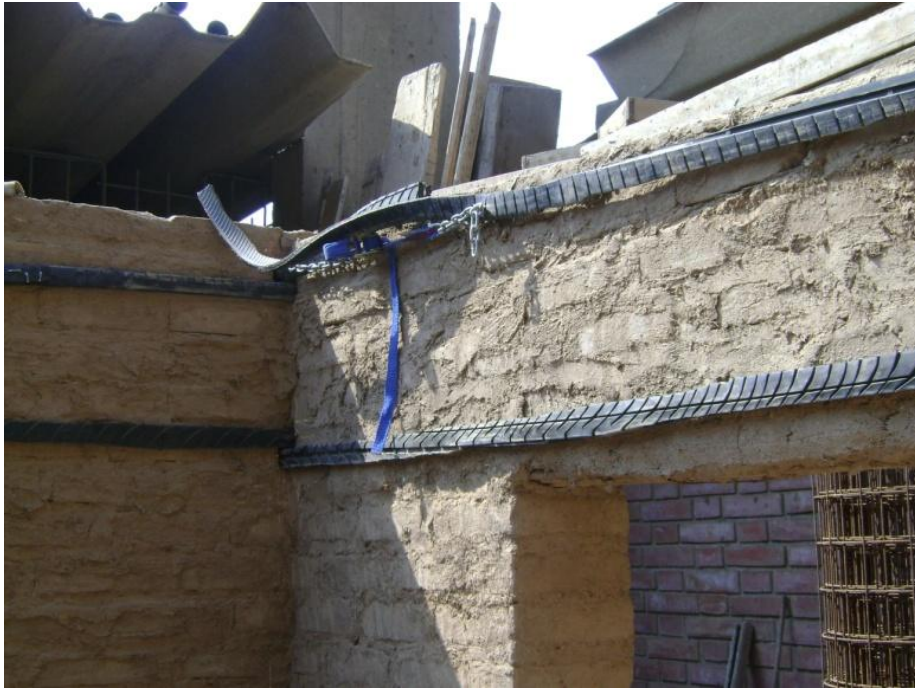
Figure 4.18 The upper strap is taut but requires shortening using a hacksaw before nailing the joint.

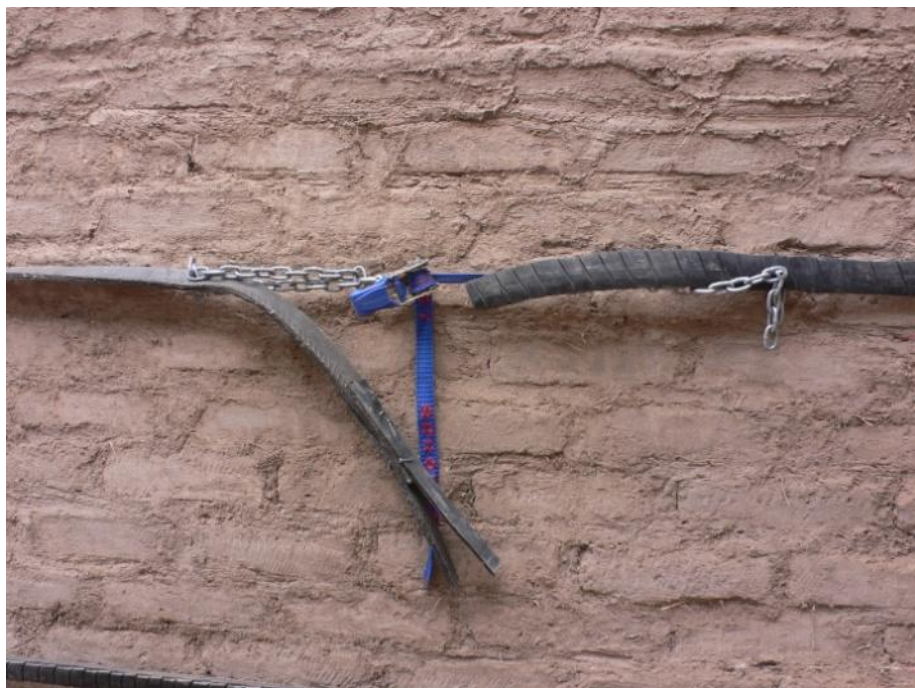
Figure 4.19 Strap is tensioned with the half pre-nailed joint hanging down. The right-hand end of the strap requires shortening.

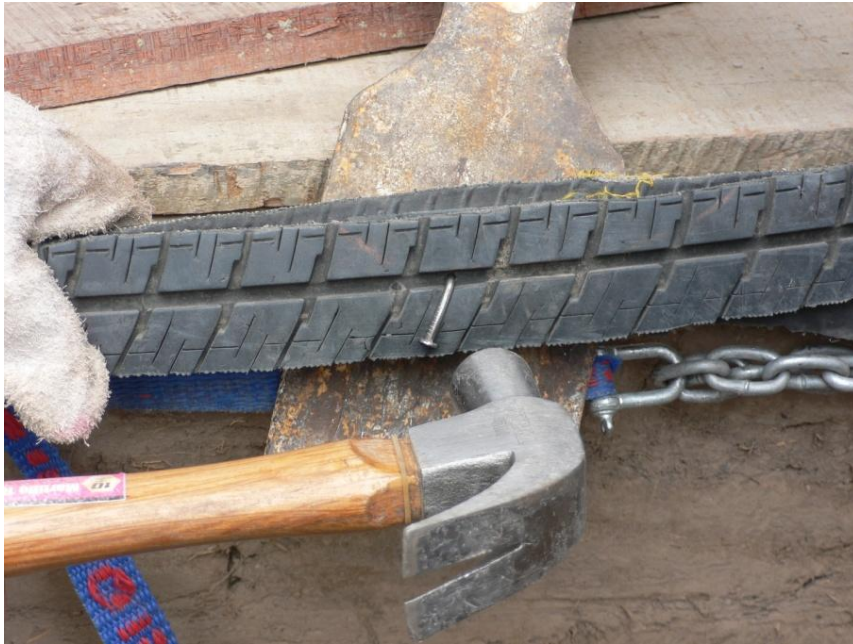
Figure 4.21 After using a wooden backing block to drive a nail half-way through, a steel plate helps bend the nail down on the back of a strap.

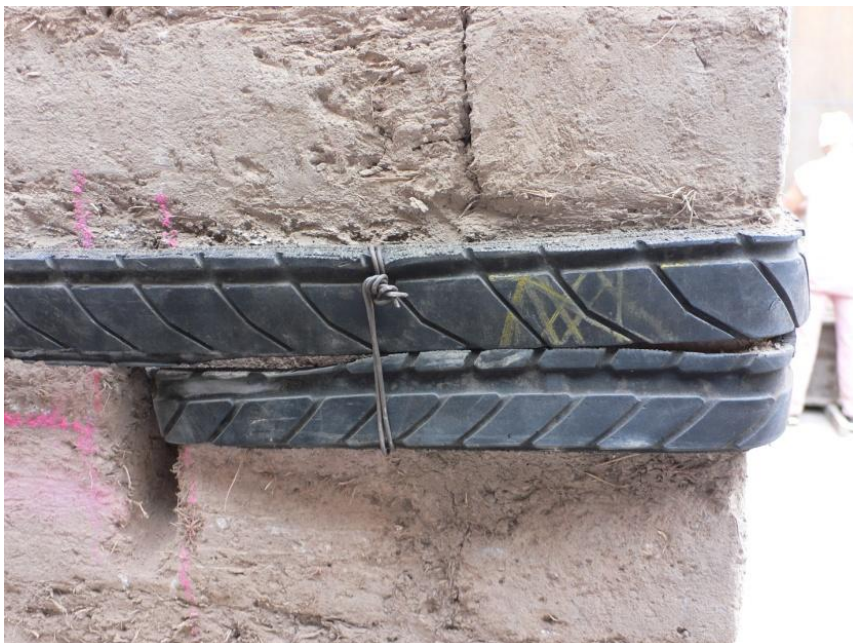
Figure 4.22 Two straps around an exterior corner. The upper edge of the top strap is aligned with the horizontal mortar joint. The horizontal joint between the two straps is therefore approximately mid-height of an adobe block. Note that the hole for the lower strap is deeper vertically than necessary.

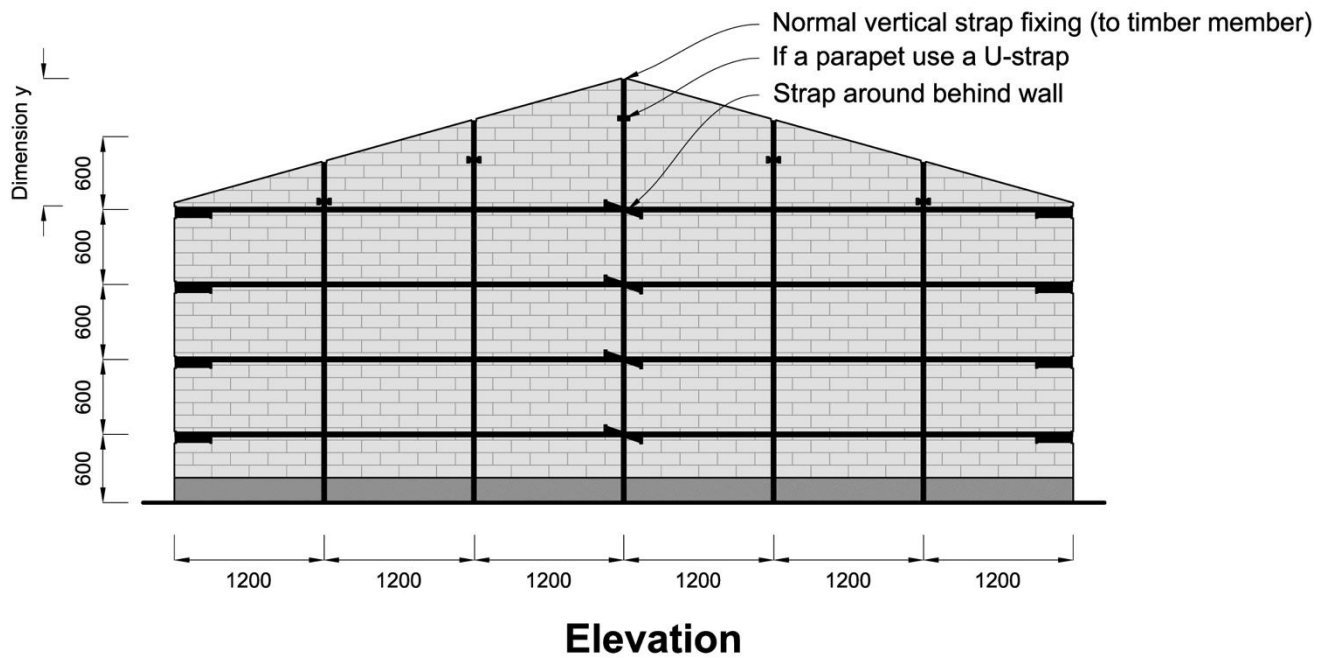
Figure 4.26 A gable and a parapet wall. There is a wall behind the middle of the gable wall. If ‘y’ is greater than 1000 mm, use two top horizontal straps side by side along the return wall to tie it to the gable wall.

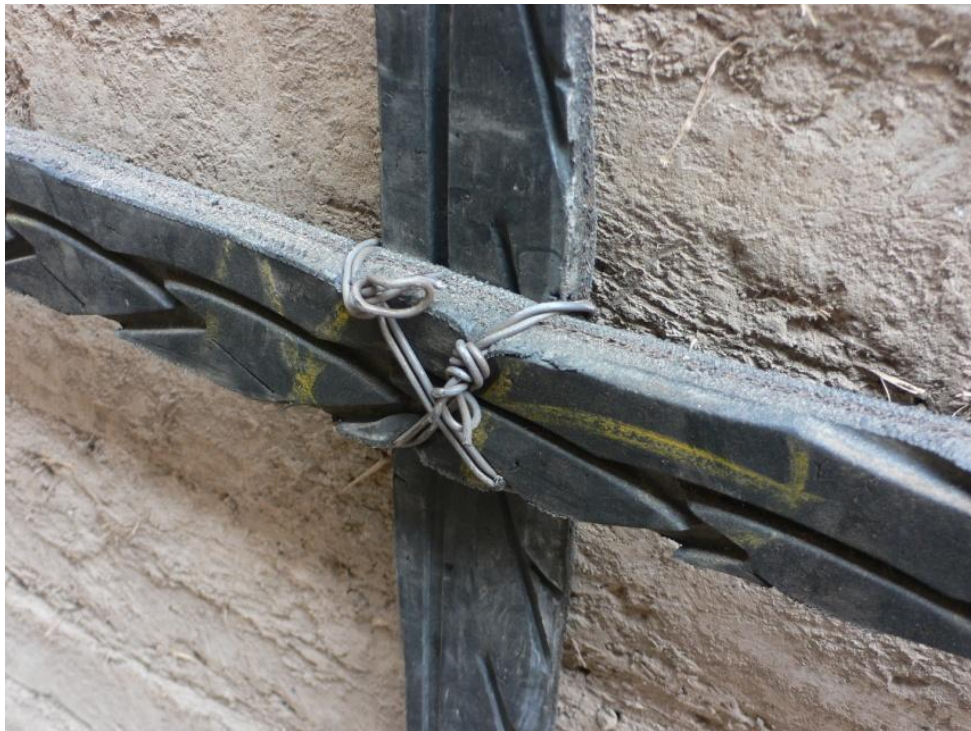
Figure 4.30 A strap junction tied together and through the wall tightly by a pair of tie wires.

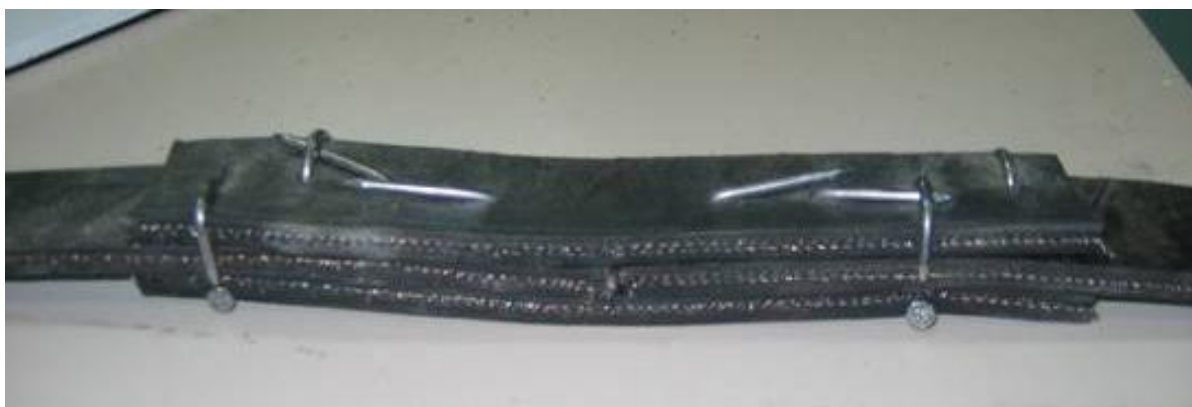
Figure A.1 A completed nailed joint showing the bent nails.

Straps are butted together and connected via two short lengths of overlapping straps to form a butt joint. Four 3.15 mm diameter by 70 mm long nails on each side of the joint are bent carefully to prevent a premature nail pull-through failure mechanism (Figure A.1).

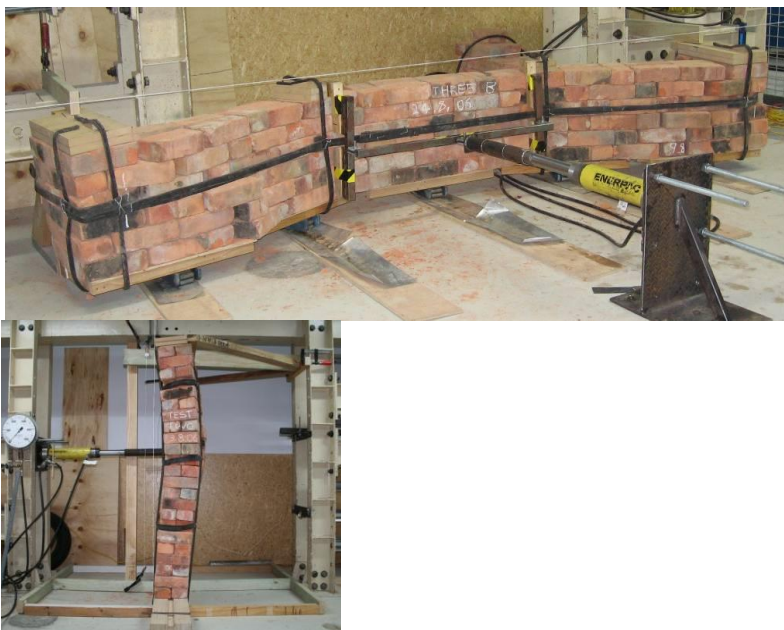
Figure A.2 An out-of-plane test with the wall pushed towards the supports

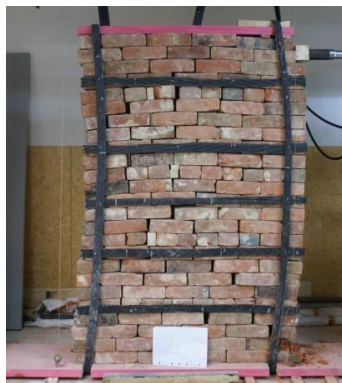
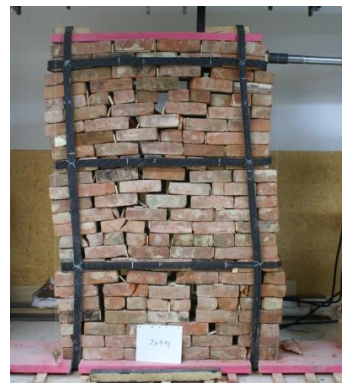
Figure A.4 Walls 1 (left) and 2 at a similar stage of their cyclic loading sequence.

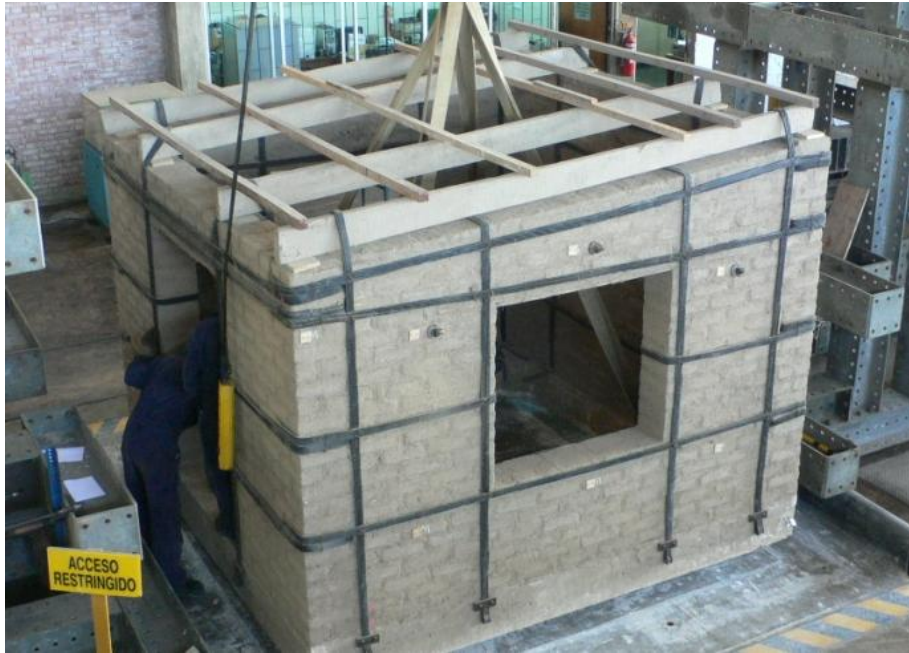
Figure A.5 The module being lowered onto the shaking table.

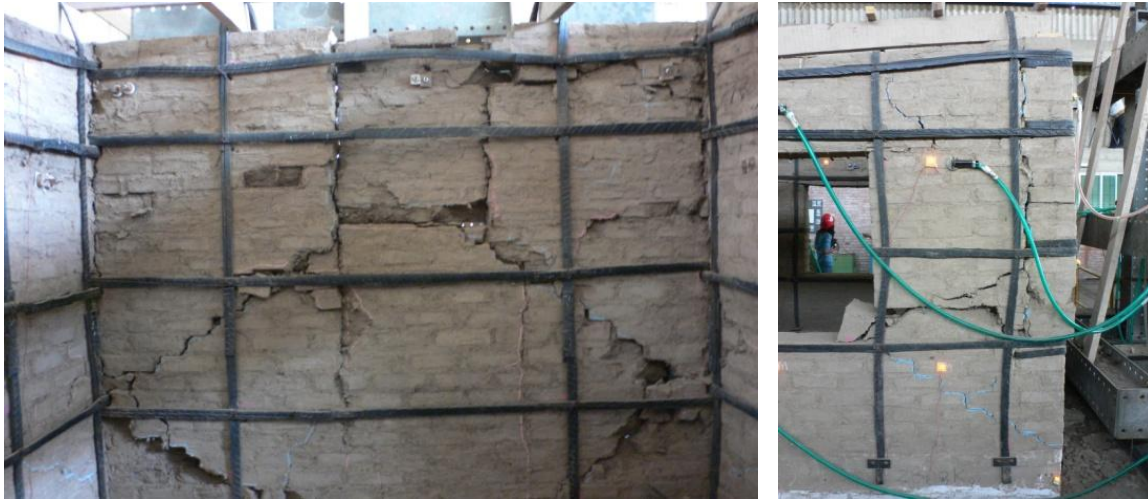
Figure A.6 Damage to the rear wall after the Phase 3 (maximum shaking) (left) and the most heavily damaged pier.

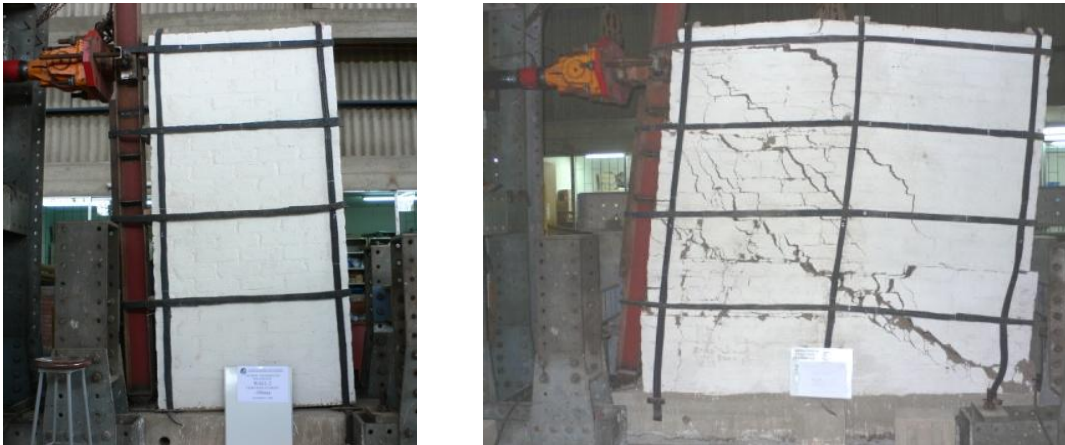
Figure A.7 Horizontal load is applied to the top of a vertical steel post pin-jointed at its base which then transfers loads to the wall in compression, via wooden blocks, and tension, via horizontal straps. The 1.2 m long wall (left) is being pulled to the left and is rocking at its base while the 2.4 m long wall (right) has undergone five cycles of loading.
