STONE MASONRY CONSTRUCTION

Marjana Lutman, Slovenian National Building and Civil Engineering Institute, Slovenia

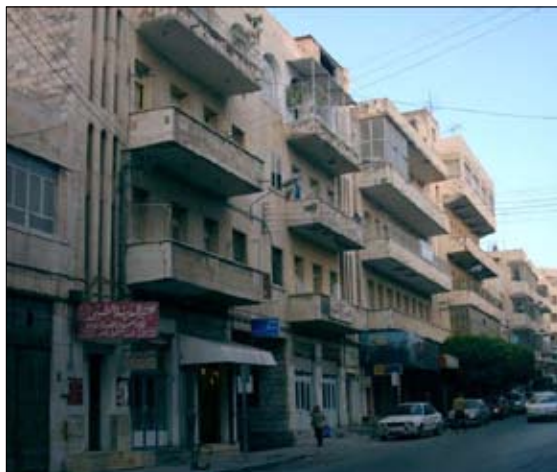
Figure 3: Unreinforced concrete and stone masonry building in the Palestinian Territories (WHE Report 49)

The key seismic deficiencies of the two-wythe stone masonry buildings in the Palestinian Territories (WHE Report 49) are poor connections between the walls and slabs, as well as a very poor bond between the concrete and stones in masonry walls. These deficiencies result in the disintegration of wall wythes and collapse of the walls.

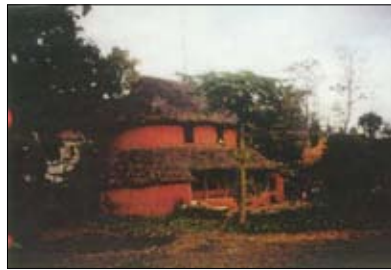
Figure 5: Traditional oval-shaped rural stone house in Nepal (WHE Report 74)

Rural one-story stone masonry houses with timber frames and thick flat roofs for thermal insulation ("khan") are widely spread throughout India. In the mountainous and hilly regions of Nepal there are two types of stone masonry houses: a traditional oval-shaped house and a rectangular-shaped house, both typically two stories high. In hilly Mediterranean countries the number of stories varies between two in rural areas and five in towns. Typically, stone masonry houses are used by the lower and middle classes, however in historical urban centers they are often inhabited by the upper classes. Urban masonry buildings are characterized with several internal renovations and updates in the course of their useful life.

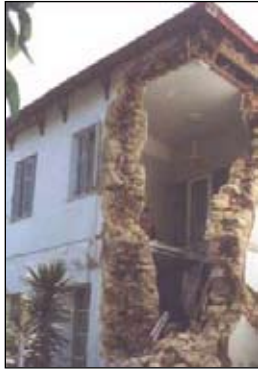
Figure 6: Typical collapse of a corner (WHE Report 16, Greece)

Delamination and disintegration of the masonry are damage patterns typical for walls built with two exterior wythes and rubble infill in weak mud mortar with many air voids. Out-of-plane failure can occur when the connections between the exterior and interior walls are inadequate. When the connections between the perpendicular walls are strong, the wall shear capacity can be exhausted, thus causing typical shear cracks to develop.

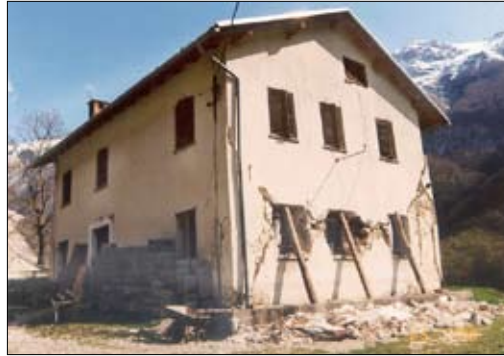
Figure 7: Typical damage during the 1998 Bovec earthquake in Slovenia (WHE Report 58)

- 8% in the 1999 Athens earthquake (M5.9) (Greece, WHE Report 16)
- 12% in the 1998 Bovec earthquake (M5.6) (Slovenia, WHE Report 58)
- 15% in the 1993 Maharashtra earthquake (M6.5) (India, WHE Report 18)

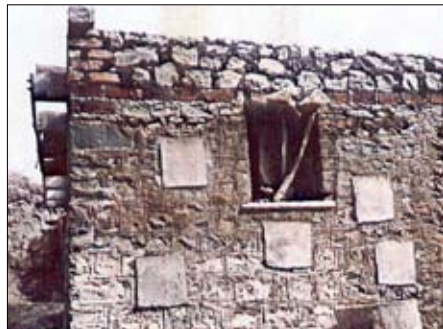
Figure 8: The application of through-stones as practiced in India (WHE Report 18)

In order to increase the seismic resistance of structural walls, the basic building material has to be strengthened. Stone masonry can be strengthened by means of deep repointing and/or by systematically filling the voids with injected cement-based grout (practiced in Greece and Slovenia). The installation of through-stones, the pointing of exterior walls with cement mortar and the strengthening of wall corners using wire mesh and cement overlay is practiced in Algeria, India, and Nepal.

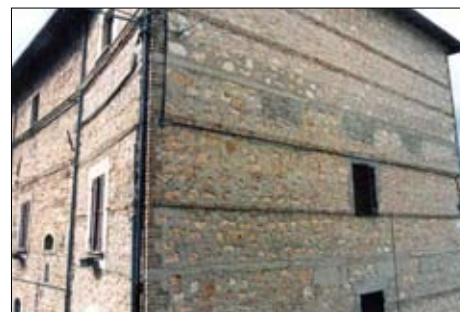
Figure 10: Seismic-strengthening techniques in Italy: installation of new steel wall ties (WHE Report 28)

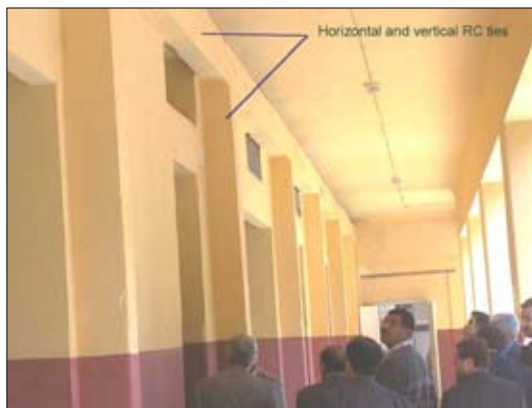
Figure 11: An example of a strengthened building with vertical and horizontal reinforced concrete ties at the first floor level as practiced in Algeria (WHE Report 75)

The actual shear resistance of structural walls can be enhanced if they are properly tied and connected to floor and roof structures. In the case of existing buildings, this is achieved by means of steel, timber, or reinforced concrete ties at floor levels. Vertical ties of the same material are inserted at the corners and between openings to prevent instability. The timber joists of floor structures are connected to the walls by means of steel anchors and plates. Ties are placed symmetrically on both wall sides; alternatively, RC are placed at the exterior and steel ties are placed at the interior wall surface. (This technique is practiced in Algeria, WHE Report 75.)
