A TUTORIAL: Improving the Seismic Performance of Stone Masonry Buildings

Jitendra Bothara • Svetlana Brzev

First Edition, July 2011

Publication Number WHE-2011-01

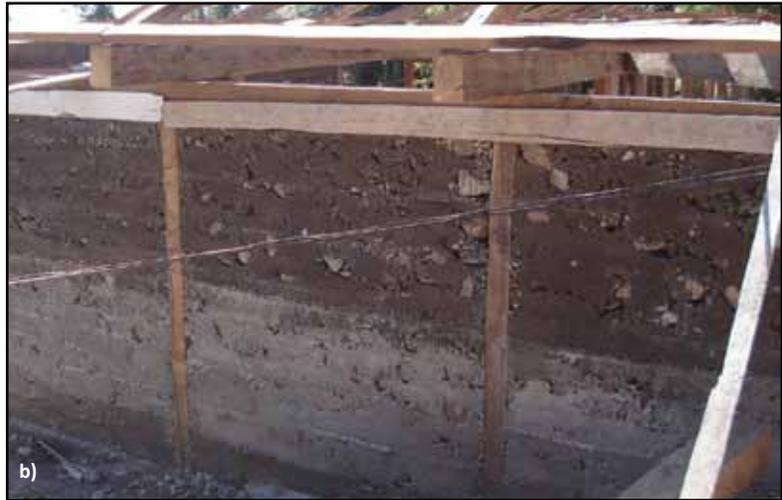
Figure 1.16 Concrete wall construction using stone rubble: a) an ancient Roman concrete wall, and b) in-situ concrete construction with stone rubble in Pakistan (photos: T. Schacher)

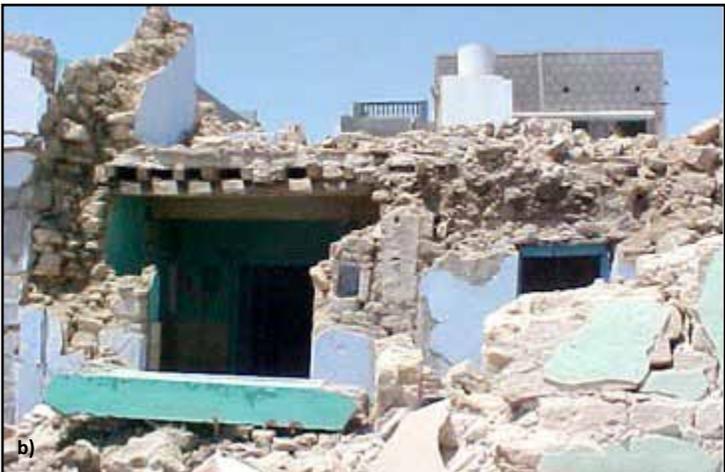
Figure 2.14 Roof deficiencies in the area affected by the 2001 Bhuj, India, earthquake: a) discontinuous rafters over interior walls, and b) inadequate wall-to-floor connections caused the severe building damage (photos: C.V.R. Murty)

In the Anjar area of Gujarat, India, which was affected by the 2001 Bhuj earthquake, buildings are characterized by thick stone masonry walls (thickness around 750 mm) built in sandstone and lime mortar (Jain et al. 2002). In this area, the traditional buildings have timber roofs with rafters spanning two walls in a room, instead of spanning the full length of the building. As a result, the floor in each room acted as an independent system, and had a tendency to pull apart from the other floors during the strong ground shaking. This caused a partial or total collapse of many stone masonry buildings in the area (Figure 2.14).

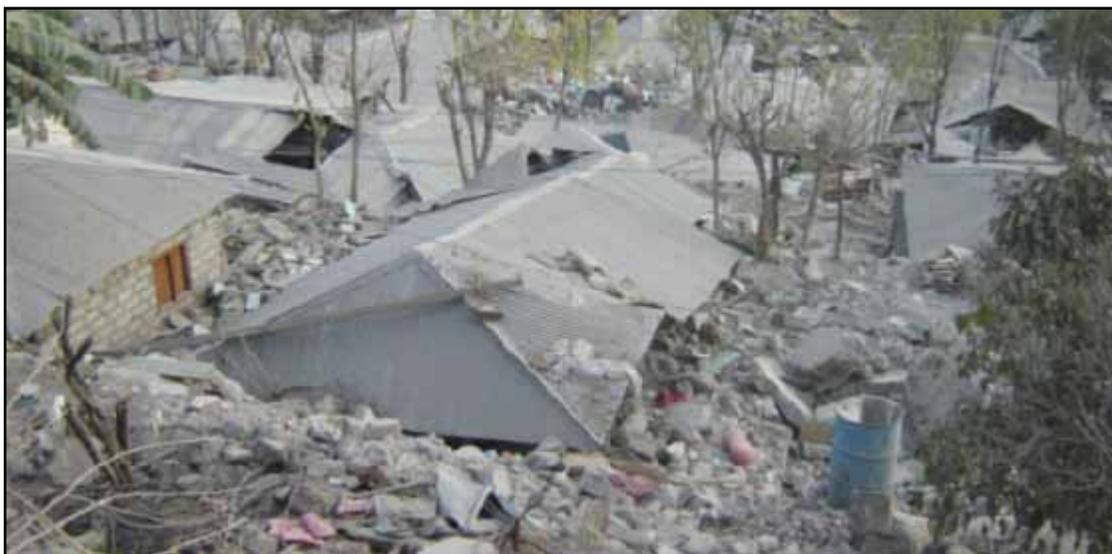
Figure 2.17 Collapse of stone masonry buildings with hipped roofs in the 2005 Kashmir, Pakistan, earthquake (source: Bothara and Hiçyılmaz 2008)

the 2005 Kashmir, Pakistan, earthquake. These buildings have a few important seismic deficiencies, such as an absence of effective ties or ring beams (bands) at the eaves level (beneath the roof), inadequate wall-to-roof anchorage, and an absence of through-stones in the walls. Buildings of this type showed poor performance in the earthquake due

to the collapse of stone masonry walls, as shown in Figure 2.17. It should be noted that the seismic performance of hipped roofs in the earthquake was excellent in terms of maintaining their integrity and shape. After the earthquake, people were able to lift the roof of their collapsed house and rebuild the walls (Bothara and Hiçyılmaz 2008).

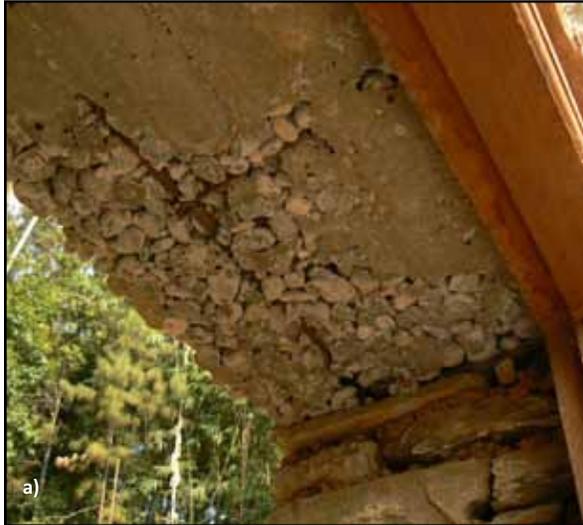
Figure 3.19 Concrete cover in RC bands: a) exposed bars due to inadequate cover, b) concrete spacers made from PVC pipes, and c) RC band under construction showing use of concrete spacers (photos: Smart Shelter Foundation)

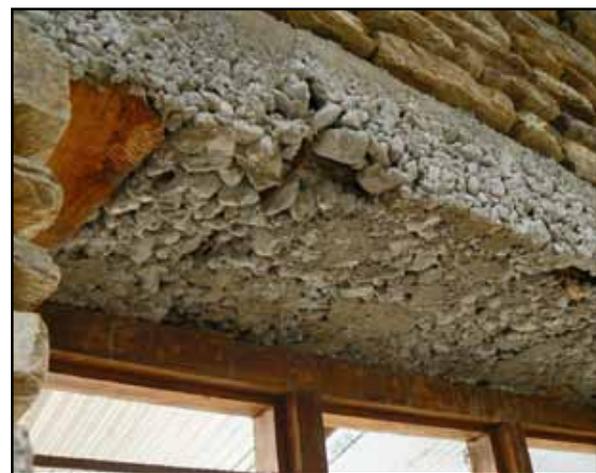
Figure 3.20 Poor concrete construction quality in an RC lintel band (photo: Smart Shelter Foundation)

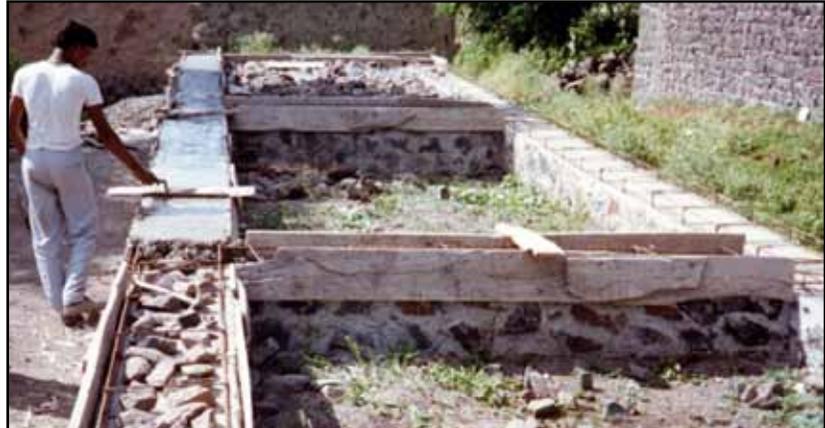
Figure 3.39 Construction of an RC plinth band using large stone rubble (also known as "stone-crete") (photo: S. Brzev)

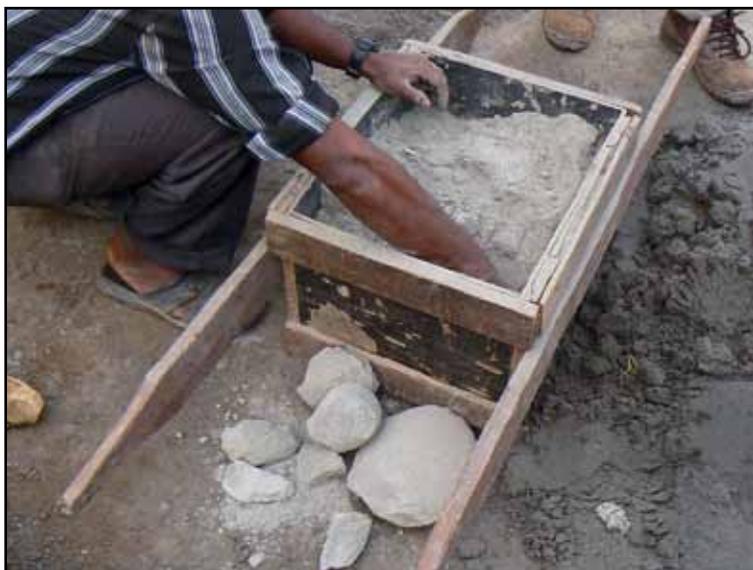
Figure 3.43 Cement with large lumps should not be used for construction (photo: Smart Shelter Foundation)

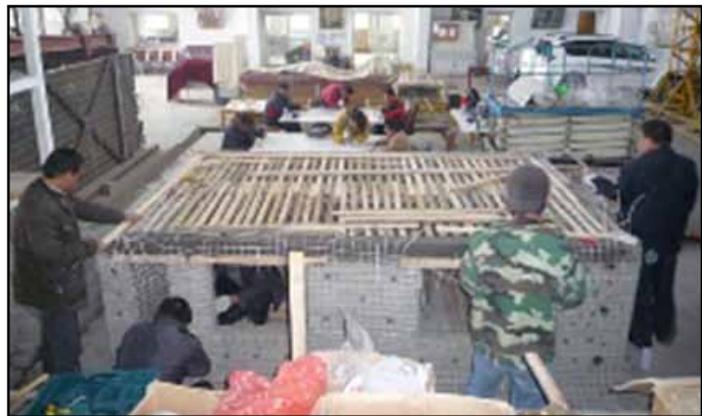
Figure 4.26 Testing polypropylene bands at IEM in Harbin, China (photo: W. Feng)

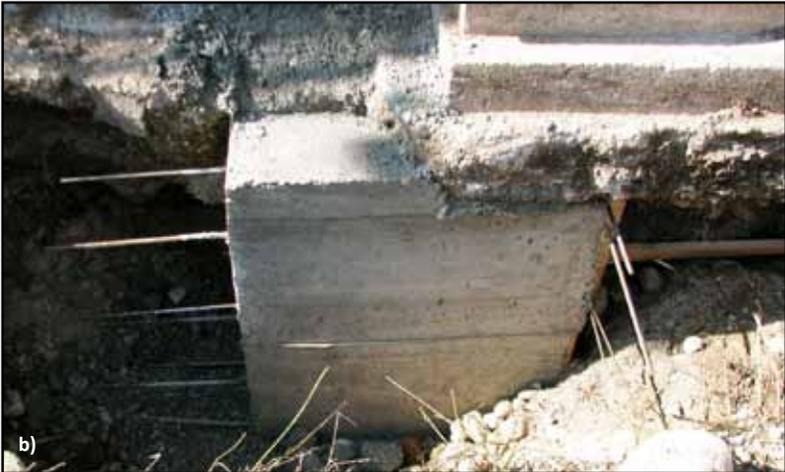
Figure 4.30 Strengthening a stone masonry foundation: a) reinforcement cage and formwork, and b) new reinforced concrete foundation under construction (photos: M. Lutman)
