World Housing Encyclopedia

HOUSING REPORT

Stone masonry residential buildings

Report #	138
Report Date	26-05-2007
Country	PAKISTAN
Housing Type	Stone Masonry House
Housing Sub-Type	Stone Masonry House : Rubble stone without/with mud/lime/cement mortar
Author(s)	Qaisar Ali, Taj Muhammad
Reviewer(s)	Robin Spence

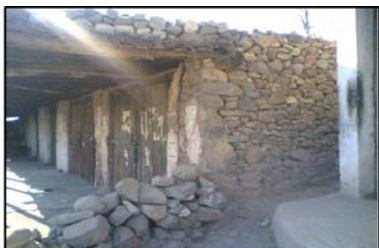
Figure 1 (a): A view of typical stone masonry house constructed in dry (without any mortar) with earthen roof.

Figure 1: Typical stone masonry house, mud mortar with earthen roof.

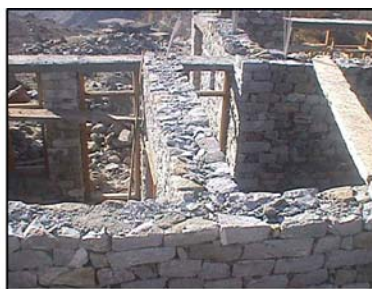
Figure 1 (b): A view of under construction stone masonry house in dry.

Figure 2: Stone masonry without mortar under construction

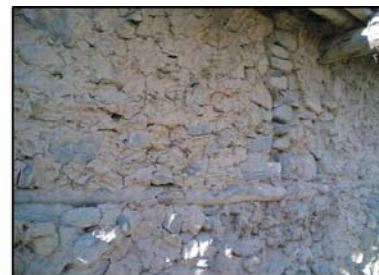
Figure 1 (c): A view of typical stone masonry wall constructed in mud mortar.

Figure 3: View of typical stone masonry wall construction, with mud mortar

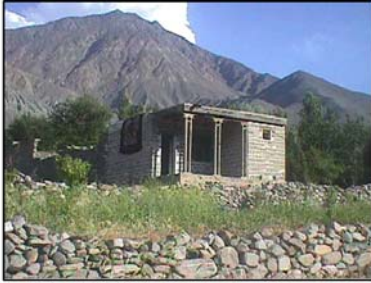
Figure 1 (d): A view of typical stone masonry house constructed in cement sand mortar with earthen roof.

Figure 4: Typical stone masonry house constructed in cement sand mortar with earthen roof

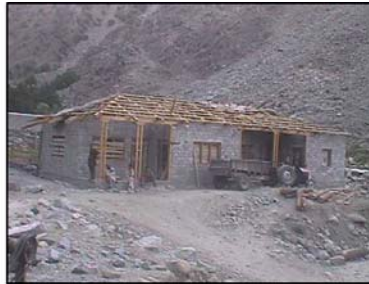
Figure 1 (f): A view of under construction stone masonry house in cement sand mortar with wooden truss and G.I. Sheet roof.

Figure 5: Stone masonry house under construction with cement sand mortar with wooden truss and G.I. Sheet roof

In the Northern part of Pakistan, which mostly consists of mountainous terrain and where building stones are more abundantly available than any of the alternate building material, people commonly construct single story stone masonry buildings for residential purpose. A variety of building typologies are in use. An approximate distribution of common types of such buildings is:- Stone masonry houses without mortar with earthen roof (Fig 1a). 10% Stone masonry houses in mud mortar with earthen roofs (Fig 1c). 40% Stone masonry houses in cement mortar with earthen roof (Fig 1d). 10% Stone masonry houses in cement mortar with G.I.Sheet roof (Fig 1f). 30% Stone

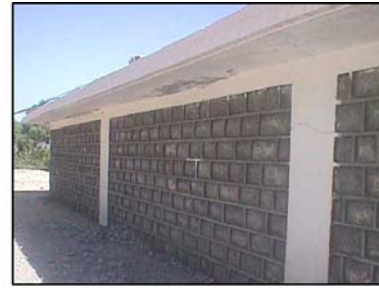
Figure 1 (g): A view of stone masonry house constructed with dressed stones in cement sand mortar having R.C.C. roof.

Figure 6: Stone masonry house with dressed stones in cement sand mortar with RCC roof

masonry houses with R.C roofing (Fig 1g) 10%. Construction of houses in rubble stone masonry, in dry or in mud mortar, was most common and was generally practiced in the past in these areas. It is still in practice in most construction. Presently, among all, about 50% of the buildings are of this type. In new construction mud mortar is steadily being replaced with cement mortar. Wall thickness in all cases usually varies from 1 to 1 ½ ft. Roofs are usually earthen and generally consist of thatch covered with mud/earth and supported on wooden beams (or logs) and rafters. Some time wooden columns are also provided beneath the beams along the walls or in between the walls to support the roofing. Wooden rafters, planks and G.I. sheets are also used in modern construction for roofing. Any particular or regular layout is not used for construction of these residential buildings. It varies depending on the available space. Size of the building also varies from a single room to more than one room as per requirement of the family (Figs 3a--3c). These structures are considered, from experience, to be strong enough to withstand the applied gravity loads, but their seismic performance has not properly been investigated and is believed to be vulnerable to earthquake of even moderate shaking, particularly when confining elements such as wooden columns are not used. In a typical type of construction, historically known to be well resistant to seismic effects, horizontal and vertical wooden members are provided in the walls. These horizontal and vertical members are inter-connected at corners and other locations through wooden nails. The remaining space of the wall is then built in stone masonry of any type. This type of construction was commonly practiced in remote North parts of this region in the past and is still in practice for improved seismic performance in some of the buildings (figs 5a--5e).

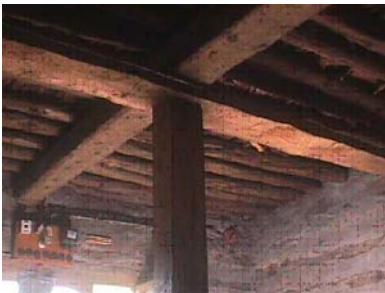
Figure 7: A wooden column in the center of a room, in addition to the main stone masonry walls, is provided to support roof gravity load

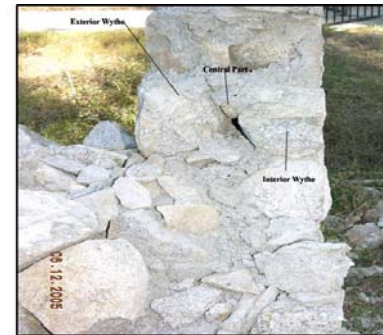
Figure 4 (b): Typical wall section; photo of a damage wall from October 08, 2005 earthquake 2005; two wythes & central portion of wall are clearly visible.

Figure 12: Damaged wall from October 8 2005 earthquake. Two wythes and central portion of wall are clearly visible.

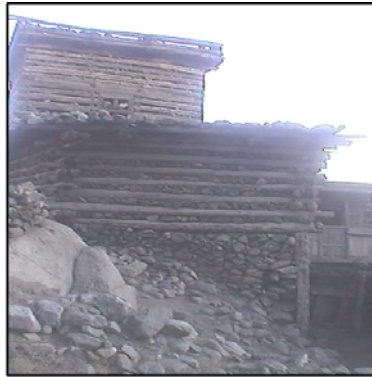
Figure 5 (a): An old house with wooden seismic bands.

Figure 14: An old house with wooden seismic bands

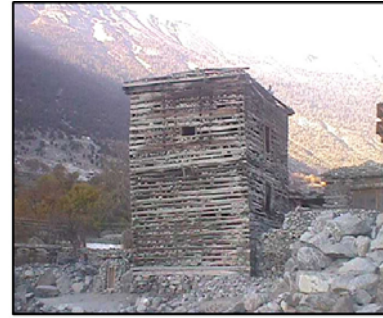
Figure 5 (b): A historical three story building, with single room at each floor; well standing the past seismic events.

Figure 15: A historical three story building, with single room at each floor; well standing the past seismic events

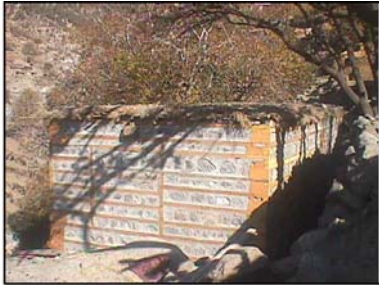
Figure 5 (c): A recently built stone masonry house in cement sand mortar and earthen roof; horizontal and vertical wooden bands are clearly visible.

Figure 16: A recently built stone masonry house in cement sand mortar and earthen roof; horizontal and vertical wooden bands are clearly visible

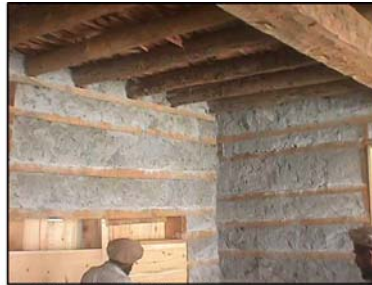
Figure 5 (d): Inner close view of building in fig 5 c.

Figure 17: Inner close view of building in previous figure (fig 5 c)

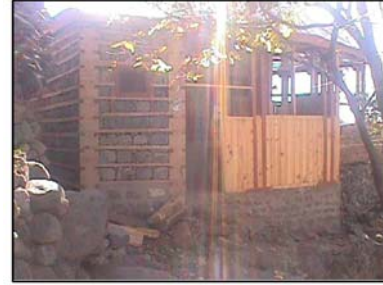
Figure 5 (e): An under construction house, being built with wooden seismic bands.

Figure 18: A house under construction, being built with wooden seismic bands

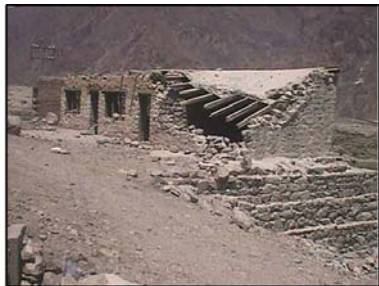
Figure 6 (a): Typical corner failure of a stone masonry house in mud mortar with earthen roof, Pakistan earthquake of October 08, 2005.

Figure 19: Typical corner failure of a stone masonry house in mud mortar with earthen roof; Pakistan earthquake of October 08, 2005

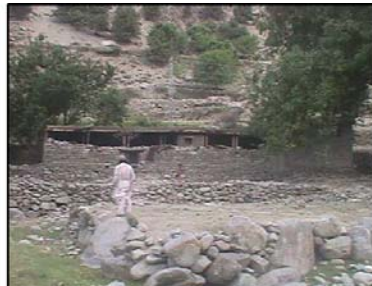
Figure 6 (b): Out-of-plane failure of stone masonry in dry, Pakistan earthquake of October 08, 2005

Figure 20: Out-of-plane failure of stone masonry with no mortar; Pakistan earthquake of October 08, 2005

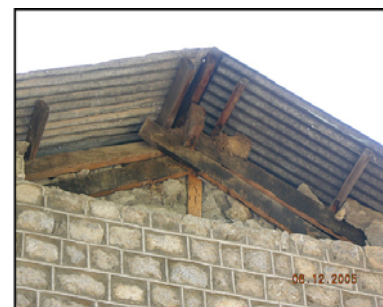
Figure 6 (c): Gable wall failure: Pakistan earthquake of October 08, 2005.

Figure 21: Gable wall failure: Pakistan earthquake of October 08, 2005

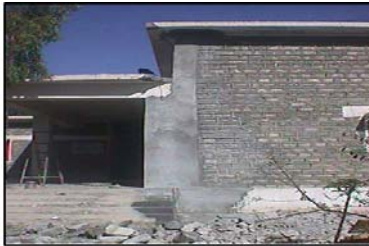
Figure 7 (a): Seismic strengthening technique; Column repaired after the earthquake.

Figure 25: Seismic strengthening technique; column repaired after the earthquake

The area is seismically very active. Earthquake in the past have caused damage in different localities. Being scattered, far-flung, and mountainous no documentation of such type of damage in the area is recorded and available. No defined retrofit (or strengthening) practice is known except only making a stronger component than that damaged in the earthquake through reconstruction or new construction, fig 7 (a) though 7 (c).

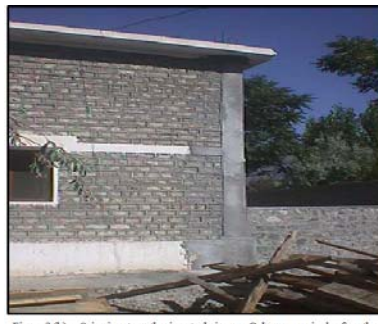
Figure 7 (b): Seismic strengthening techniques; Column repaired after the earthquake.

Figure 26: Seismic strengthening techniques; column repaired after the earthquake

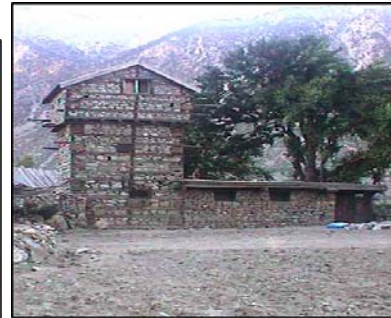
Figure 7 (c): Seismic strengthening techniques; Horizontal and Vertical wooden bands introduced after the earthquake.

Figure 27: Seismic strengthening techniques; horizontal and vertical wooden bands introduced after the earthquake
