World Housing Encyclopedia

HOUSING REPORT

Rubble stone masonry walls with timber frame and timber roof

Report #	18
Report Date	06-05-2002
Country	INDIA
Housing Type	Stone Masonry House
Housing Sub-Type	Stone Masonry House : Rubble stone without/with mud/lime/cement mortar
Author(s)	Svetlana N. Brzev, Marjorie Greene, Ravi Sinha
Reviewer(s)	Ravi Sinha

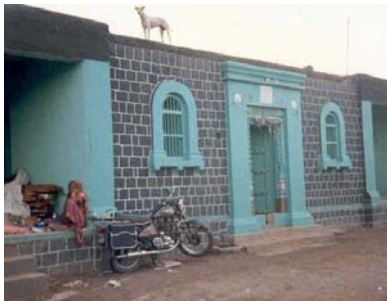
Figure 1: Typical Building

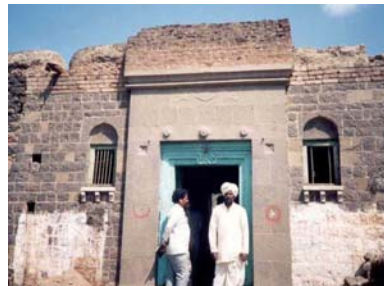
Figure 1A: Typical Building

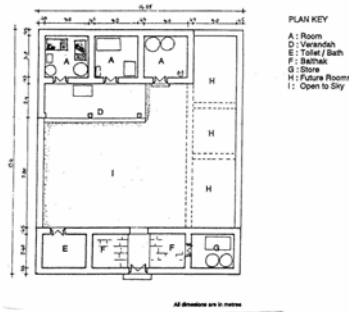
Figure 2A: Plan of a Typical Building

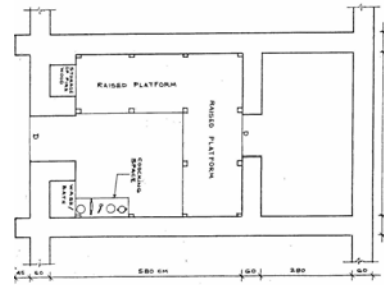
Figure 2B: Plan of Typical Building

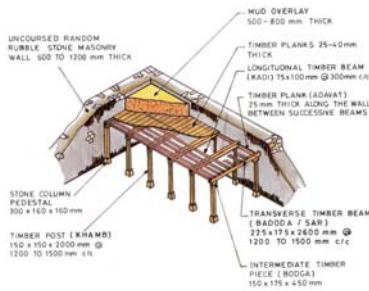
Figure 3: Key Load-bearing Elements (Source: GOM 1998)

The vertical load-resisting system is timber frame load-bearing wall system. Gravity load-bearing system consists of timber frames-khanda, which carry the weight of the roof and frame self-weight down to the stone pedestals. Stone walls act as enclosure and carry mainly the self-weight down to the foundations (if provided). An exception is the case when there are no timber posts provided; in such a case the entire roof weight is carried by the walls.

The lateral load-resisting system is timber frame load-bearing wall system. The load-bearing structure for this housing type is a traditional timber frame system, known as "khan". It is a complete frame with timber posts spanned at about 2.6 m, with an average height of approximately 2 meters; spacing between the successive frames is 1.2 to 1.5 m. The

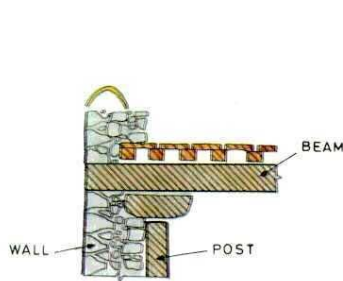
Figure 4A: Critical Structural Details - Wall-to-Roof Connection

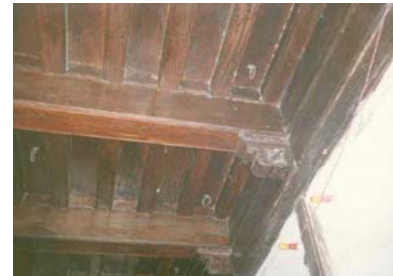
Figure 4B: Critical Structural Details - Good Quality Timber Roof Structure

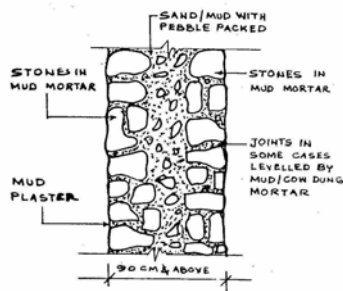
Figure 4C: Detail of an UCR Stone Masonry Wall

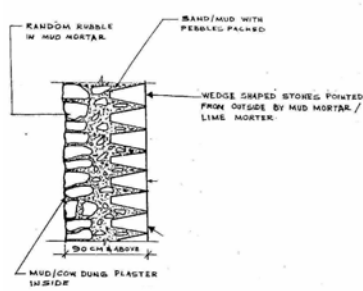
Figure 4D: Detail of an UCR Stone Masonry Wall

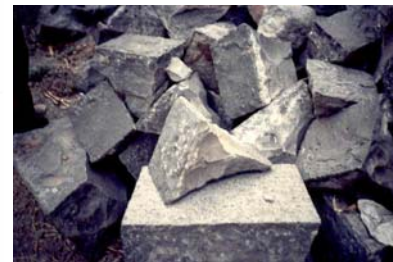
Figure 4E: A Typical Wedge-Shape Stone Used for the Exterior Wall Wythe

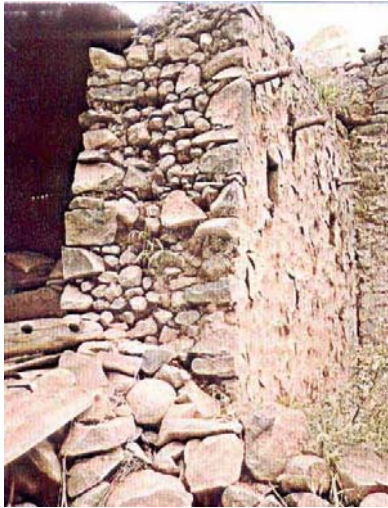
Figure 5: Key Seismic Deficiency - Extremely Thick Stone Walls

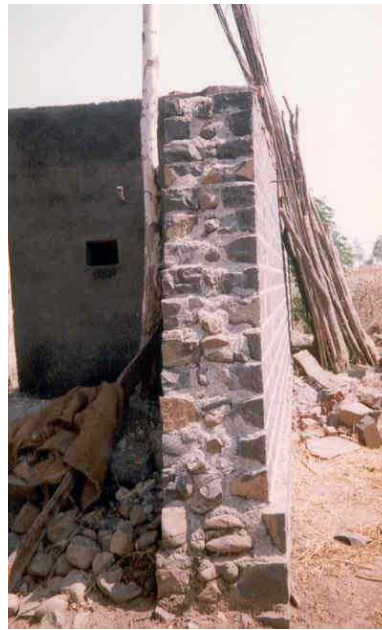
Figure 5A: Seismic Resilient Feature - Well Constructed Stone Wall

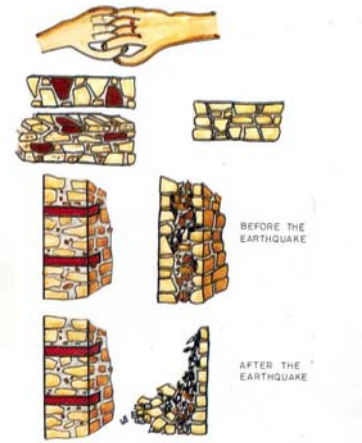
Figure 5B: Seismic Resilient Feature - Importance of Through Stones and Interlocking (Source: GOM 1998)

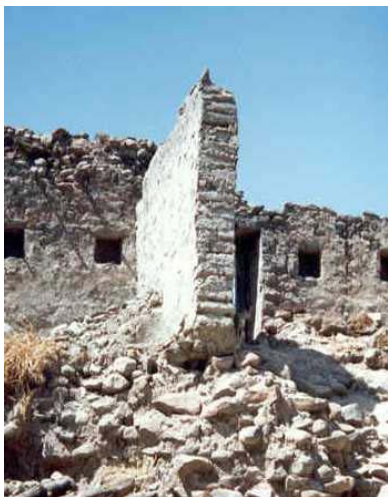
Figure 5C: Structural Deficiency - Absence of Foundations

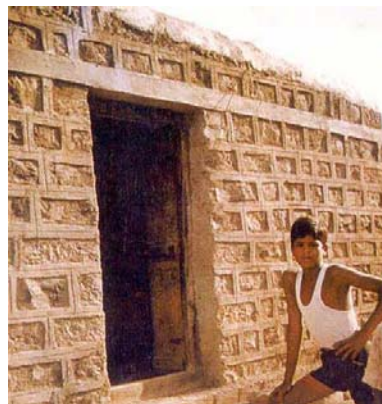
Figure 5D: Earthquake-Resistant Feature - RC Lintel Band

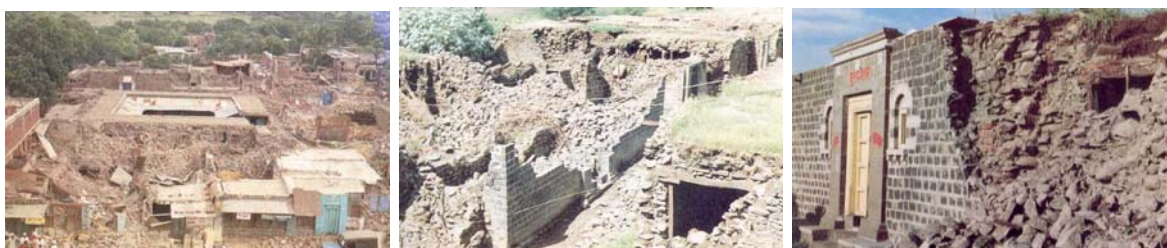
Figure 6: An Areal View of the Killari Village Devastated by the 1993 Earthquake (Source: GSI 1996)

Buildings of this construction type suffered substantial damage in the 1993 Maharashtra earthquake. Close to 30,000 houses of this type collapsed, and other 200,000 houses were damaged. Typical patterns of earthquake damage and failures reported in the 1993 earthquake were: delamination and failure of stone masonry walls (out-of-plane) separation of the walls at corners and junctions lateral swaying of timber frames due to heavy roof weight and inadequate post-to-beam connections.

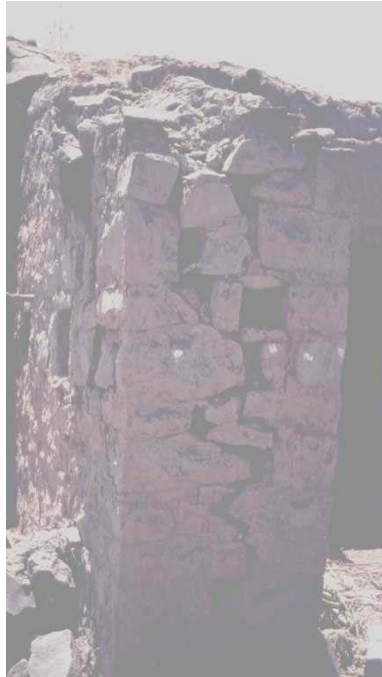
Figure 6D: Typical Earthquake Damage - Delamination of Stone Wall Wythes due to the Absence of Through Stones (1993 Killari earthquake)

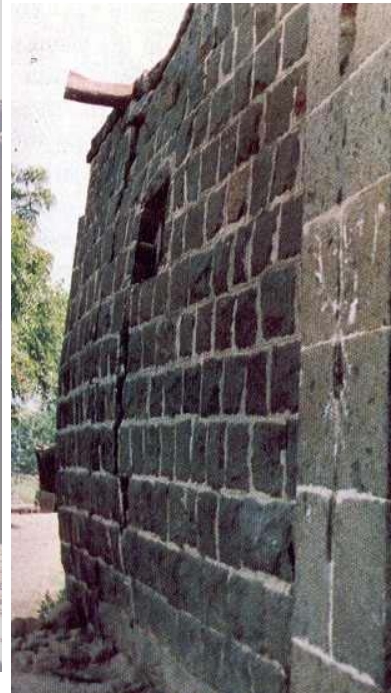
Figure 6E: Typical Earthquake Damage - Building and Cracking of a Thick Stone Wall in the 1993 Killari Earthquake (Source: GSI 1996)

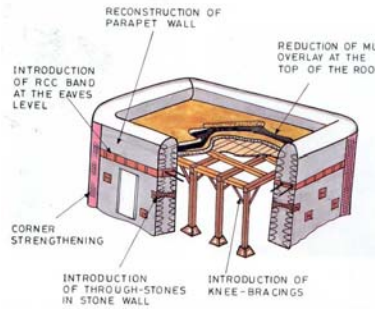
Figure 7A: Seismic Strengthening - Installation of RC Lintel Band in an Existing Building

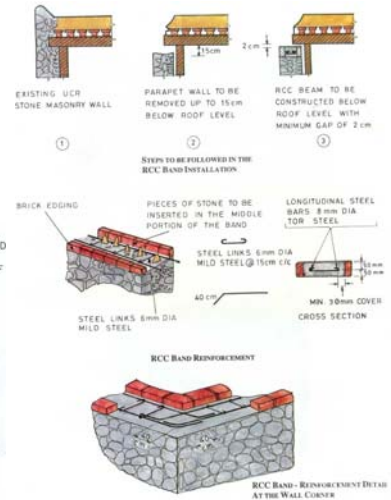
Figure 7B: Seismic Strengthening - Field Application of RC Lintel Band

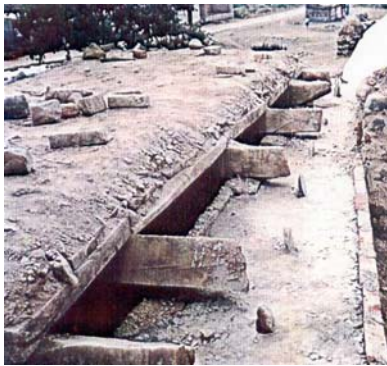
Figure 7C: Seismic Strengthening - Installation of a Bandage at the Lintel Level (an alternative to the installation of RC band) Source: GOM 1998

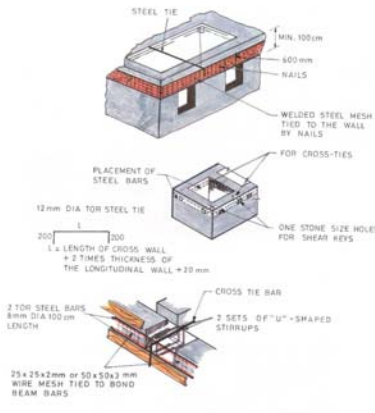
Figure 7D: Seismic Strengthening - A Field Application of Bandage (Source: GOM 1998)

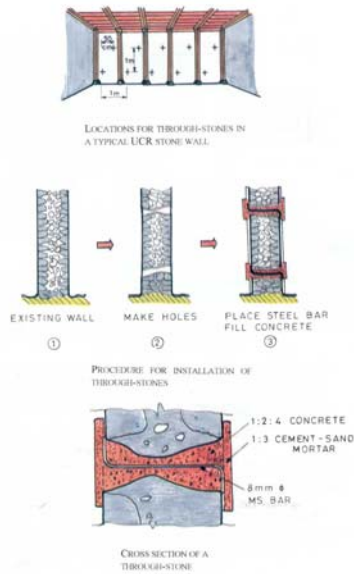
Figure 7F: Seismic Strengthening - Installation of Through Stones (Source: GOM 1998)

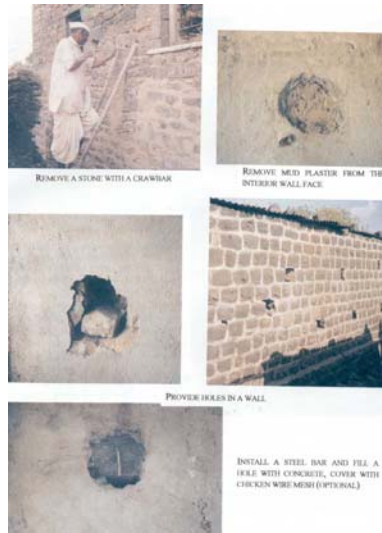
Figure 7G: Seismic Strengthening - A Field Application of Through Stones (Source: GOM 1998)

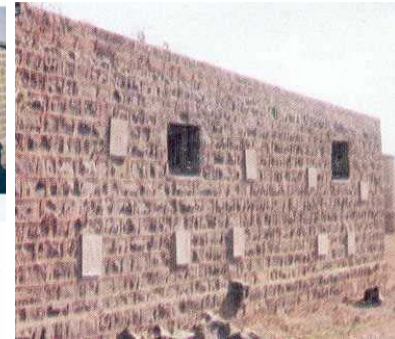
Figure 7H: Seismic Strengthening - An Example of a Retrofitted Building (note through-stones and RC lintel band)

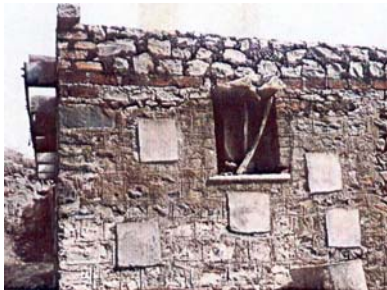
Figure 7I: Seismic Strengthening - An Illustration of Corner Strengthening Technique (Source: GOM 1998)
