UNREINFORCED BRICK MASONRY CONSTRUCTION

Dina D'Ayala, University of Bath, United Kingdom

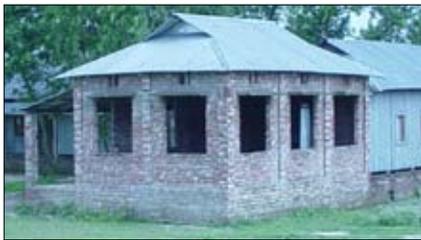
Figure 1: One-story brickwork construction in Bangladesh (WHE Report 91)

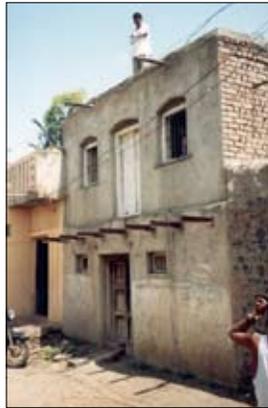
Figure 3: Unreinforced brick masonry building with reinforced concrete roof slab (WHE Report 21, India)

Evidence from recent earthquakes has confirmed that the overall performance of brick masonry buildings is dependent on the type of roof system: buildings with lightweight roofs suffered relatively less damage while buildings with reinforced concrete roofs suffered much greater damage. This performance was observed after the 2001 Bhuj (India) earthquake (M7.7), where brick buildings in the epicentral area (MMI intensity X) were surveyed (IIT Powai 2001). This is in line with the evidence collected after the 1997 Umbria-Marche (Italy) earthquake (MMI VIII), where many buildings with heavy reinforced concrete roofs suffered substantial structural damage and partial collapse. (Note that the total number of collapsed buildings was significantly less than the Bhuj earthquake.)

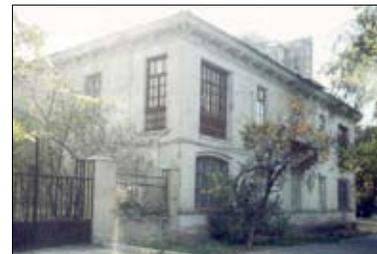
Figure 2: Two-story brick masonry building with wooden floors (WHE Report 41, Kyrgyzstan)

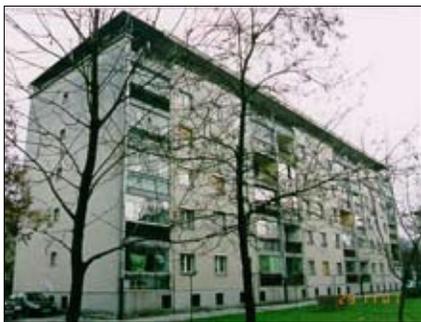
Figure 4: Six-story unreinforced brick masonry apartment building (WHE Report 73, Slovenia)

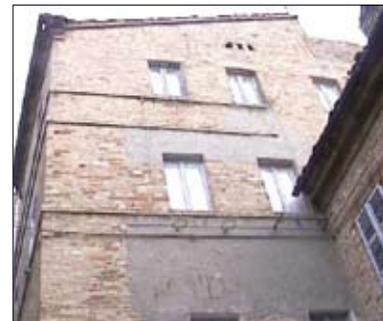
Figure 5: Four-story building with strengthened spandrels in Offida (WHE Report 29, Italy)

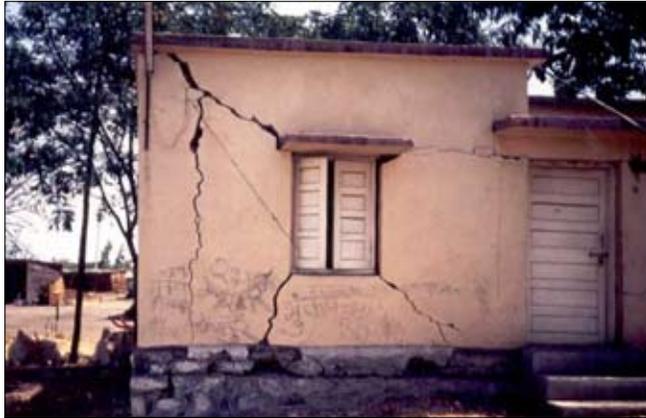
Figure 7: Shear cracks in an unreinforced brick masonry building from the 1993 Killari earthquake (WHE Report 21, India)

- Collapse of chimneys and plaster cracks (MMI intensity VII)
- Shear cracks in the walls, mainly starting from corners of openings (MMI intensity VIII)
- Partial or complete out-of-plane wall collapse due to lack of wall-to-wall anchorage and wall-to-roof anchorage. In extreme cases this is accompanied by partial or total collapse of floor and roof structures (MMI intensity VIII-IX)
- Total collapse of walls and entire buildings in some cases (MMI intensity X), for example, 2001 Bhuj (India) earthquake

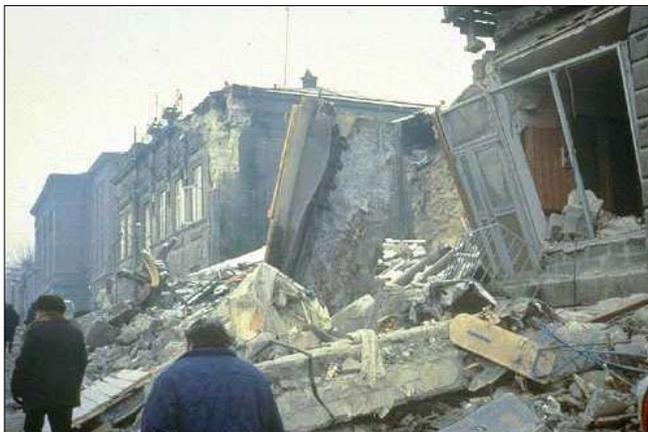
Figure 8: Collapse of brick masonry buildings in the 1988 Spitak earthquake (WHE Report 4, Armenia)

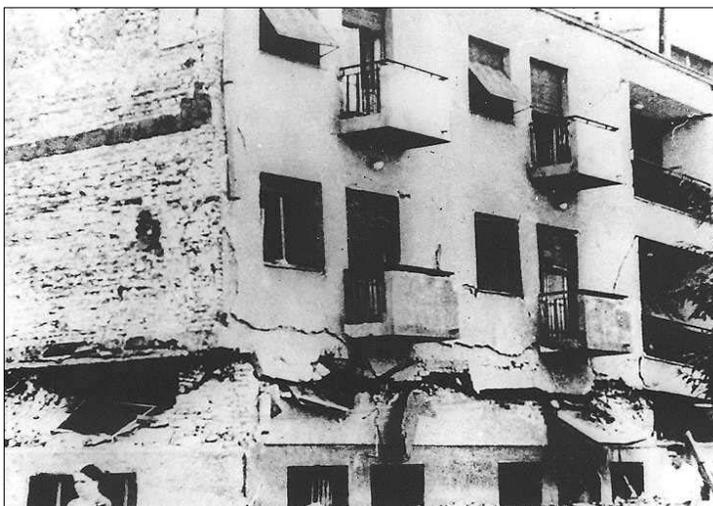
Figure 9: Severe damage to an unreinforced brick masonry building due to inadequate wall density in the 1963 Skopje, Macedonia earthquake (WHE Report 73, Slovenia)

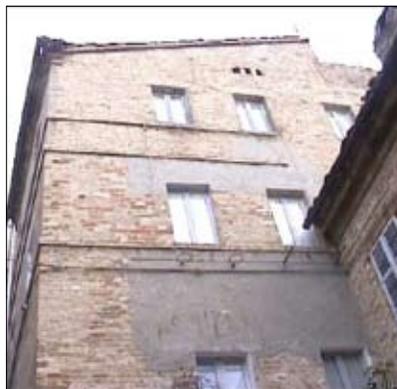
Figure 11: Grouting to improve capacity of spandrel walls (WHE Report 29, Italy)

- Stitching and grouting. Wall cracks are stitched with reinforcement and grouted with mortar to restore the wall integrity. This technique consists of drilling holes through the walls and installing steel bars; subsequently, the holes are grouted with cement grout. For historic buildings it is essential that the grout is lime-based and the bars are stainless steel or another non-corroding material.

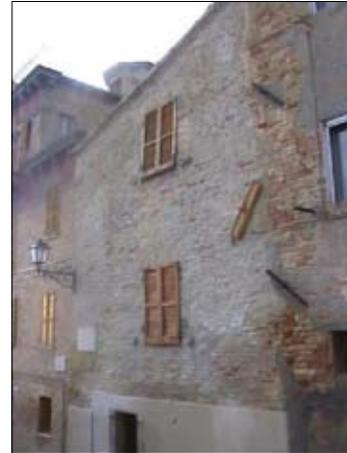
Figure 13: Tie-anchorage construction detail (WHE Report 29, Italy)

- Installation of metallic ties. These ties can anchor a wall to the floor and roof diaphragms or to an opposite wall. Roof and floor slabs are anchored to the walls to ensure the inertia force transfer to the walls. When a wall is anchored directly to an opposite wall, the metallic ties will pass under the floor structure. It is very important to accomplish a regular distribution of ties for both approaches because irregular tie distribution may be a cause of earthquake damage. Installation of ties may also require that new boundary members (chords and collectors) are added to the floor and roof to ensure the integrity and diaphragm action.
