GEM Building Taxonomy Report

Laundry-fuel storage

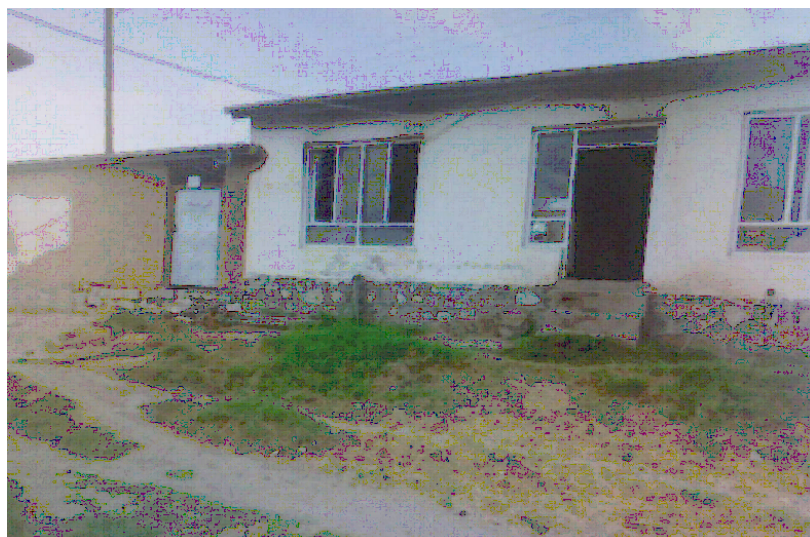
Masonry, unreinforced

Mud mortar

Wall

Shallow foundation, with no lateral capacity

Flat

Roof-wall diaphragm connection not provided

Adobe blocks

Rectangular, solid
