GEM Building Taxonomy Report

House along a drainage creek

NED University

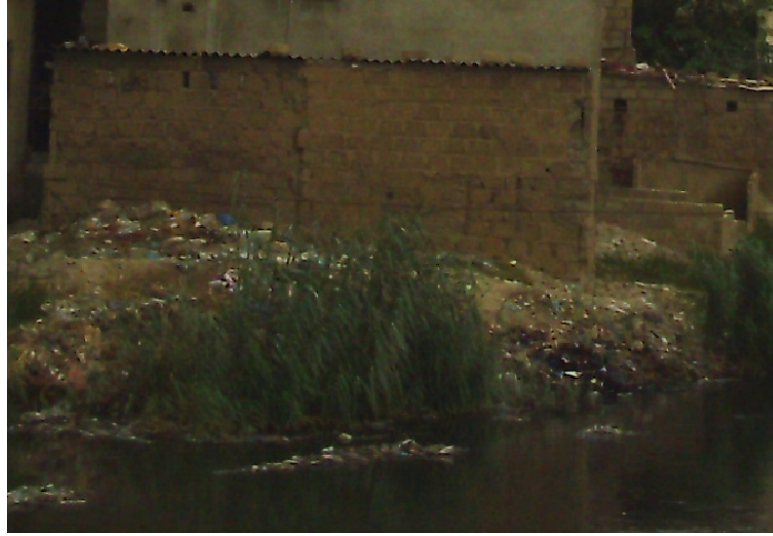
Masonry, unreinforced

Cement mortar

Wall

Flat

Roof material, other

Roof-wall diaphragm connection not provided

Masonry

Concrete blocks, solid

Metal sheets

Illegal encroachment along creek - starts off as temporary settlements consisting of rudimentary shacks but eventually builds up into solid, more permanent structures built of a variety of salvaged materials.
