GEM Building Taxonomy Report

House along a drainage creek
NED University

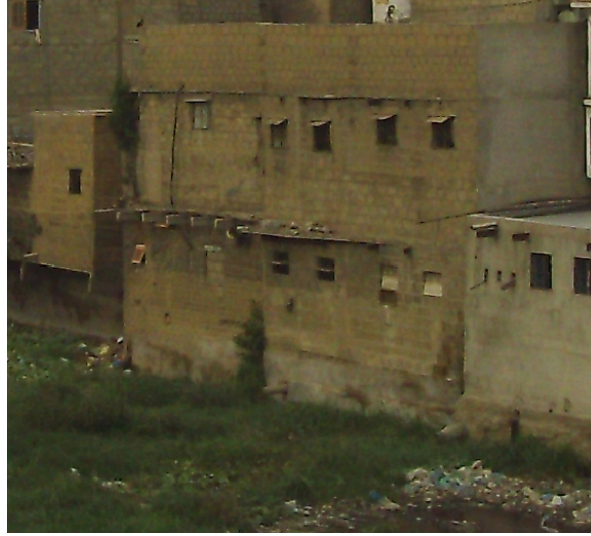
DX /MUR+CBS+MOC /LWAL /DY /MUR+CBS+MOC /LWAL / /HEX:2+HBEX:0 /RES+RES2 /BP1 /PLFR /IRRE /EWMA /RSH1+RMT1+RME+RME1+RWCN /FME+FME1+FWCN /

Masonry, unreinforced

Cement mortar

Wall

Roof-wall diaphragm connection not provided

Floor-wall diaphragm connection not provided

Rectangular, solid

Metal beams or trusses supporting light roofing

Metal beams, trusses or joists supporting light flooring

Illegal encroachment along creek - starts off as temporary settlements consisting of rudimentary shacks but eventually builds up into solid, more permanent structures built of a variety of salvaged materials.
