# GEM Building Taxonomy Report

House along a drainage creek  
NED University

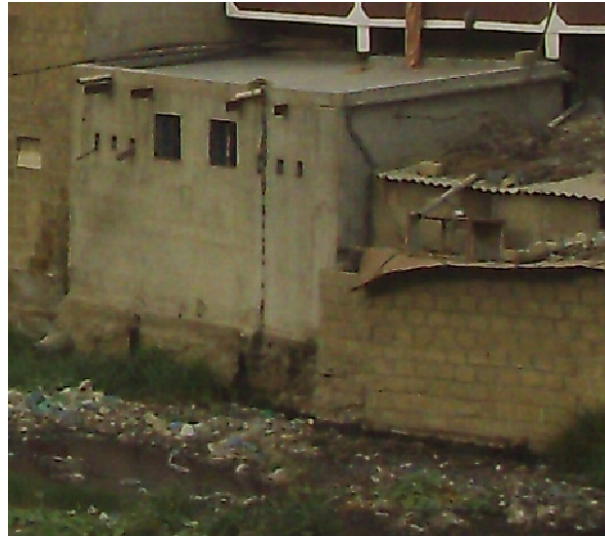
DX /MUR+CBS+MOC /LWAL /DY /MUR+CBS+MOC /LWAL / /HEX:1+HBEX:0 /RES+RES1 /BP1 /PLFSQ /IRRE /EWMA /RSH1+RMN+RME+RME2 /FN /

Masonry, unreinforced

Cement mortar

Wall

Concrete blocks, solid

Square, solid

Metal beams supporting precast concrete slabs

Illegal encroachment along creek - starts off as temporary settlements consisting of rudimentary shacks but eventually builds up into solid, more permanent structures built of a variety of salvaged materials.
