GEM Building Taxonomy Report

Grass/Thatch House

NED University

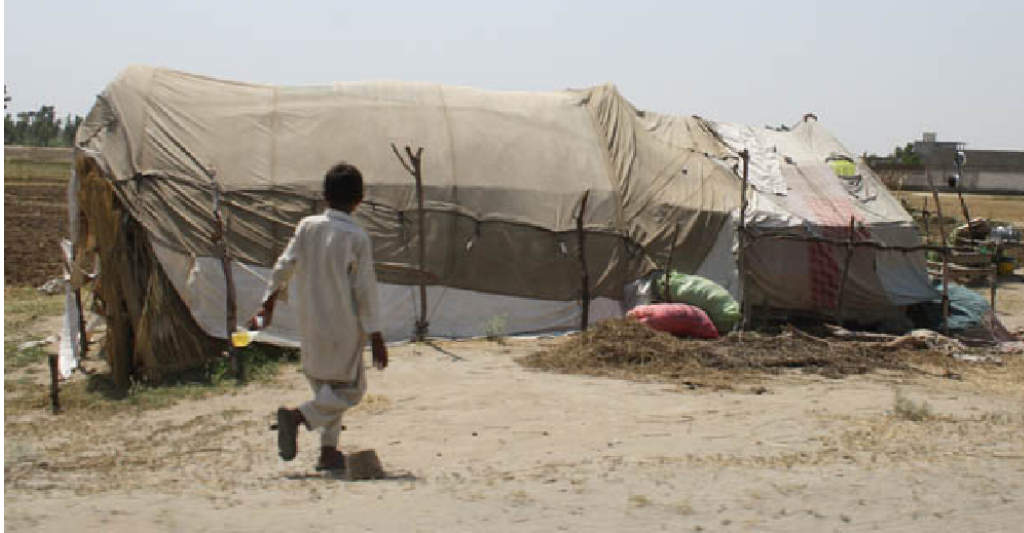
A makeshift abode for a nomad family along the Highway, Sindh
