REINFORCED CONCRETE FRAME CONSTRUCTION

Ahmet Yakut, Middle East Technical University, Turkey

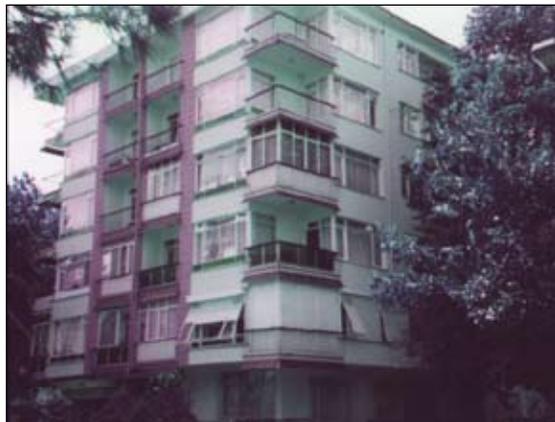
Figure 1: Typical residential RC frame building in Turkey (WHE Report 64, Turkey)

With the rapid growth of urban population in both the developing and the industrialized countries, reinforced concrete has become a material of choice for residential construction. Unfortunately, in many cases there is not the necessary level of expertise in design and construction. Design applications range from single-family buildings in countries like Algeria and Colombia to high-rises in Chile, Canada, Turkey, and China (Figure 1). Frequently, reinforced concrete construction is used in regions of high seismic

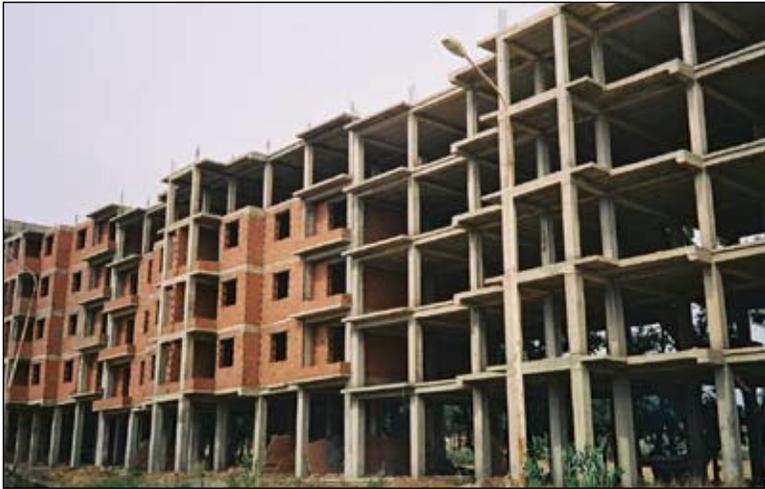
Figure 3: RC frame construction with hollow-clay tile masonry infill in Algeria (Credit: S. Brzev)

The current WHE database includes over twenty reports describing RC frame construction. The most prevalent type is RC frame with masonry infill walls (Figure 3). This construction is still practiced extensively in many parts of the world, especially in developing countries. This construction comprises approximately 75% of the building stock in Turkey, about 60% in Colombia, and over 30% in Greece. Details of this construction type including regional variations are contained in the WHE reports from Cyprus (WHE Report 13), India (WHE Report 19), Palestinian Territories (WHE Report 48), Turkey (WHE Report 64), and Romania (WHE Report 71). RC frames with concrete infill walls, also known as dual systems, are very common in earthquake-prone areas. The WHE reports from Chile (Report 6) and Syria (Report 59) describe details of this construction type.

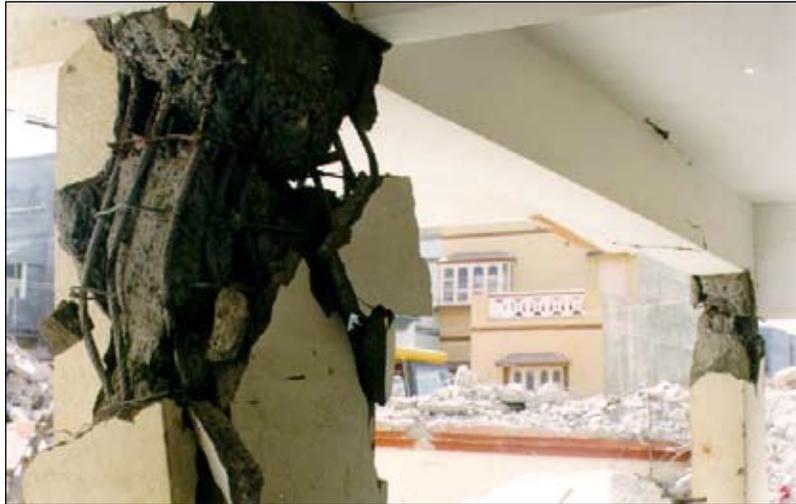
Figure 5: Shear failure of a reinforced concrete column in the 2001 Bhuj earthquake (WHE Report 19, India)

- Shear failure and concrete crushing failure in concrete columns. These are the most undesirable nonductile modes of failure (Figure 5). This behavior can lead to the loss of gravity load-bearing capacity in the columns and potentially a total building collapse.

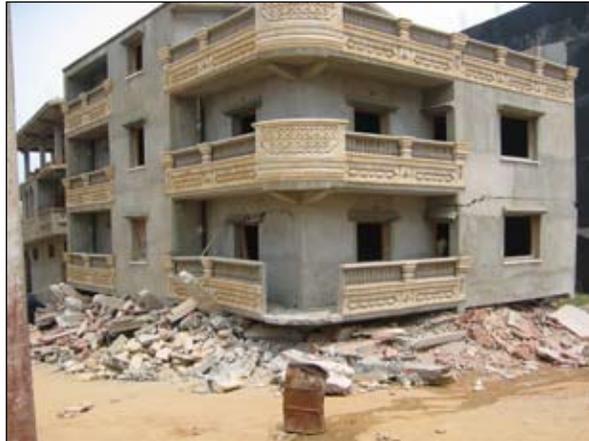
Figure 7: Building collapse due to soft-story mechanism in the 2003 Boumerdes earthquake (WHE Report 103, Algeria)
