# **A TUTORIAL: Improving the Seismic Performance of Stone Masonry Buildings**

**Jitendra Bothara • Svetlana Brzev**

First Edition, April 2011

**Publication Number WHE-2011-01**

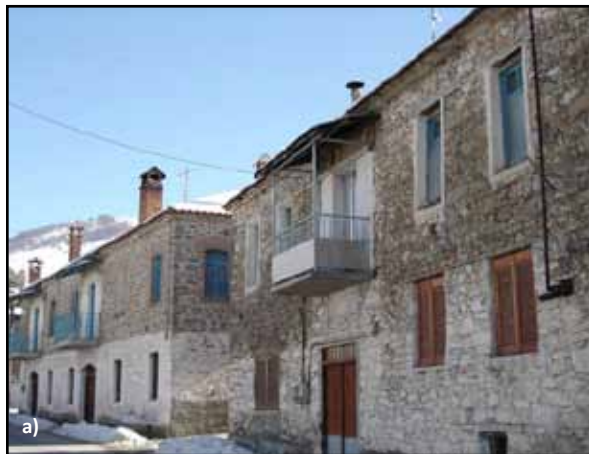
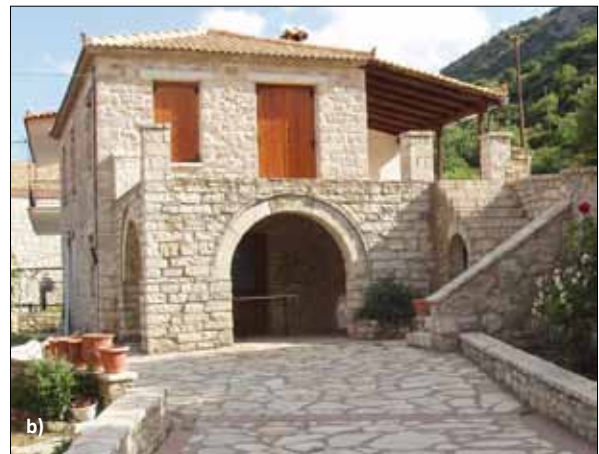
**Figure 1.1** Stone masonry buildings in Greece: a) older construction in Northern Greece, and b) recent construction (photos: S. Pantazopoulou)

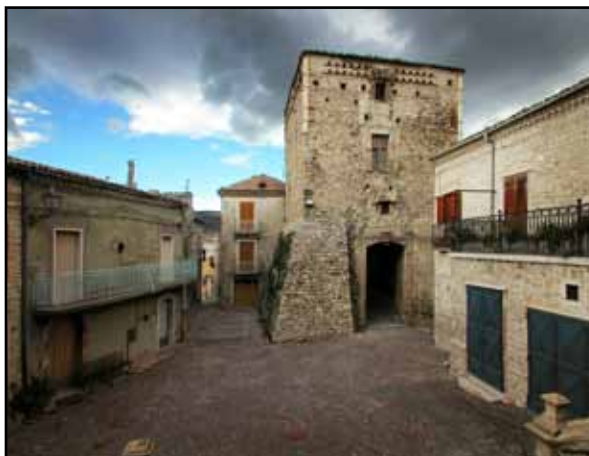
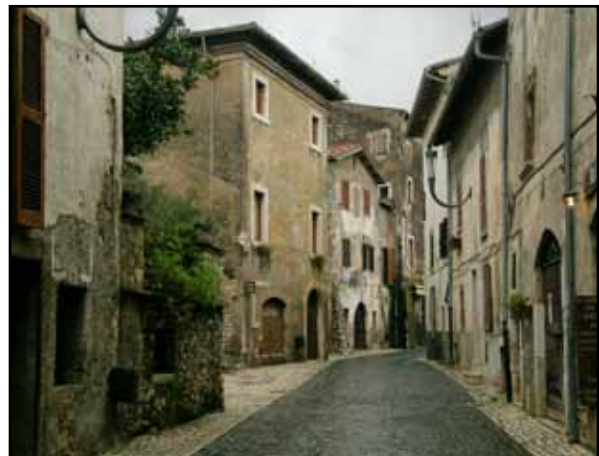
**Figure 1.2** Stone masonry in Italy: a) castle tower in San Giuliano di Puglia, the village most affected by the 2002 Molise earthquake, and b) a street lined with stone masonry houses in Sermonetta, a village between Rome and Naples (photos: R. Langenbach)

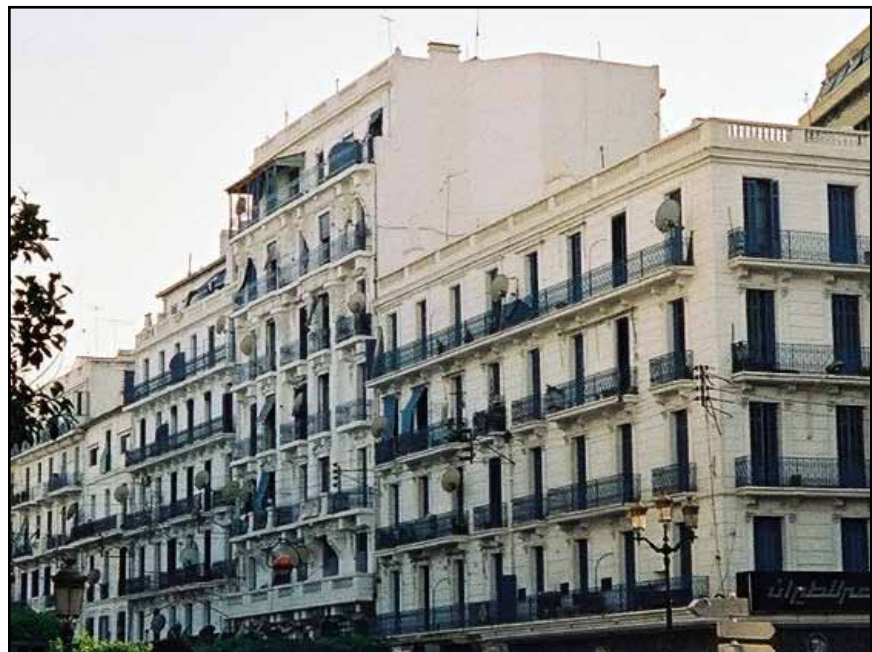
Figure 1.4 Six-story stone masonry building in Algiers, Algeria (photo: S. Brzev)

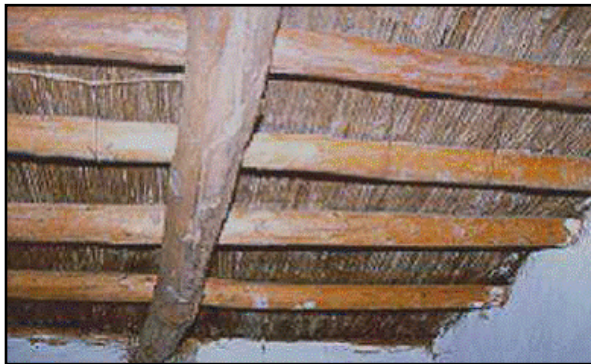
**Figure 1.11** A timber floor structure in Nepal (source: WHE Report 74)

Timber floor construction may be in the form of wooden beams covered with wooden planks, ballast fill, and tile flooring, as shown in Figure 1.10. A timber floor structure overlaid by planks and bamboo strips is also common (Figure 1.11). In hot climate regions, a thick mud overlay is provided on top of the roof for thermal comfort, as shown in Figure 1.12. Timber truss roofs are common in the area affected by the 2005 Kashmir earthquake in Pakistan, as shown in Figure 1.13. In most cases, timber joists are placed on top of walls without any positive connection; this has a negative effect on seismic performance.

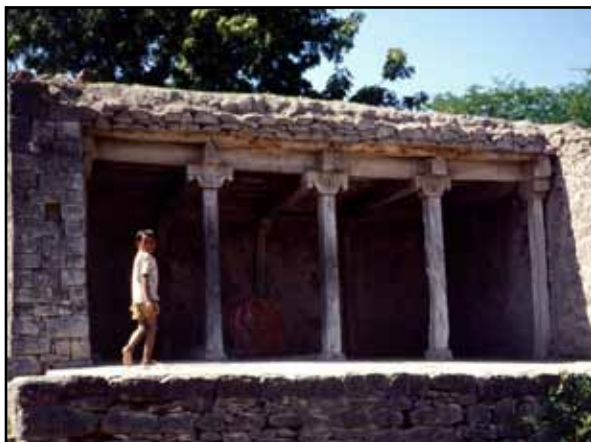
**Figure 1.12** A timber roof structure with mud overlay in Maharashtra, India (photo: S. Brzev)

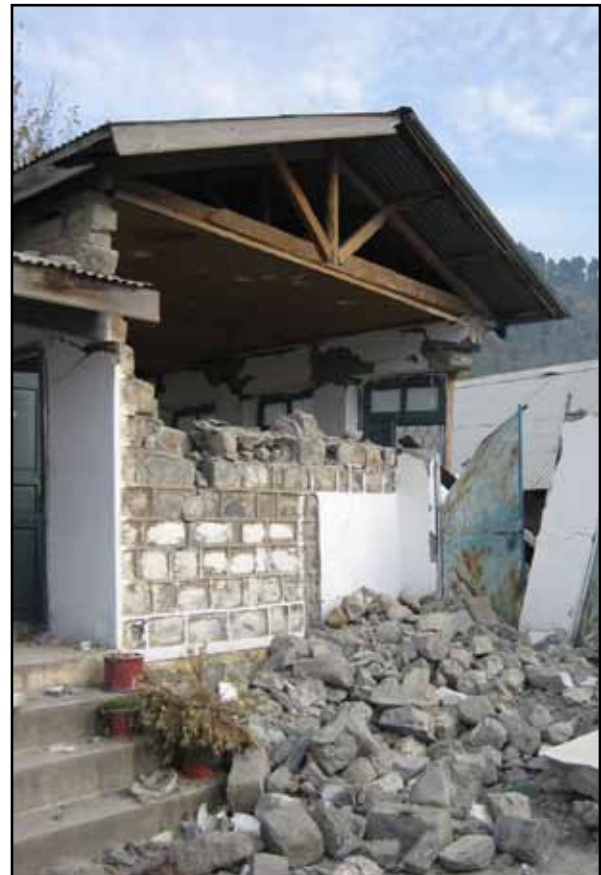
**Figure 1.13** Timber truss roof structure in the area affected by the 2005 Kashmir earthquake in Pakistan (source: M. Tomazevic 1999)

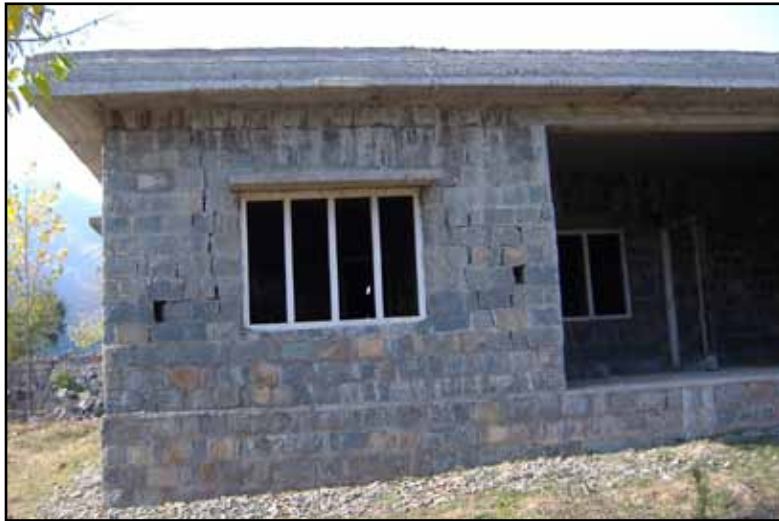
Figure 1.14 A stone masonry building with an RC slab roof in Pakistan (photo: J. Bothara)

It is a common structural/seismic rehabilitation practice to replace the original floor structures in historic buildings with either a precast concrete joist system or solid reinforced concrete (RC) slabs; examples of this practice were reported in Italy (WHE Report 28) and Slovenia (WHE Report 58). The use of RC slabs is increasingly popular because cement-based construction materials and technology are becoming widely accessible. An example of a stone masonry building with an RC roof in Pakistan is shown in Figure 1.14. RC slabs are affordable because they require low maintenance and use space efficiently.

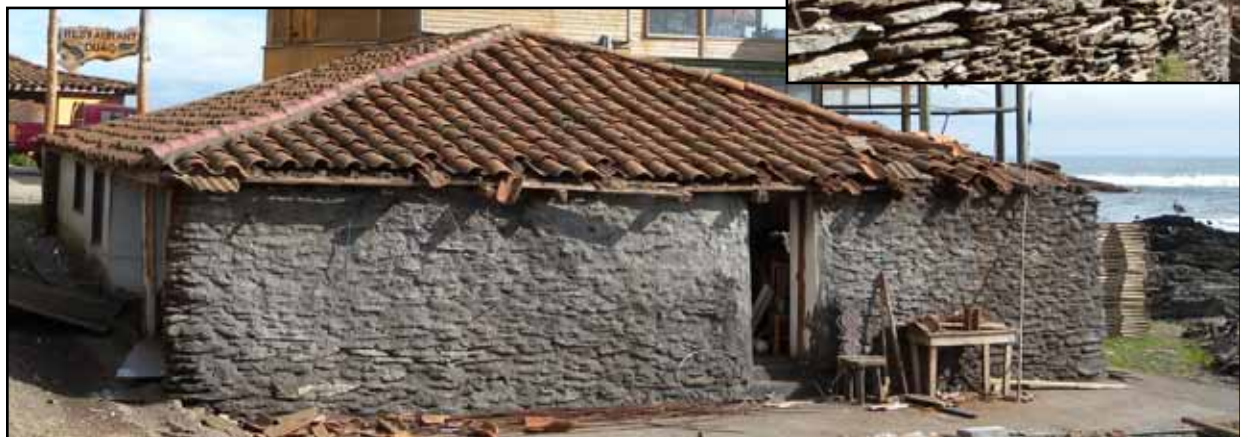
Figure 1.15 A stone masonry house built using slate stones in Duao, Chile (photos: S. Brzev)

Stone masonry walls are constructed from stone boulders bonded together with mortar; alternatively, “dry stone masonry” is used when the stones are flat in shape and no mortar is used. Figure 1.15 shows an example of dry stone masonry from Duao, Chile, a small town affected by the February 27, 2010 earthquake (M 8.8) and the subsequent tsunami. This building was located on a beach (the Pacific Ocean can be seen in the background).

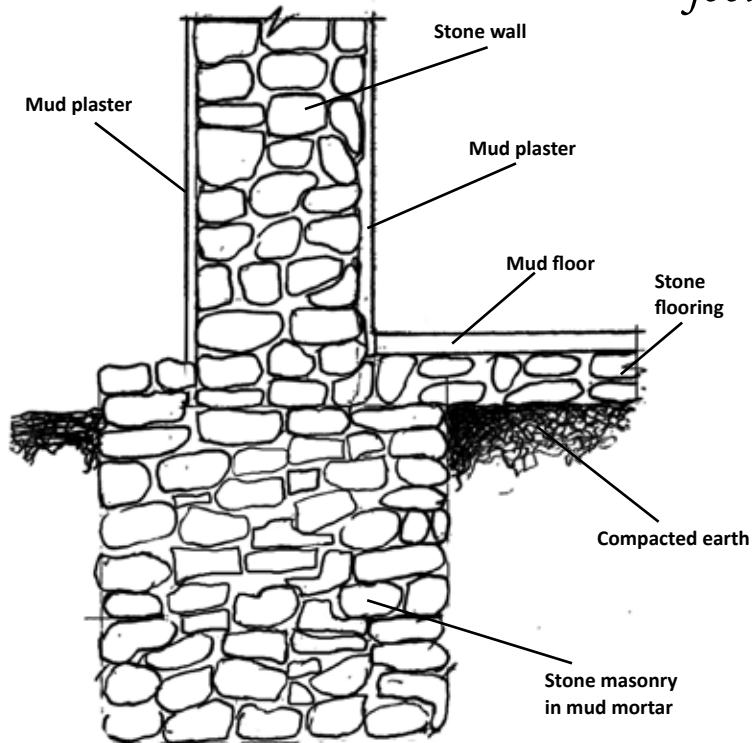
**Figure 1.17** Typical stone masonry foundation in Nepal (source: WHE Report 74)

Foundations support the wall weight and provide an interface between the underlying soil and the building structure. In most cases, stone masonry walls are supported by continuous stone masonry strip footings (Figure 1.17). In some cases, footings do not exist at all (Figure 1.18).

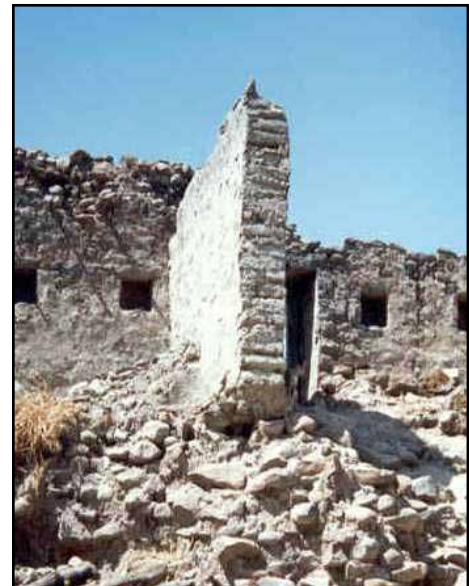
**Figure 1.18** A wall without foundations in the area affected by the 1993 Maharashtra, India, earthquake (photo: S. Brzev)

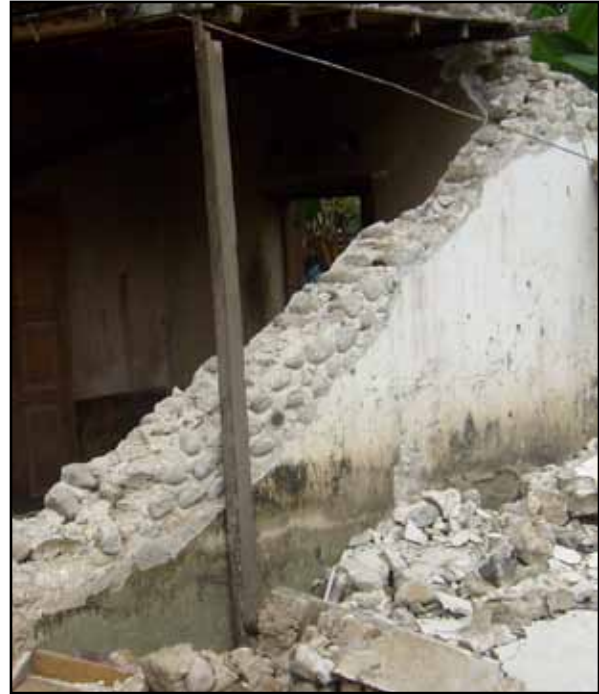
**Figure 1.19** Round stone boulders used for traditional stone masonry construction in Padang, Indonesia (photo: J. Bothara)

Stone boulders from various sources, including river stones, field stones, and quarried stones, are used for stone masonry construction. River stones or field stones are often used in their natural round or irregular forms (Figure 1.19); this is especially the case when the materials, expertise, or labor required to shape these stones is difficult to find or excessively expensive. Alternatively, an artisan stone-cutter (see Figure 1.20) can shape stones to produce semi-dressed stones, which have at least one exterior flat surface (wedged stone), as shown in Figure 1.21. In some cases, stones can be fully dressed into regular shapes to better suit construction.

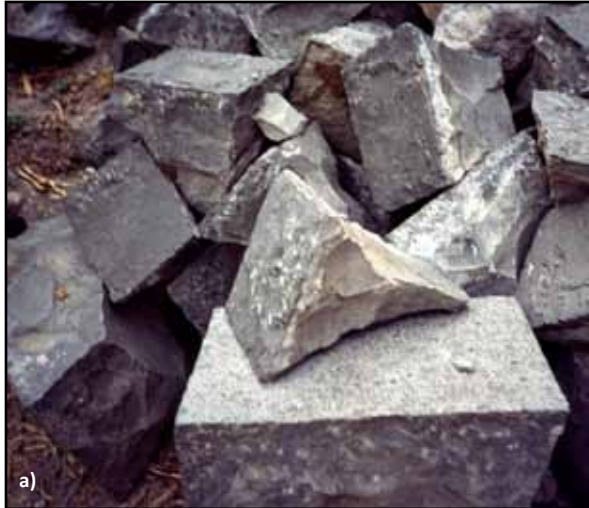
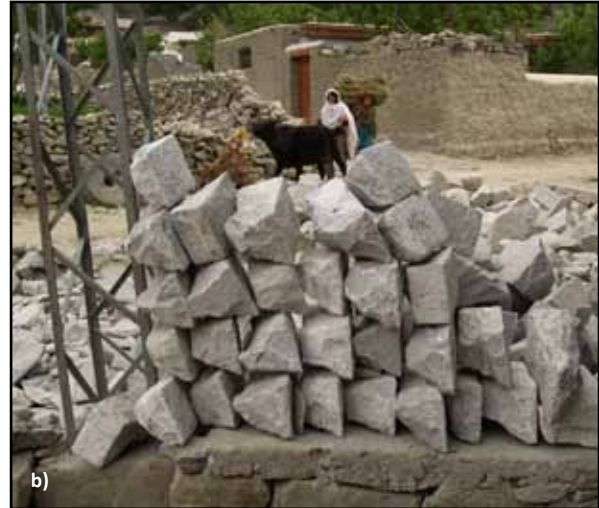
**Figure 1.21** Semi-dressed stones ready for wall construction: a) wedged stones in Maharashtra, India (photo: S. Brzev), and b) shaped stones in Pakistan (photo: T. Schacher)

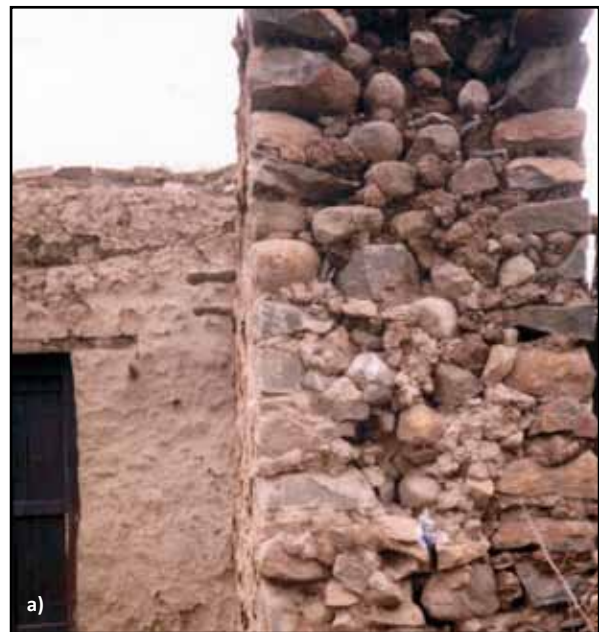
**Figure 1.22** Typical uncoursed random rubble stone walls: a) an uncoursed random rubble stone wall in Maharashtra, India, showing exterior wythes and stone rubble in mud mortar in between (photo: S. Brzev) and b) plan view of a stone wall under construction in Nepal (note stone rubble between the wall wythes) (photo: Smart Shelter Foundation)

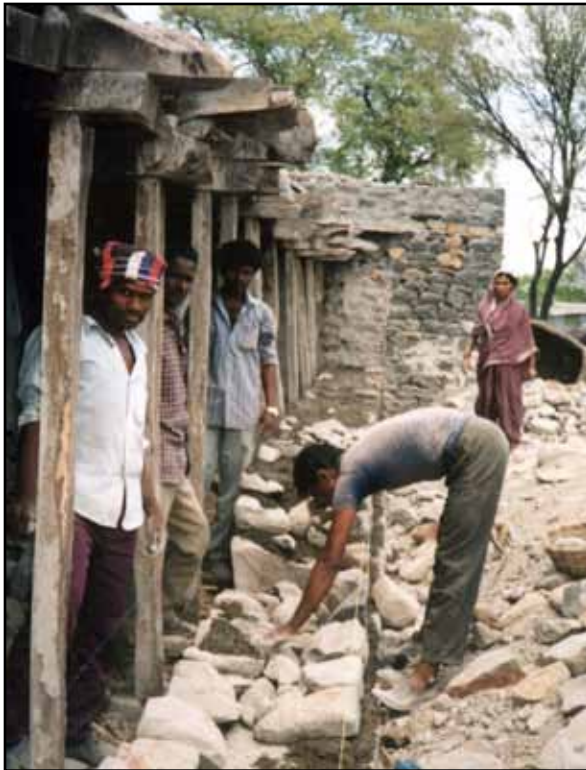
**Figure 1.23** Construction of an uncoursed random rubble stone wall in Maharashtra, India (photo: S. Brzev)

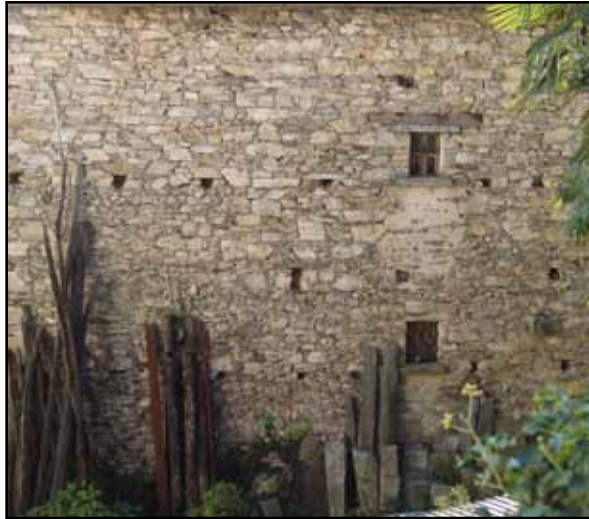
**Figure 1.25** A building with uncoursed stone masonry walls in lime mortar in L'Aquila, Italy (note round stone boulders) (photo: T. Schacher)

Stone used for this type of construction is of irregular shape, including small or medium-size river stones, smooth stone boulders with rounded edges, or stones from a quarry (Figures 1.22 to 1.25). Sometimes, these round stones are partially dressed to achieve a relatively regular shape (Figure 1.25). These stones are usually laid in a low-strength mortar such as mud or lime mortar. The walls consist of two wythes and the space between the wythes is filled with mud, small stones and pieces of rubble. Through-stones (long stones that extend through all wythes), which are essential for bonding the wythes and ensuring wall integrity, are usually absent. The wall thickness is usually on the order of 600 mm, but it can be excessively large—up to 2 m. In many instances, the exterior walls in the building are constructed first and the interior walls are constructed later without any connection. Rooms in these buildings are generally small and there are few small wall openings (if any).

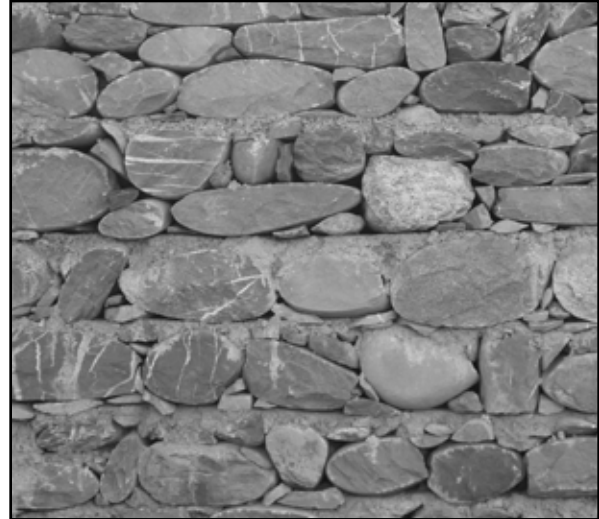
**Figure 1.26** Uncoursed semi-dressed stone masonry wall in Southern Switzerland (photo: T. Schacher)

This construction type is similar to random rubble stone masonry in that there are two external wall wythes and an interior filled with rubble or dirt. However, in the case of semi-dressed stone masonry, the exterior wythes are dressed. As a result, the construction has a better appearance, although its seismic performance may not be significantly improved. Examples of uncoursed semi-dressed stone masonry from Switzerland and Pakistan are shown in Figures 1.26

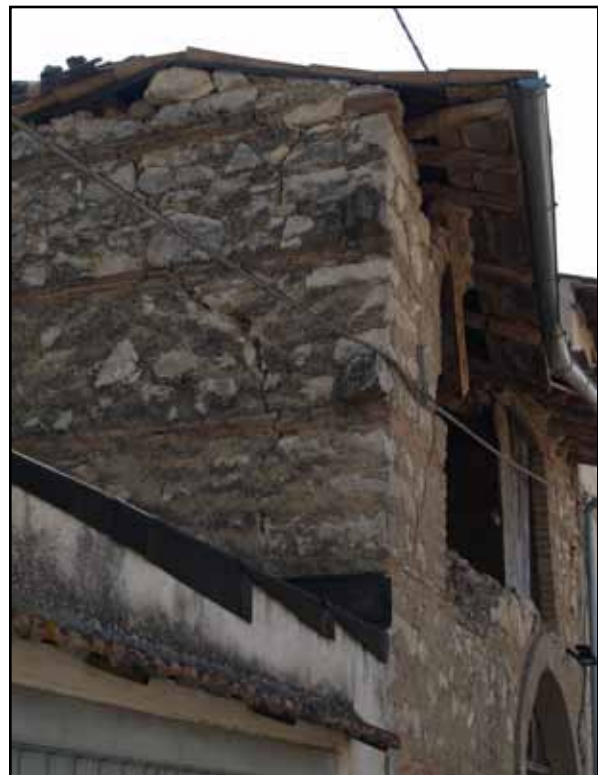
**Figure 1.29** Stone masonry construction with timber bands in Pakistan (photo: T. Schacher)

In some regions of the world, timber or brick bands are used to enhance the wall stability in both uncoursed random rubble and semi-dressed masonry. This is a traditional practice in some parts of Nepal, India, Pakistan, Turkey, and Greece. Examples from Italy and Pakistan are shown in Figures 1.29 and 1.30. Use of timber bands (hatils) in Turkish stone masonry construction has been discussed by Erdik (1990). Figure 1.30 shows a stone masonry building in Italy with brick bands, which are expected to have an effect similar to timber bands.

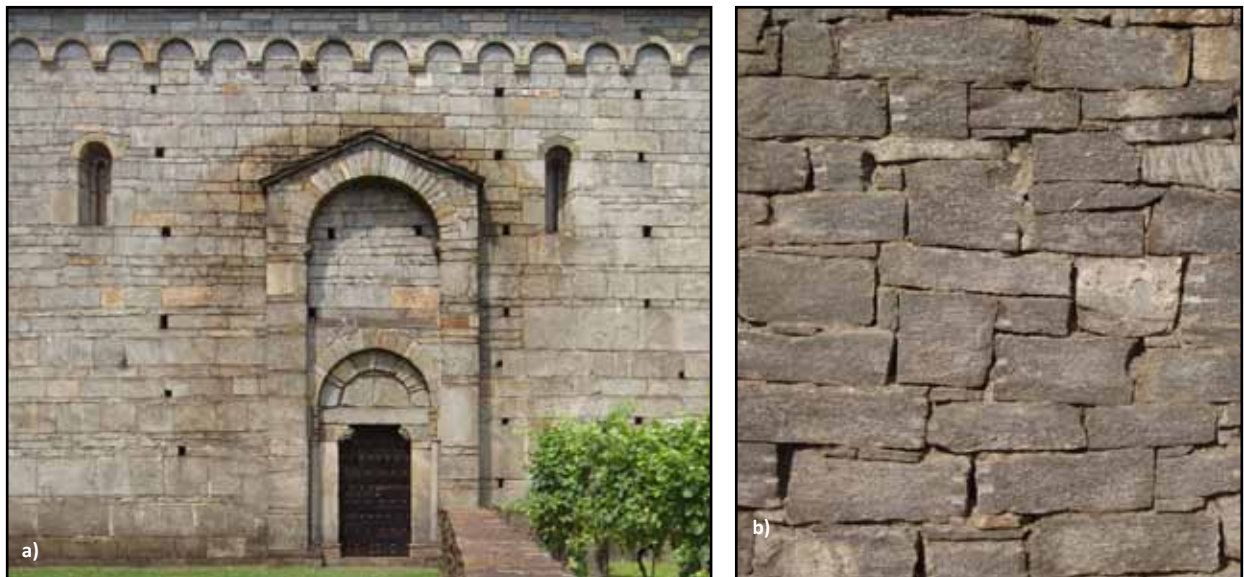
**Figure 1.32** Dressed stone masonry construction in Southern Switzerland: a) a typical building in Giornico, and b) a detail of the exterior (photos: T. Schacher)

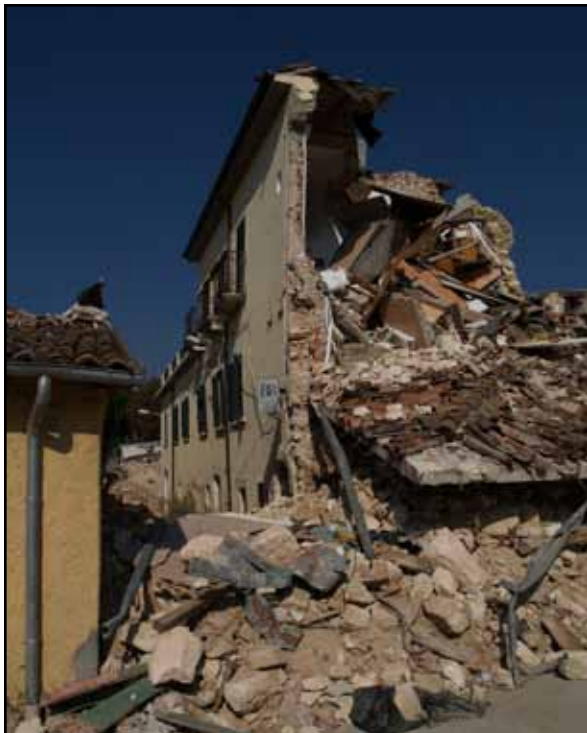
**Figure 2.1** Extensive damage to stone masonry buildings in the 2009 L'Aquila, Italy, earthquake (photo: T. Schacher)

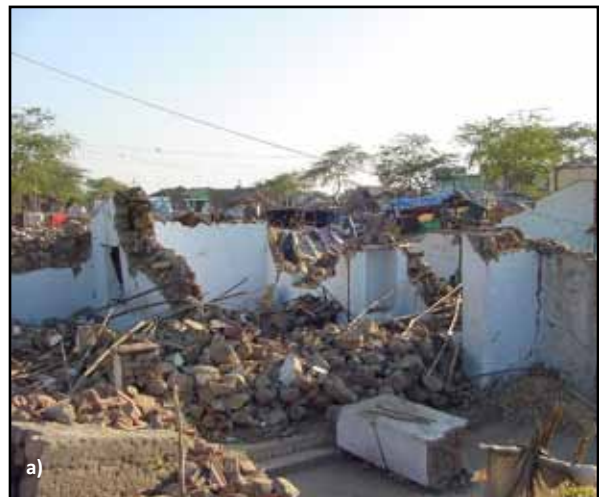
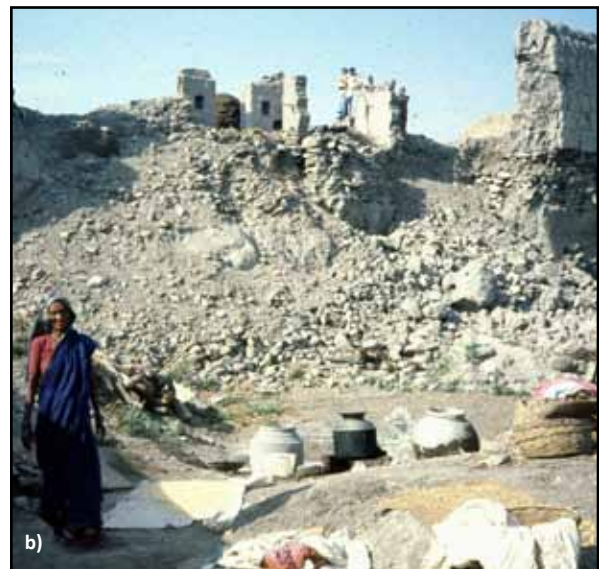
**Figure 2.2** Extensive damage to stone masonry buildings in Indian earthquakes: a) the 2001 Bhuj, Gujarat, earthquake (photo: C.V.R. Murty), and b) the 1993 Maharashtra earthquake (photo: S. Brzev)

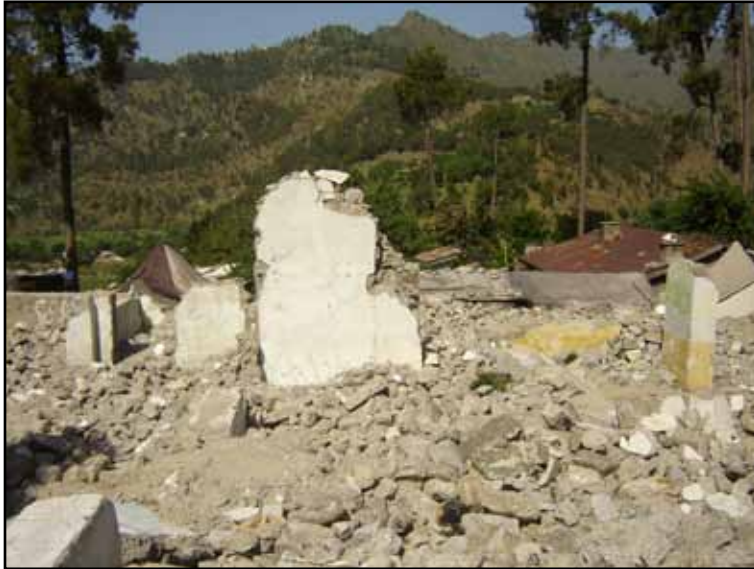
Figure 2.3 Collapse of stone masonry buildings, 2009 Bhutan earthquake (photo: K. Vatsa)

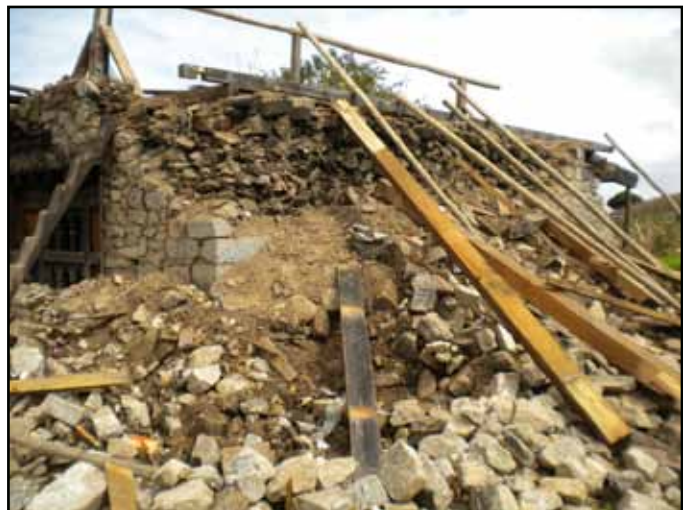
Figure 2.4 Collapsed stone masonry buildings, 2009 Bhutan earthquake (photo: K. Vatsa)

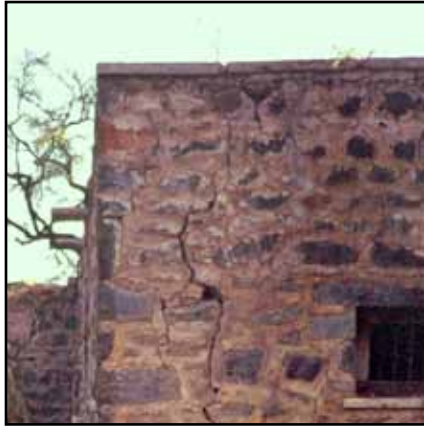
**Figure 2.7** Vertical crack in a stone masonry wall due to the 1993 Maharashtra, India, earthquake (photo: S. Brzev)

Wall intersections are particularly vulnerable to earthquake effects due to significant tensile and shear stresses developed when seismic forces are transferred from walls B (transverse walls) to walls A (shear walls), as illustrated in Figure 2.6. As a result, vertical cracks develop or separation may take place at wall intersections. These damage patterns have been observed in past earthquakes, as shown in Figures 2.7 to 2.9. In some cases, intersecting walls are built using different materials (a combination of brick or block and stone masonry), and are more susceptible to damage compared to other walls, as shown in Figure 2.37.

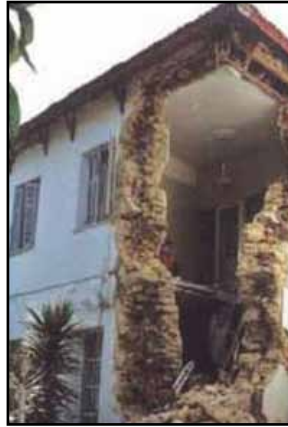
**Figure 2.8** Disintegration of stone masonry walls in Greece (source: WHE Report 16)

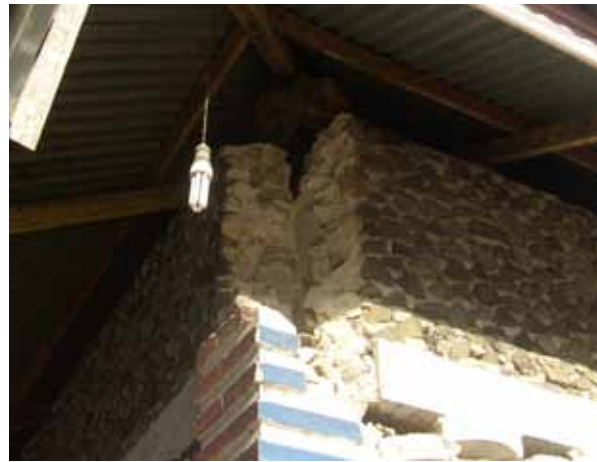
**Figure 2.9** Damage at a wall intersection of a single-story stone masonry building in the 2009 Padang, Indonesia, earthquake (note absence of bands at lintel and roof levels) (source: Bothara et al. 2010)

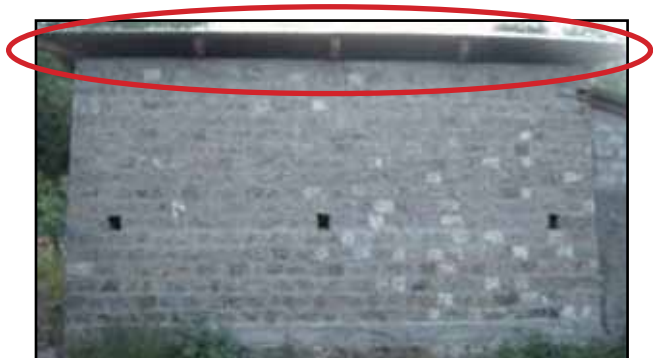
**Figure 2.10** A stone masonry building in Muzzaffarabad was undamaged in the 2005 Kashmir, Pakistan, earthquake; this was attributed to the presence of an RC band at the eaves level (photo: J. Bothara)

bandages). An example of a stone building with an RC roof band that remained undamaged in the 2005 Kashmir earthquake in Pakistan is shown in Figure 2.10. Figure 2.11 shows a building with an RC lintel band that showed good performance in the same earthquake.

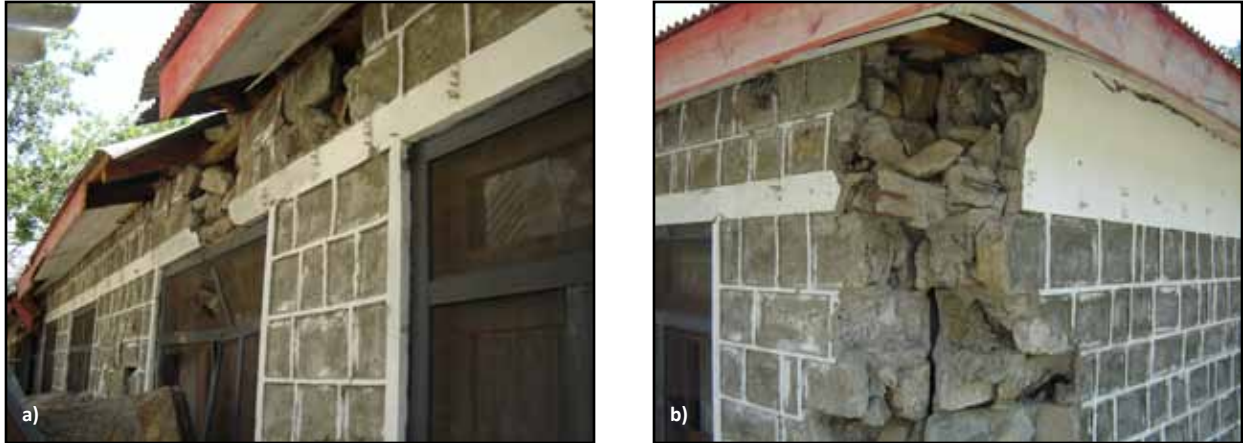
**Figure 2.11** A stone masonry building with an RC lintel band that survived the 2005 Kashmir earthquake in Pakistan: a) the building suffered only moderate damage in the top portion, and b) separation at the wall intersection took place in spite of the band (note inadequate anchorage of the band reinforcement) (photos: Builders Without Borders)

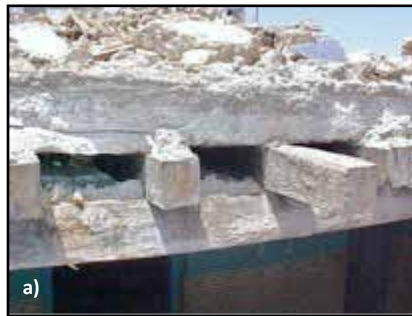
Figure 2.14 Roof deficiencies in the area affected by the 2001 Bhuj, India, earthquake: a) discontinuous rafters over interior walls, and b) inadequate wall-to-floor connections caused the severe building damage (photos: C.V.R. Murty)

In the Anjar area of Gujarat, India, which was affected by the 2001 Bhuj earthquake, buildings are characterized by thick stone masonry walls (thickness around 750 mm) built in sandstone and lime mortar (Jain et al. 2002). In this area, the traditional buildings have timber roofs with rafters spanning two walls in a room, instead of spanning the full length of the building. As a result, the floor in each room acted as an independent system, and had a tendency to pull apart from the other floors during the strong ground shaking. This caused a partial or total collapse of many stone masonry buildings in the area (Figure 2.14).

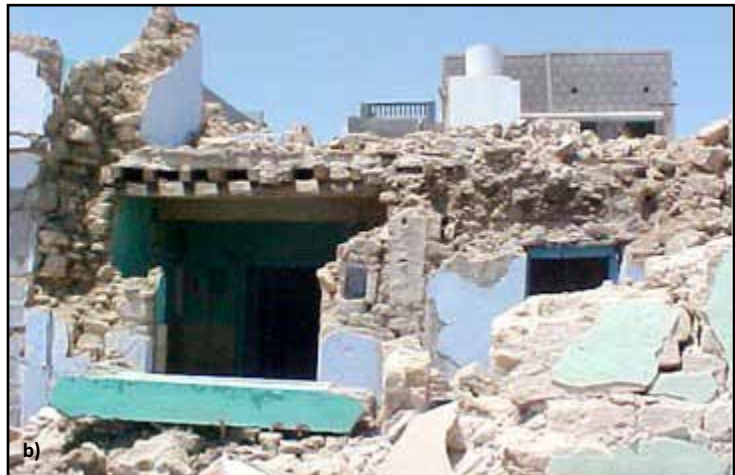
**Figure 2.15** A building with horizontal wall anchors at the floor level survived the 2009 L'Aquila, Italy, earthquake (photos: T. Schacher)

Evidence from past earthquakes has shown that buildings with good floor-wall and roof-wall anchorages are able to resist earthquake effects and maintain integrity without collapse (Figures 2.15 and 2.16).

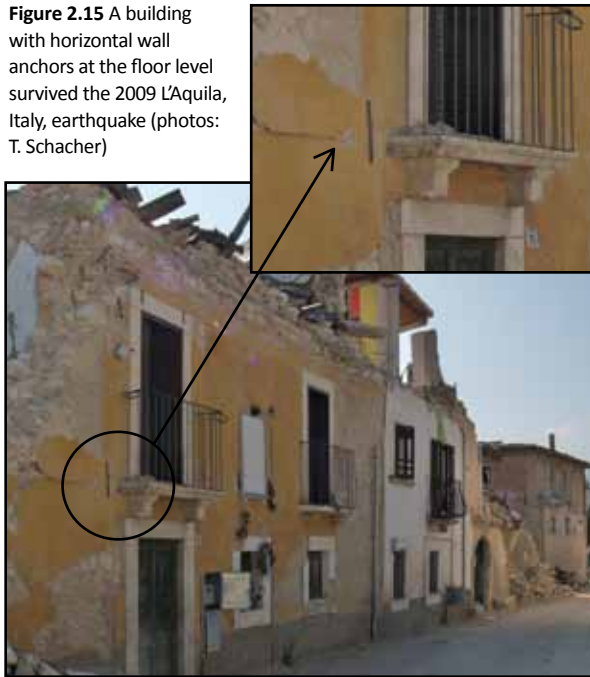
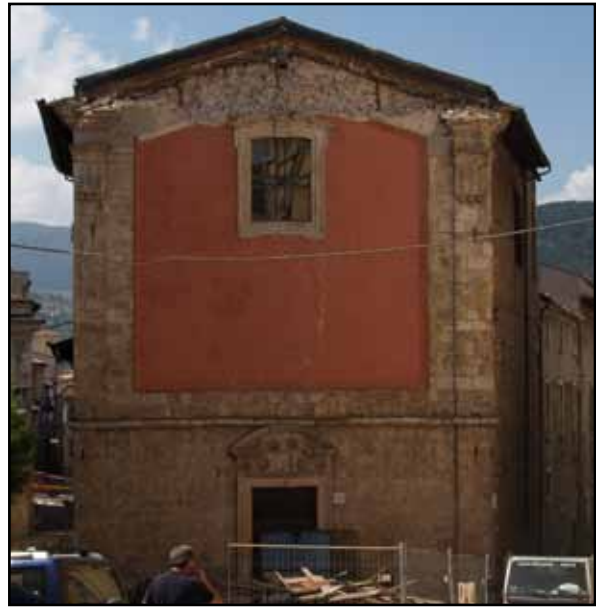
**Figure 2.16** A building with roof-to-wall anchors survived the 2009 L'Aquila, Italy, earthquake (photos: T. Schacher)

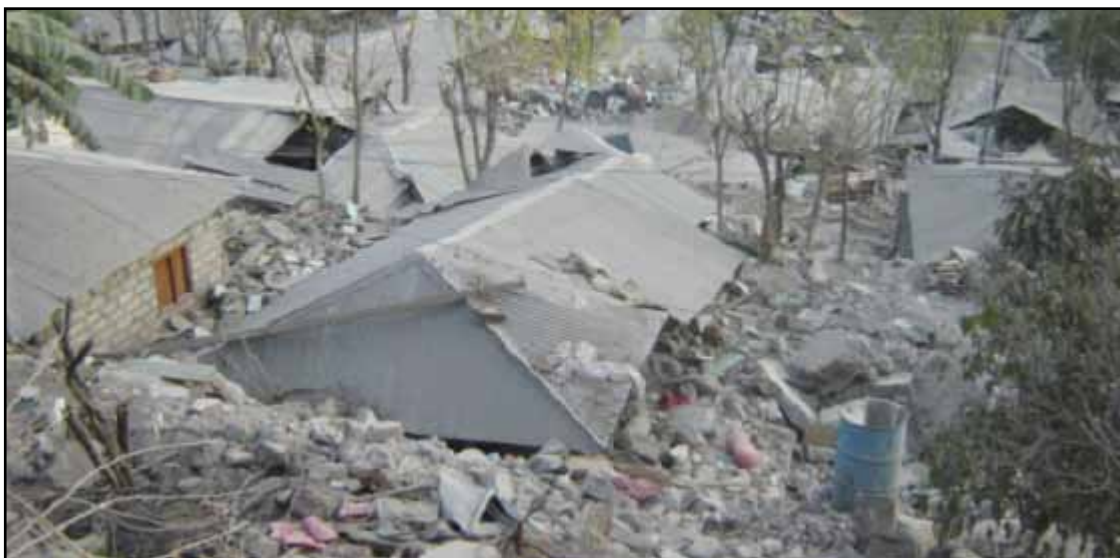
**Figure 2.17** Collapse of stone masonry buildings with hipped roofs in the 2005 Kashmir, Pakistan, earthquake (source: Bothara and Hıçyılmaz 2008)

quake. These buildings have a few important seismic deficiencies, such as an absence of effective ties or ring beams (bands) at the eaves level (beneath the roof), inadequate wall-to-roof anchorage, and an absence of through-stones in the walls. Buildings of this type showed poor performance in the earthquake due to the collapse of stone masonry

walls, as shown in Figure 2.17. It should be noted that the seismic performance of hipped roofs in the earthquake was excellent in terms of maintaining their integrity and shape. After the earthquake, people were able to lift the roof of their collapsed house and rebuild the walls (Bothara and Hıçyılmaz 2008).

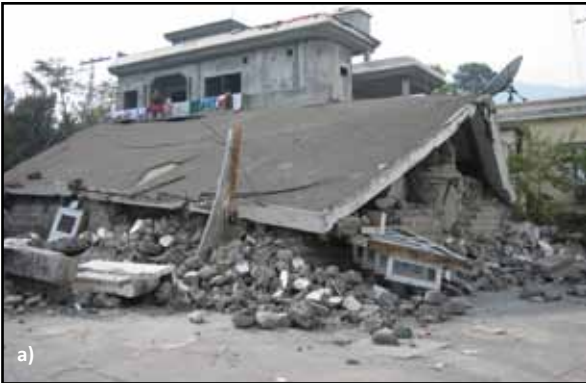
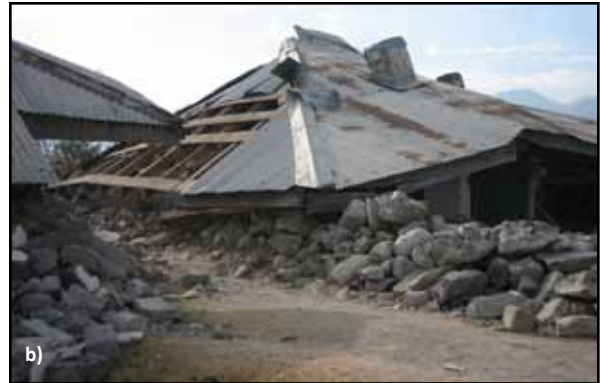
**Figure 2.18** Collapse of roof structures due to the loss of gravity load-bearing capacity of stone walls in the 2005 Kashmir, Pakistan, earthquake: a) reinforced concrete roof, and b) timber and steel roof (photos: M. Tomazevic)

Roof collapse is one of the major causes of fatalities in masonry buildings during earthquakes, and it can take place when either the walls lose the ability to resist gravity loads and collapse, or when the roof structure collapses (e.g. timber post-and-beam construction) (Coburn 1987). Roof collapse is often caused by inadequate wall-to-roof anchorage. The roof structure can simply “walk away” from the walls and cave into the building. Roof collapse can also be caused by the collapse of supporting walls, as shown in Figure 2.18.

Some stone masonry buildings have heavy roofs that contribute to their seismic vulnerability. Heavy RC roof slabs contributed to the collapse of buildings in the 2005 Kashmir earthquake (Figure 2.18a). Traditional buildings in the Marathwada area of Maharashtra, India, affected by the 1993 earthquake, were characterized by a timber plank-and-joist roof supporting

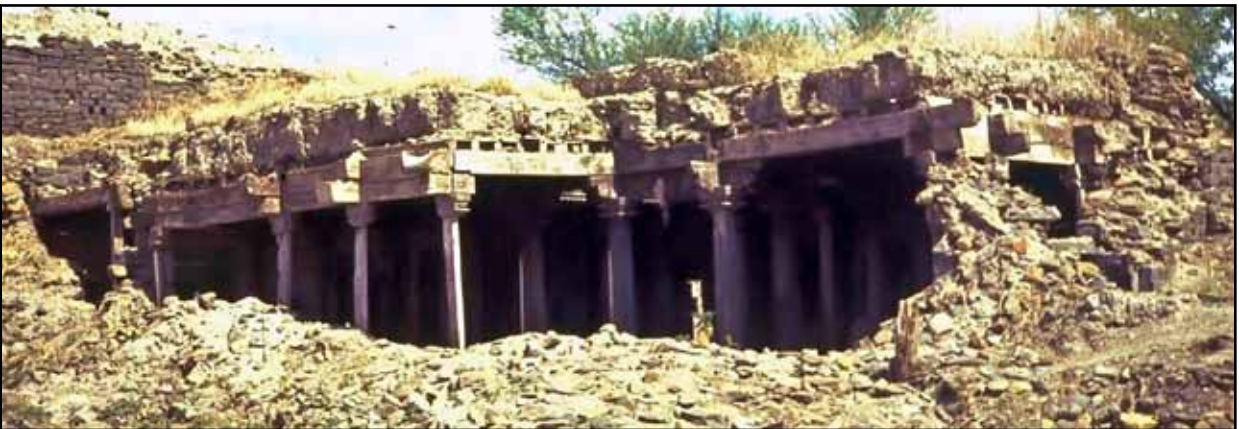
**Figure 2.19** Wall collapse in the 1993 Maharashtra, India, earthquake. Stone masonry buildings had timber roofs with heavy mud overlays (photo: S. Brzev)

a 500 to 800 mm thick mud overlay (GOM 1998). The roofs were supported by interior timber frames (called khands) which were not connected to the walls, as shown in Figure 2.19. In the earthquake, heavy roof mass caused lateral swaying of the frames, which pushed the stone walls outward and caused their collapse.

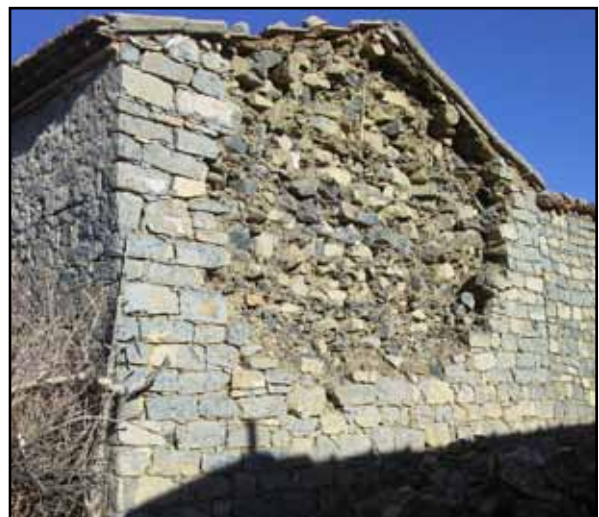
**Figure 2.22** Delamination of a stone masonry wall in the 2000 Beni-Ouartilane, Algeria, earthquake (photo: M. Farsi)

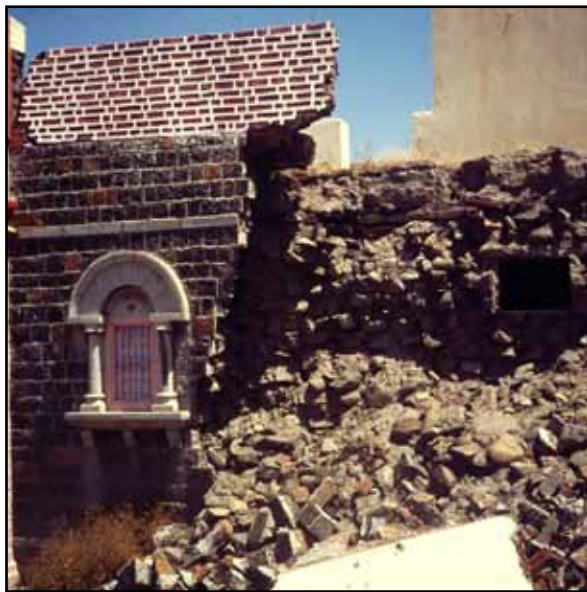
Figure 2.23 Delamination was a common damage pattern observed in the 1993 Maharashtra, India, earthquake (photos: S. Brzev)

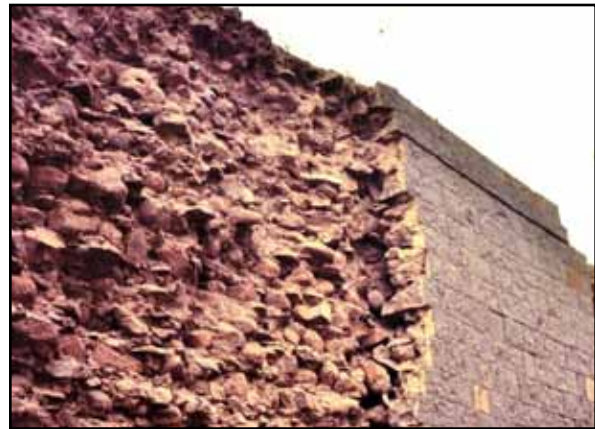
Figure 2.24 Out-of-plane vibrations of stone masonry walls are most pronounced at the top floor level (source: Tomazevic 1999)

Out-of-plane wall collapse is one of the major causes of destruction in stone masonry buildings, particularly in buildings with flexible floors and roofs. As discussed earlier in this chapter, overall building integrity is critical for the satisfactory seismic performance of stone masonry buildings. The connections between structural component are important for maintaining building integrity, as discussed in Chapter 3. Integrity is absent or inadequate when the walls are not connected at their intersections and there are no ties or ring beams at the floor and roof levels. As a result, each wall vibrates on its own when subjected to earthquake ground shaking and is therefore likely to collapse. In multi-story buildings, this type of collapse usually takes place at the top floor level due to the significant earthquake accelerations there (Figures 2.24 and 2.25).

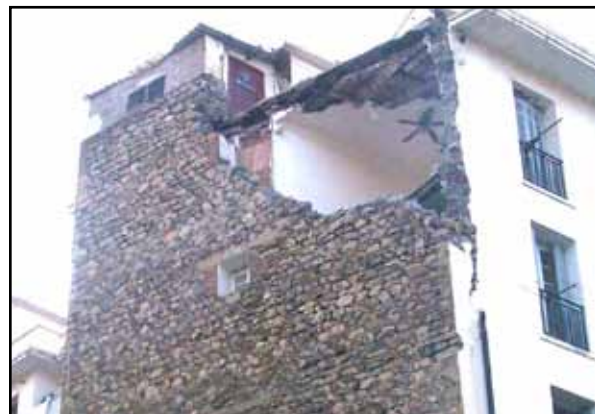
Figure 2.25 Out-of-plane collapse at the top floor of a stone masonry building in the 2003 Boumerdes earthquake in Algeria (photo: M. Farsi)

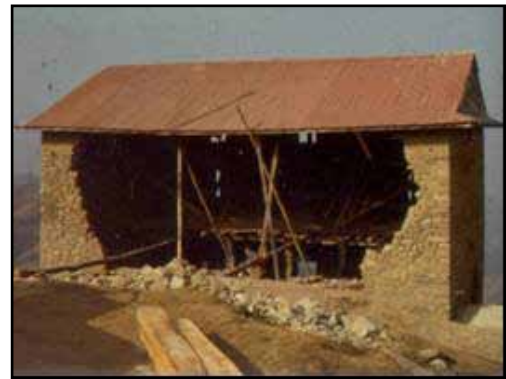
**Figure 2.27** Out-of-plane collapse of a long wall in the 1988 East Nepal earthquake (photo: TAEC Consult, Nepal)

When cross walls parallel to the direction of earthquake shaking are far apart, the central areas of long walls are subjected to significant out-of-plane vibrations and may collapse (Figure 2.27). The inadequacy of connections between the cross walls and long walls is one of the key factors influencing out-of-plane wall collapse. When connections are inadequate, long walls are more susceptible to the effects of out-of-plane vibrations and the chances of collapse are higher (Figure 2.28).

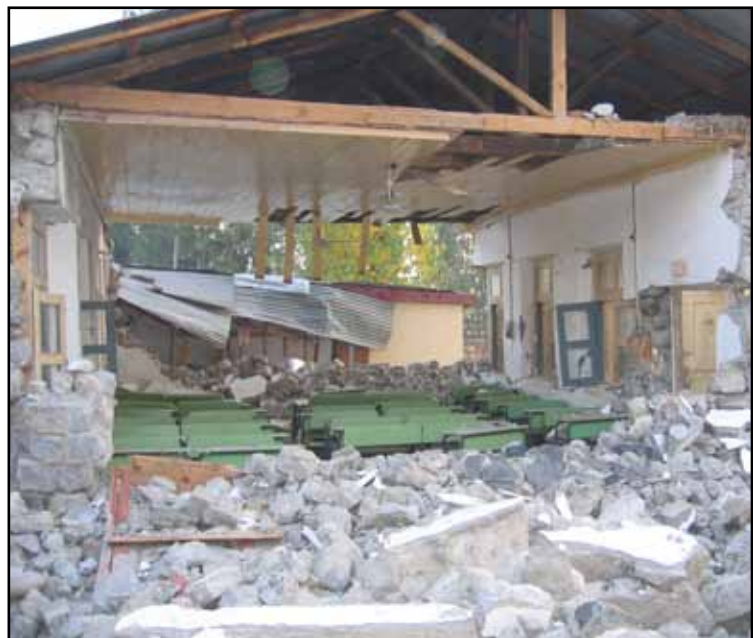
**Figure 2.28** Out-of-plane collapse of two parallel walls, NWFP Pakistan (photo: SDC)

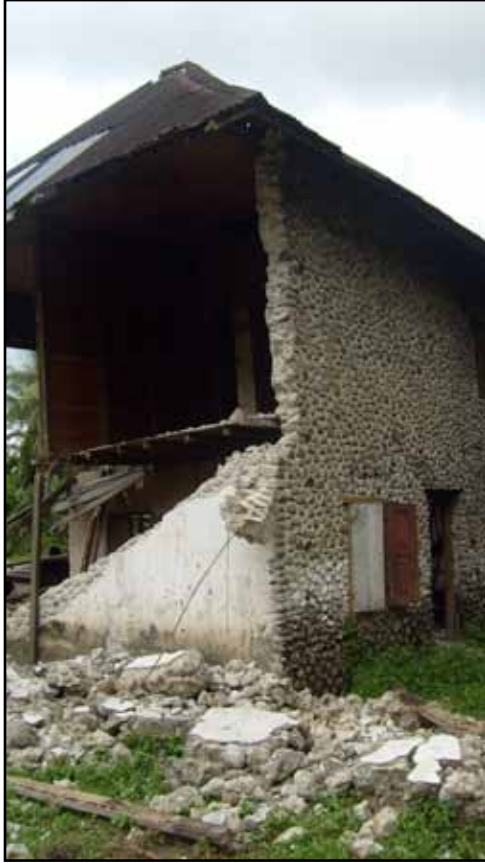
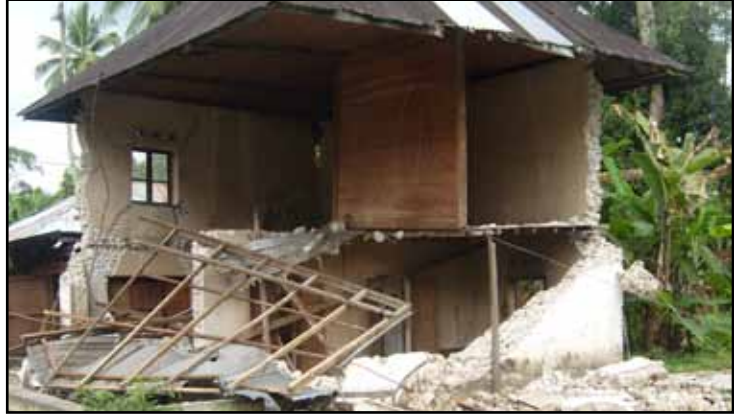
Figure 2.29 (left and above) Out-of-plane collapse of stone masonry walls in the 2009 Padang, Indonesia, earthquake (source: Bothara et al. 2010)

Out-of-plane wall collapses were reported in the area affected by the 2009 Padang earthquake in Indonesia. The two-story buildings shown in Figure 2.29 had light metal roofing supported by timber trusses. The floors were inadequately connected to the walls. Stone masonry walls were 250 mm thick and relatively slender. The walls were constructed using 100 to 120 mm diameter round or angular stones in lime/sand mortar. The walls collapsed due to the absence of floor and roof anchorages and bands (refer to Chapter 3).

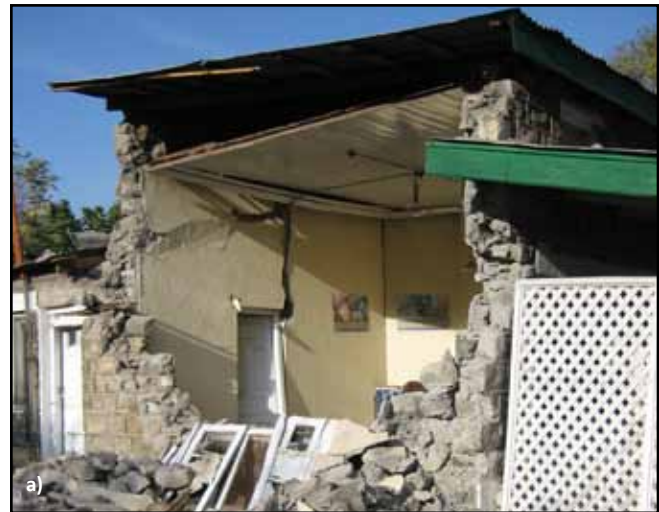
Figure 2.30 Out-of-plane collapse of stone masonry walls in buildings with flexible roofs and inadequate wall-to-roof connections: a) the 2005 Kashmir, Pakistan, earthquake (photo: M. Tomazevic); b) the 2003 Boumerdes, Algeria, earthquake (photo: M. Farsi)

Out-of-plane wall collapse is common in buildings with flexible roofs and floors, and where wall-to-roof connections are inadequate, as shown in Figure 2.30.

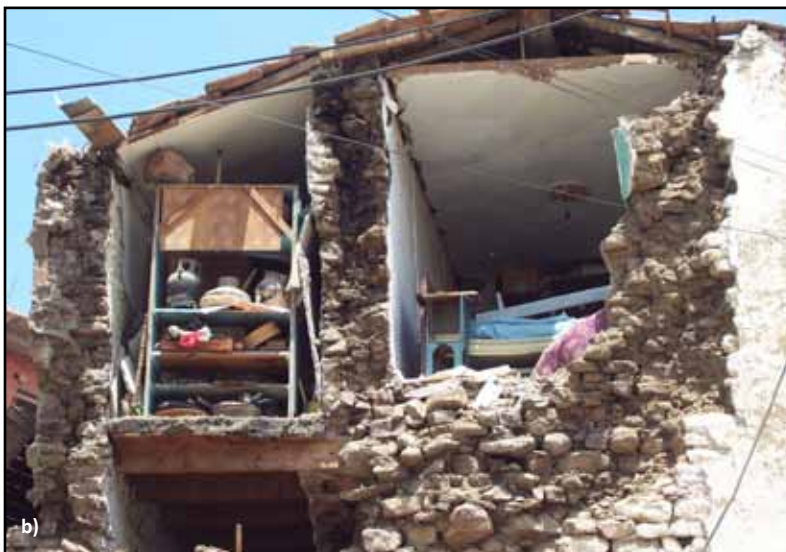
**Figure 2.31** A tall gable wall in Nepal that is at risk due to the absence of a roof connection (photo: Smart Shelter Foundation)

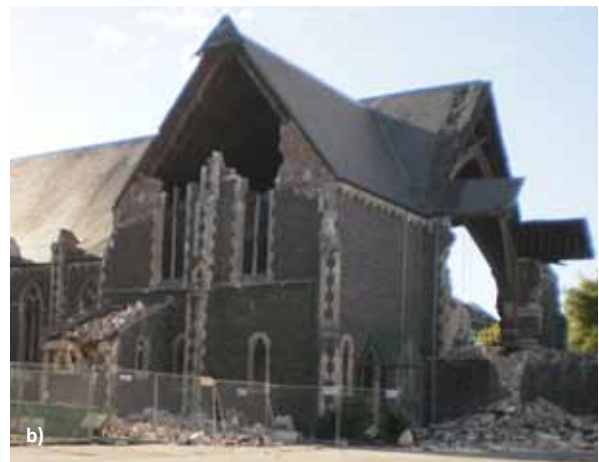
**Figure 2.32** Collapse of stone masonry gable walls in New Zealand earthquakes: a) a partial collapse in the 2010 Darfield earthquake, and b) total collapse of the same building in the 2011 Christchurch earthquake (photos: J. Bothara)

Buildings with pitched roofs have gable walls. These are taller than other walls and tend to vibrate as free-standing cantilevers during earthquakes, unless they are tied to the roof structure. These walls are often inadequately connected to the roof, as shown in Figure 2.31. Out-of-plane collapse of gable walls is often reported after earthquakes. Several stone masonry gable walls collapsed in the 2010 and 2011 New Zealand earthquakes, as shown in Figure 2.32.
