# **A TUTORIAL: Improving the Seismic Performance of Stone Masonry Buildings**

**Jitendra Bothara • Svetlana Brzev**

First Edition, April 2011

**Publication Number WHE-2011-01**

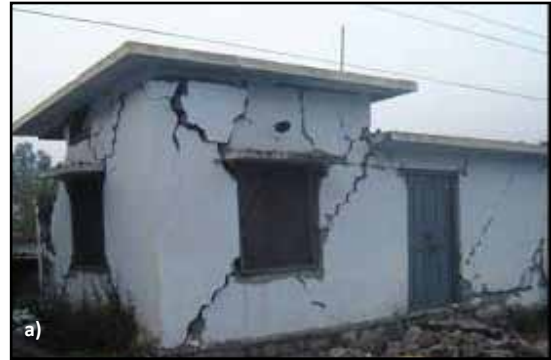
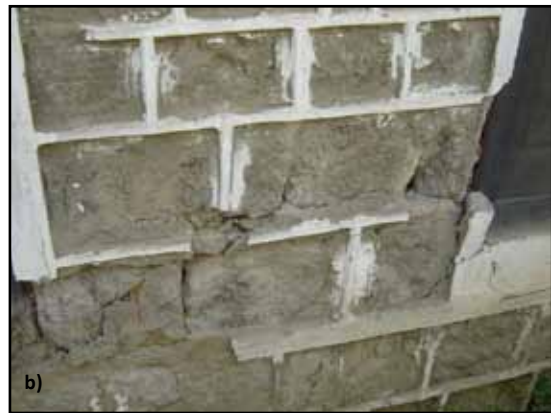
**Figure 2.34** Shear failure in stone masonry walls: a) shear cracks initiated at the corners of openings in the 2005 Kashmir, Pakistan, earthquake (Photo: Bothara and Hiçyılmaz, 2008), and b) shear cracking in a stone masonry pier damaged by the same earthquake (photo: Builders Without Borders)

Several factors influence the in-plane failure mechanism of stone masonry buildings, including pier dimensions, wall thickness, building height, and masonry shear strength. Rocking behavior is more desirable than diagonal shear cracking. In-plane wall damage patterns observed in past earthquakes are illustrated in Figure 2.34.

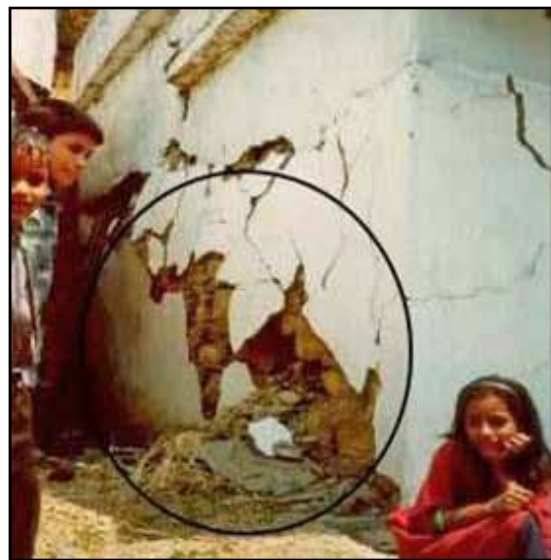
**Figure 2.35a** Localized wall failure caused by irregular stones (source: WHE Report 74)

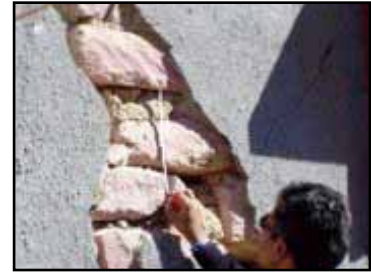
**Figure 2.36** A stone masonry wall with thick mud mortar (thickness on the order of 80 mm) in the area affected by the 2001 Bhuj, India, earthquake (photo: J. Arlekar)

When the mortar used for construction is made of mud instead of cement and/or lime, the mortar becomes the weak link and prevents a proper bond between the mortar and the stones. In some cases, mud mortar is excessively thick (Figure 2.36). Even when cement mortar is used, minimum quality standards (as discussed in Chapter 3) are often not met during construction.

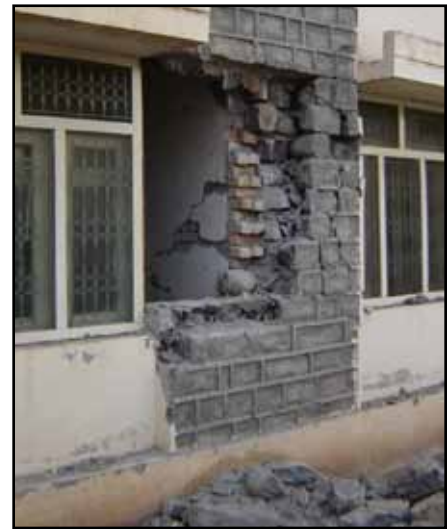
**Figure 2.37** Vertical cracking at a wall intersection due to the 2005 Kashmir, Pakistan, earthquake due to absence of connection between the intersecting walls, a stone masonry and a brick-masonry wall (source: Bothara and Hiçyılmaz 2008)

Another problematic construction practice is the use of more than one kind of material for wall construction, for example, stones and brick. Because of the differences in size and shape of materials, the bonds between orthogonal walls are reduced. Figure 2.37 shows a building in which one wall is constructed of brick masonry and the other of stone masonry. The use of mixed structural materials and systems results in dissimilar strength and stiffness in the different parts of a building. This can cause torsional effects once damage begins to accrue in the building. It is acceptable to mix materials provided that only one material is used for each story. The stronger materials should be used for the ground floor wall construction.

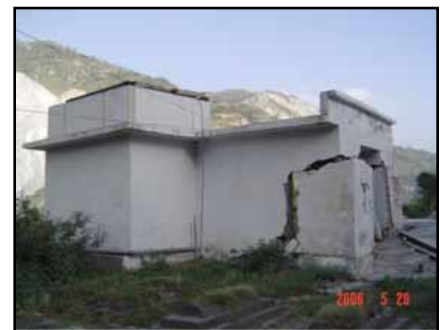
**Figure 2.38** Soil spreading in the 2005 Kashmir, Pakistan, earthquake - note wide cracks in the walls (source: Bothara and Hiçyılmaz 2008)

Foundations are not considered to be critical in the seismic performance of stone masonry buildings. However, it was reported after the 2005 Kashmir, Pakistan, earthquake that buildings on foundations of adequate size suffered less damage than those supported by shallow foundations. Foundation soils may be prone to instability, in the form of soil spreading or landslides (Figure 2.38). Buildings in hilly areas were most affected by the 2005 Kashmir earthquake due to soil movement.

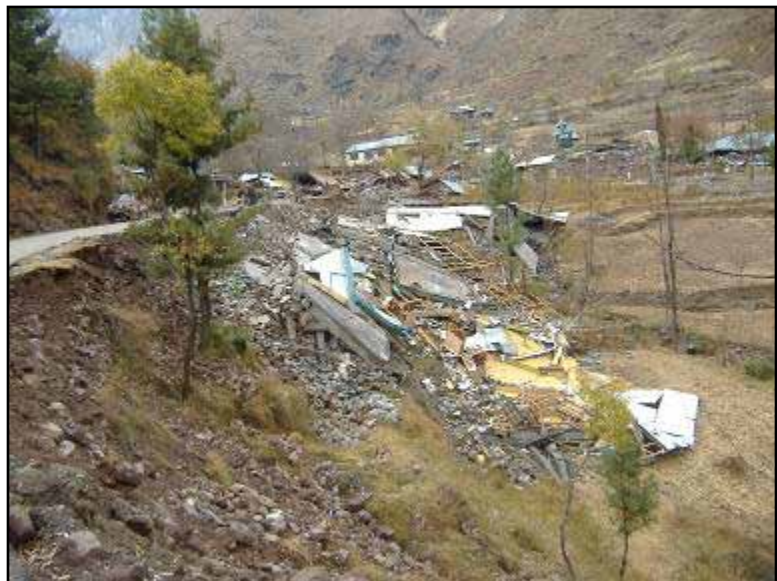
**Figure 3.1** A collapsed building on a steep slope after the 2005 Kashmir earthquake, Pakistan (source: Bothara and Hıçyılmaz 2008)

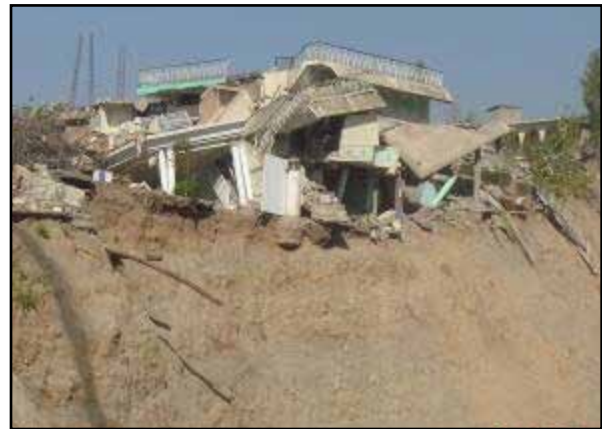
Figure 3.3 A building damaged by a landslide in the 2005 Kashmir, Pakistan, earthquake (source: Bothara and Hıçyılmaz 2008)

Under normal conditions, the slopes may be stable, but an earthquake could trigger landslides or rock-falls, which can cause a partial or complete building collapse (Figures 3.3). Retaining walls, rock barriers and green barriers can provide protection. A simple indication of slope instability is the presence of inclined standing trees.

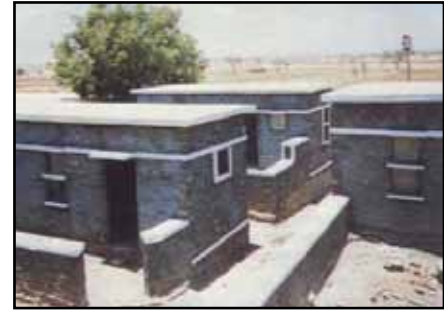
Figure 3.15 Stone masonry houses with RC lintel bands built after the 1993 Maharashtra, India, earthquake (source: GOM 1998)

RC bands are generally a better choice than timber bands due to their low maintenance, long service life, and improved integrity with the stone, provided the concrete is properly mixed, placed, and compacted. Stone masonry buildings with RC bands performed well in past earthquakes, such as the 2005 Kashmir, Pakistan, earthquake, as discussed in Chapter 2, and were used in post-earthquake rebuilding efforts in India, as shown in Figure 3.15.

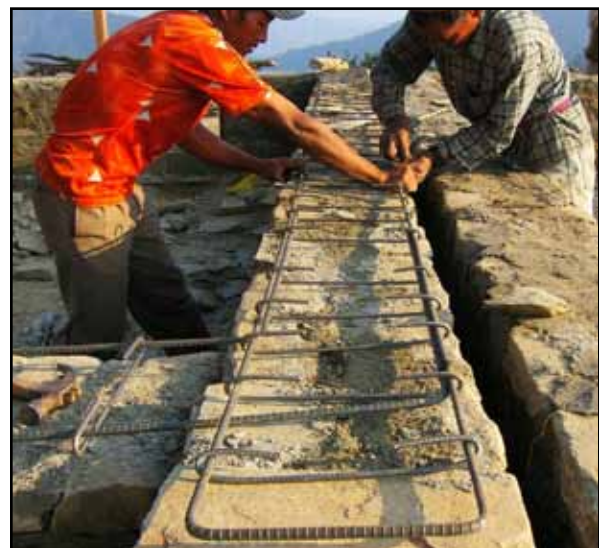
Figure 3.18 Properly bent steel links for RC band construction (photo: Smart Shelter Foundation)

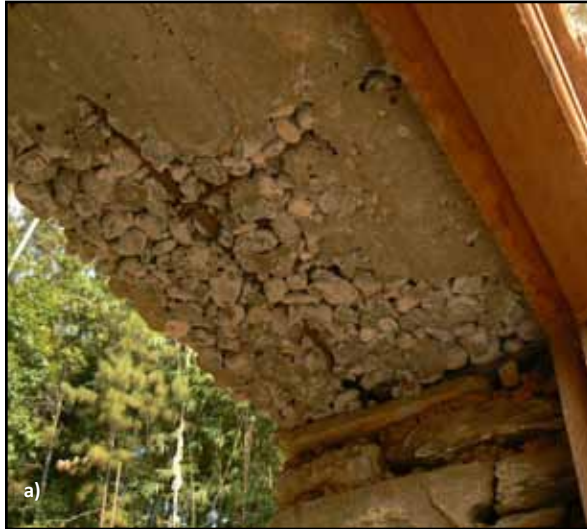
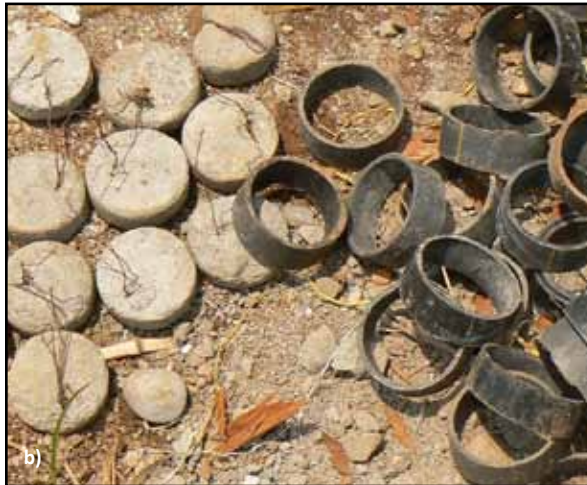
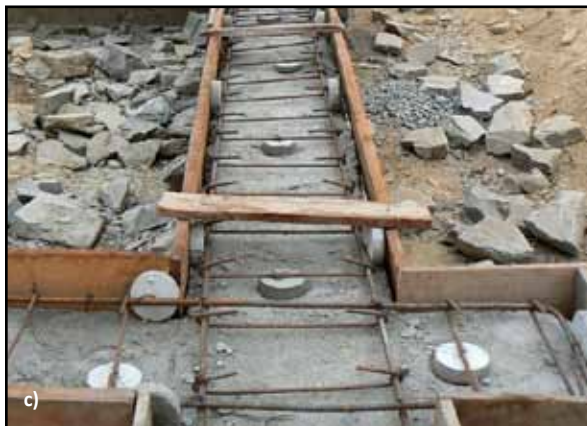
**Figure 3.19** Concrete cover in RC bands: a) exposed bars due to inadequate cover, b) cement spacers made from PVC pipes, and c) RC band under construction showing use of cement spacers (photos: Smart Shelter Foundation)

It is very important to provide sufficient cover to the reinforcement in RC bands. Inadequate cover results in corrosion of the reinforcement accompanied by cracking of the concrete. An example of exposed and corroded reinforcing bar in an RC lintel band is shown in Figure 3.19a.

A proper concrete cover can be achieved by casting concrete spacers, as shown in Figure 3.19b. The spacers can be made by cutting PVC pipes into 25 mm thick rings. These rings are filled with concrete and a steel wire is embedded in the center (wire is used to tie the spacers to the reinforcing bars). These spacers were successfully used by Smart Shelter Foundation in their school projects in Nepal. An example of an RC band under construction using spacers is shown in Figure 3.19c.

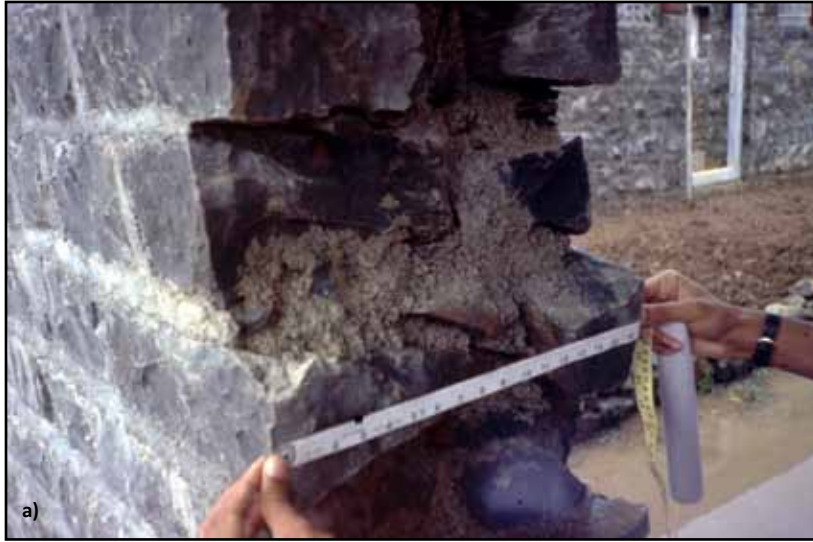
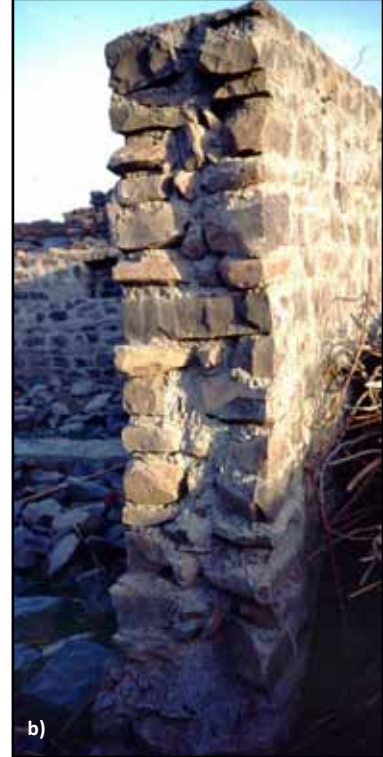
**Figure 3.27** Stone masonry in cement mortar with a wall thickness limited to 450 mm (note through-stones) (photos: S. Brzev)

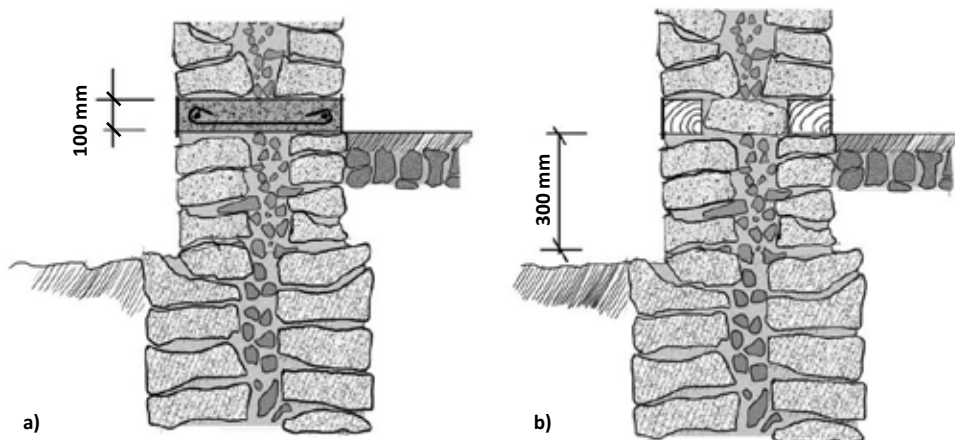
Figure 3.38 Stone masonry foundation with plinth bands: a) RC band, and b) timber band

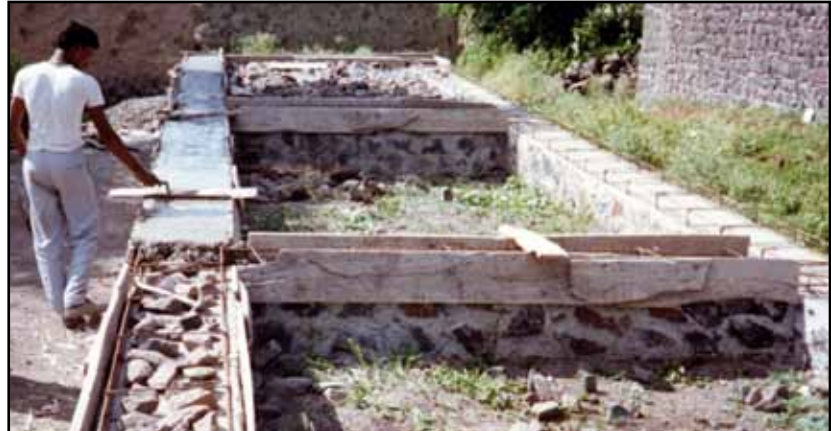
**Figure 3.39** Construction of an RC plinth band using large stone rubble (also known as "stone-crete") (photo: S. Brzev)

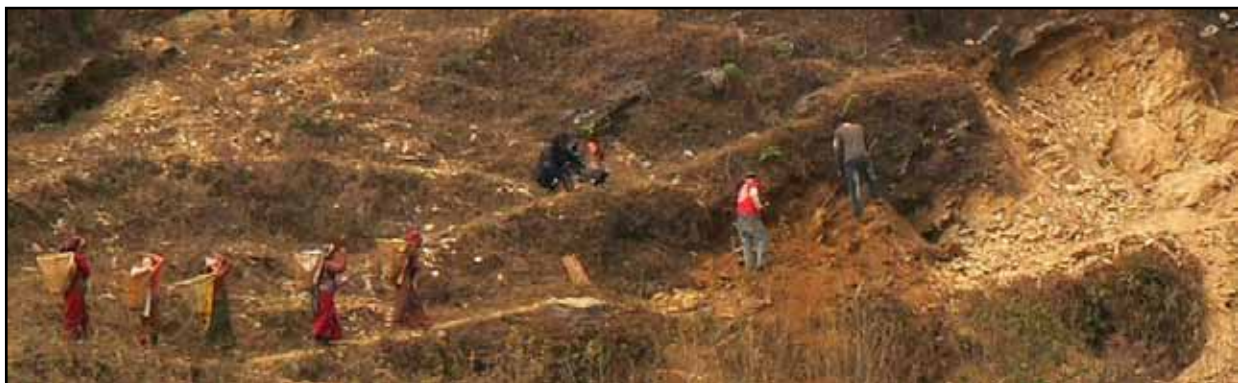
**Figure 3.40** Stone construction in hilly areas of Nepal: a) collection of stones, and b) delivery to the building site (photos: Smart Shelter Foundation)

Round-shaped stone boulders commonly found in river valleys should not be used without further shaping (dressing). Figure 3.40 illustrates the collection of stones in a hilly area of Nepal.

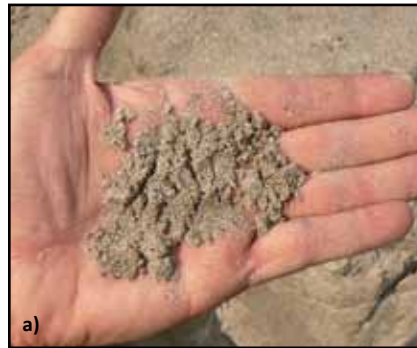
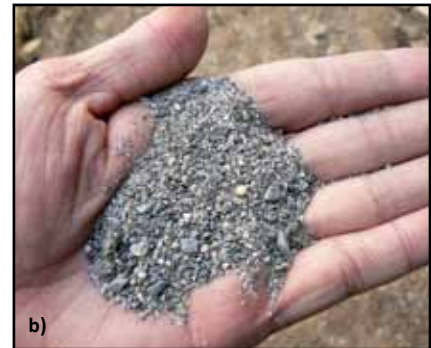
Figure 3.41 Testing of sand

Take a bottle and fill it with the sand until it is half full. Pour in clean water until the bottle is three-quarters full. Shake it violently for about half a minute and leave to settle for about one hour. Clean sand will settle immediately, while silt and clay will settle slowly on top of the sand. The thickness of the clay and silt layer should not exceed one-tenth of the sand below.

Sand used for mortar mix should be clean and free of organic matter. It should not contain more than 10% clay or silt (note that excess clay or silt can be removed from the sand by washing). The suitability of sand can be tested, as shown in Figure 3.41.

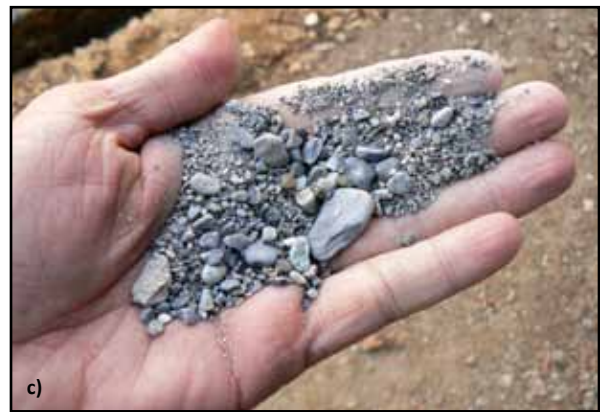
Figure 3.42 Sand for different uses: a) fine sand for plaster construction; b) coarse sand for mortar and concrete construction, and c) excessively coarse sand (photos: Smart Shelter Foundation)

Different types of sand and their uses are illustrated in Figure 3.42. If the sand is too coarse, small pebbles must be sieved out. These pebbles could be added to aggregate for concrete construction. Sand from the sea or ocean should not be used due to the presence of salt, which causes corrosion of steel reinforcement.

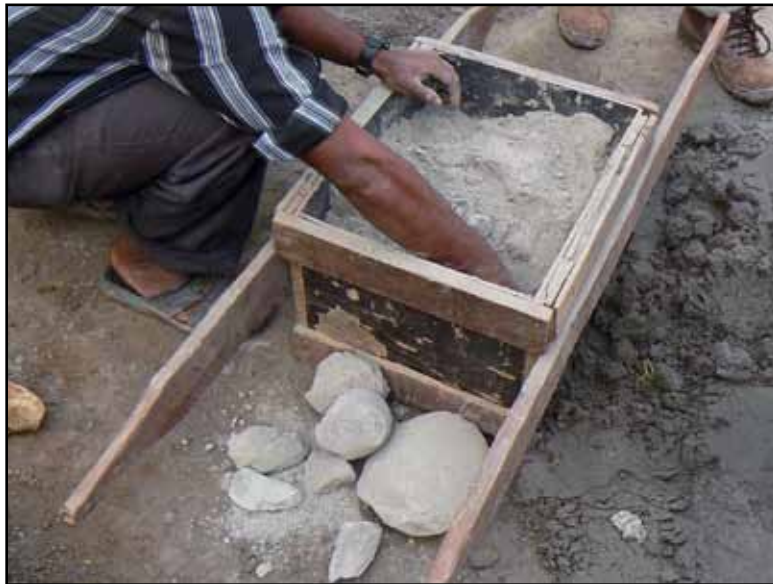
**Figure 3.43** Cement with large lumps should not be used for construction (photo: Smart Shelter Foundation)

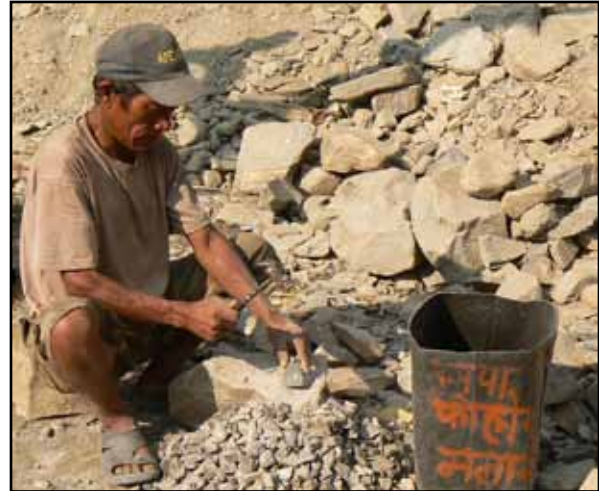
**Figure 3.44** Stones can be cut to produce aggregates for concrete construction—an example from Nepal (photo: Smart Shelter Foundation)

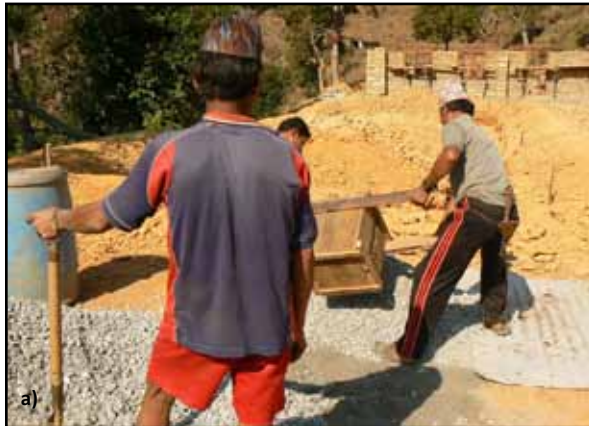
**Figure 3.45** Measuring concrete materials: a) proportioning concrete ingredients using a measuring box, and b) a measuring box (photos: Smart Shelter Foundation)

A measuring box such as that shown in Figure 3.45 a can be used to ensure the consistent proportion of materials in concrete mix. The box dimensions are 300 mm x 300 mm x 350 mm (or 1 ft x 1 ft x 1 ft 2 in). In many countries, cement is available in 50 kg bags, and measuring boxes should have the same volume as one bag of cement. Therefore, two boxes filled with coarse sand and four boxes of aggregate would be required for a 1:2:4 concrete mix.

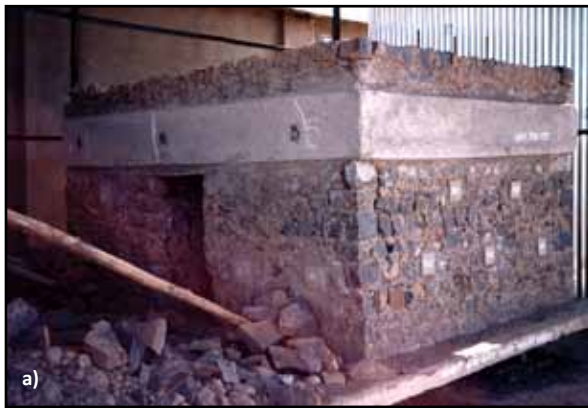
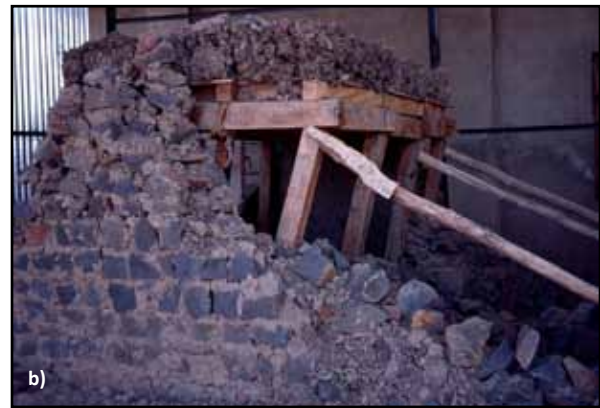
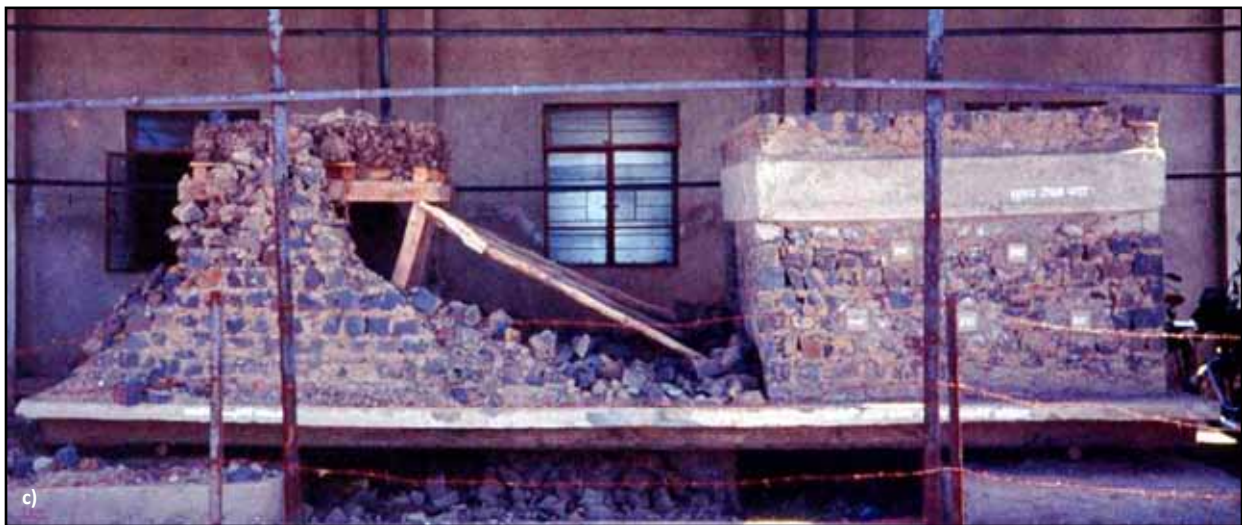
**Figure 4.1** Effectiveness of seismic retrofitting methodology for stone masonry buildings: a) strengthened model, b) unstrengthened model after testing, and c) models at the end of the experiment (unstrengthened model shown on the left) (source: GOM 1998)

Figure 4.1 presents models used for shake-table testing performed after the 1993 Maharashtra, India, earthquake, with an objective to compare the seismic performance of strengthened and unstrengthened uncoursed stone masonry buildings. Two one-half scale models of a traditional building with uncoursed random rubble stone masonry walls and timber roofs were tested on a wagon-type

field shake-table that simulated earthquake effects. The strengthened specimen survived all 12 tests, while the unstrengthened one collapsed. This testing confirmed the effectiveness of seismic strengthening provisions, including bandages and through-stones, in resisting earthquake effects.

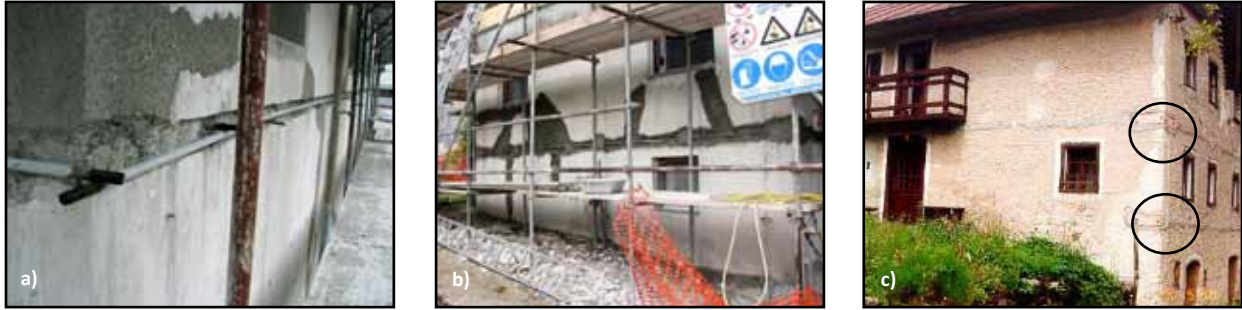
**Figure 4.4** A field application of ties in Slovenia: a) and b) installation of steel ties after the 1998 Bovec, Slovenia, earthquake (note that anchorage end-plates are yet to be attached), and c) an example of a retrofitted building (photos: M. Lutman)

Iron ties have been used for many centuries to strengthen masonry buildings in Mediterranean Europe, including Italy and neighboring countries. Steel ties have been used for seismic retrofitting in several post-earthquake projects in Europe (including after the 1979 Montenegro earthquake); for more details refer to UNIDO (1983) and Tomazevic (1999). Steel ties are 16 to 20 mm threaded rods installed horizontally beneath the floors and roof. These rods are restrained at the ends by steel anchor plates. Steel tie concepts and layouts are shown in Figures 4.2 and 4.3. The rods help to connect the walls at floor and roof levels and thus prevent separation during ground shaking. In the case of flexible roofs and floors, ties are effective in increasing the stiffness of these diaphragms. Experimental studies on brick masonry building models tested on a shake-table with and without ties confirmed the effectiveness of ties in preventing the separation and disintegration of walls (Tomazevic 1999). An example of a field application is shown in Figure 4.4.

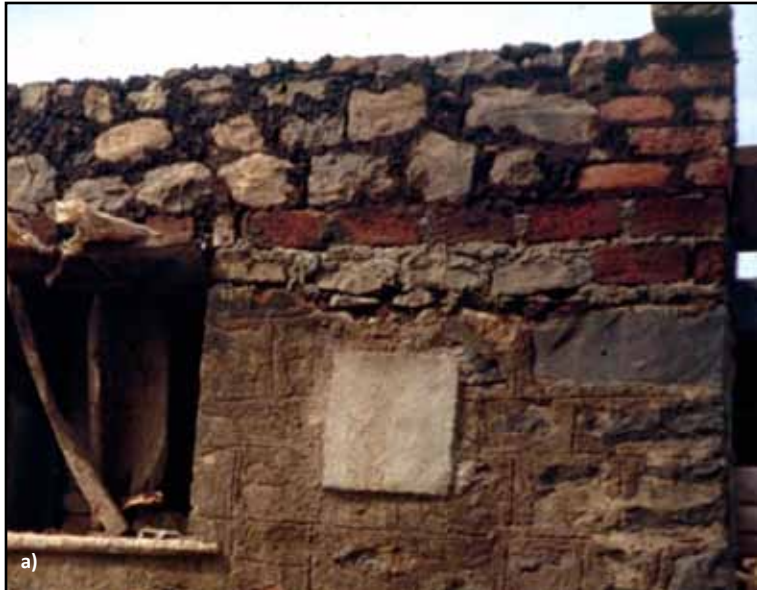
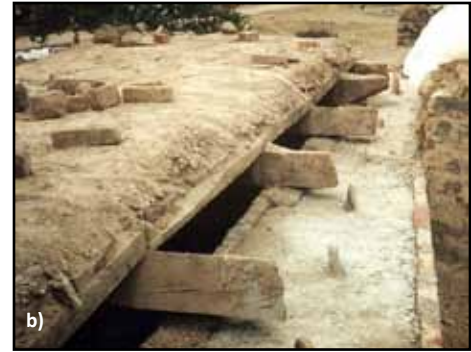
**Figure 4.6** An example of a field application of an RC band in an existing stone masonry building in Maharashtra, India: a) RC band installation completed (note brick edging at the band level and a newly constructed portion of the wall above the band), and b) RC band at the roof level underneath the timber beams (note that roof is supported by an interior timber frame) (photos: S. Brzev)

wall span between the adjacent cross walls and the seismic zone at the site. For a detailed explanation of RC band construction in stone masonry buildings refer to GOM (1998). A field application of RC band construction in Maharashtra, India is shown in Figure 4.6.

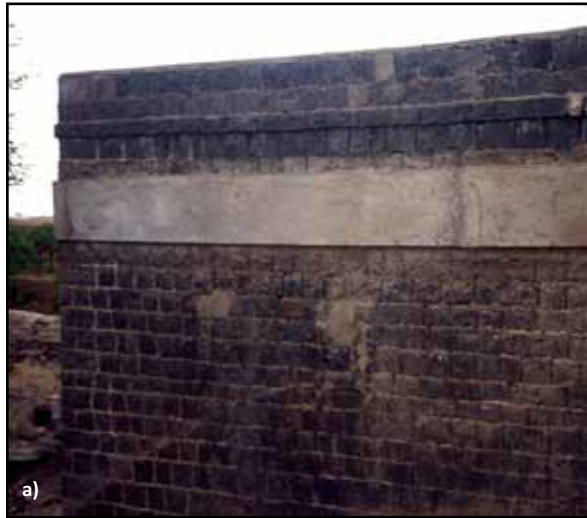
Figure 4.8 Construction of a reinforced concrete bandage: a) a retrofit application in Maharashtra, India and b) concept (source: GOM 1998)

mm (GOM, 1998). Reinforced cement and sand plaster or micro-concrete (with a maximum aggregate size of 5 mm) is applied in two layers, and the welded wire mesh reinforcement is placed between them. A connection between the exterior and the interior bandage is achieved by providing through-wall anchors (Figure 4.8).

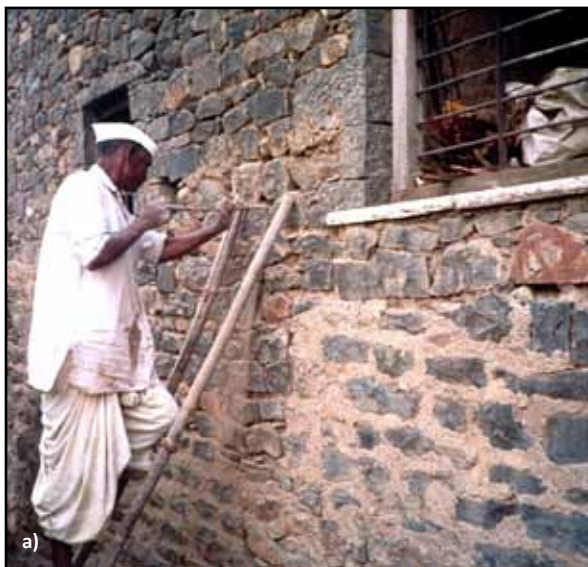
Figure 4.19 Examples of through-stone retrofit in Maharashtra, India: a) removing stone from the existing wall, and b) surface of a through-stone covered with a plaster (photos: S. Brzev)

mimic good construction practice for stone masonry where long stones (bonding stones) are provided. The effectiveness of through-stones in new construction is discussed in Chapter 3.

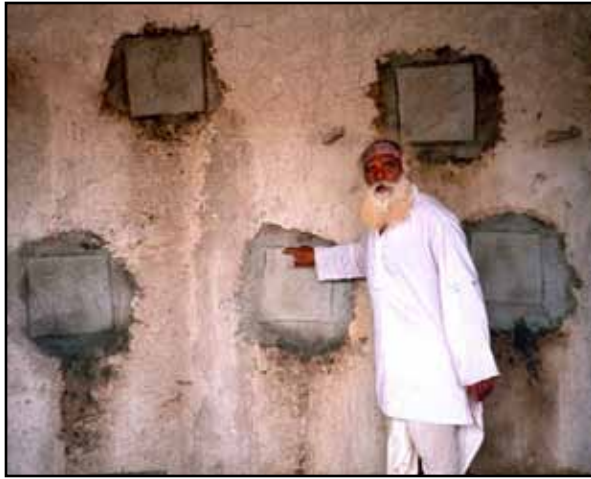
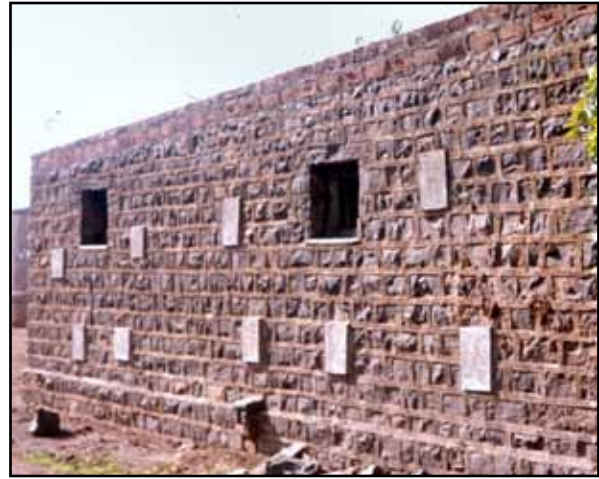
Figure 4.20: Examples of completed through-stone retrofit projects in Maharashtra, India (photos: S. Brzev)

interior. A hooked steel bar needs to be installed and the hole should be filled with concrete. Finally, the exposed surface should be covered with a rich cement and sand plaster coating and cured for at least 14 days. Through-stones should be installed very carefully, otherwise surrounding portions of the wall may be damaged. Installation of through-stones in building applications is shown in Figures 4.19 and 4.20.

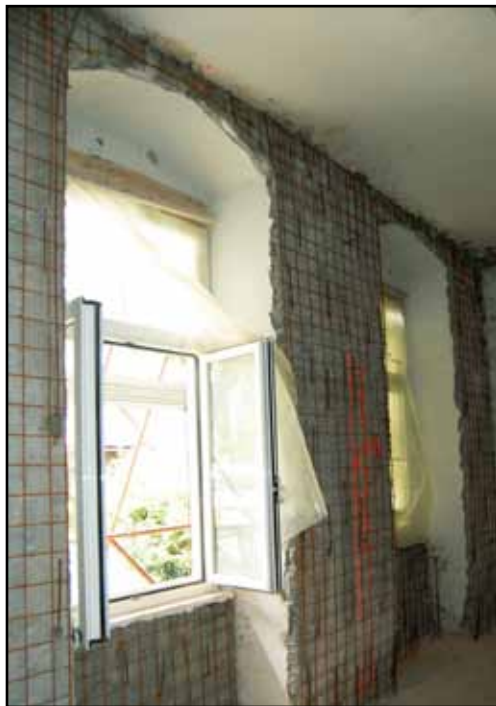
**Figure 4.24** Jacketing of a stone masonry wall in Slovenia (photo: M. Lutman)

the floors below and above and the foundations. Figure 4.24 shows a stone masonry building in Slovenia being jacketed. Note the dowels extending from the floor structure below.

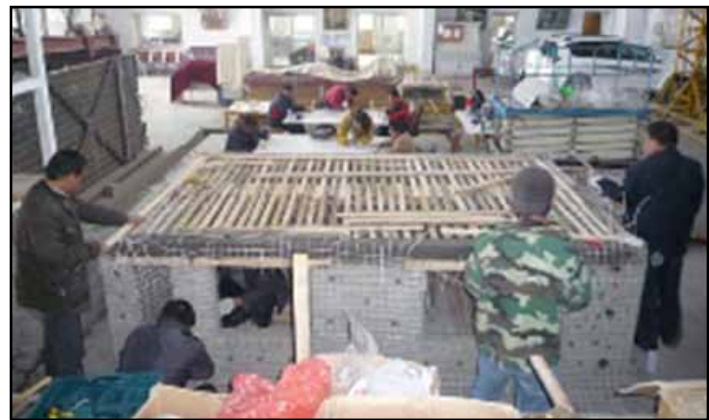
**Figure 4.26** Testing polypropylene bands at IEM in Harbin, China (photo: W. Feng)

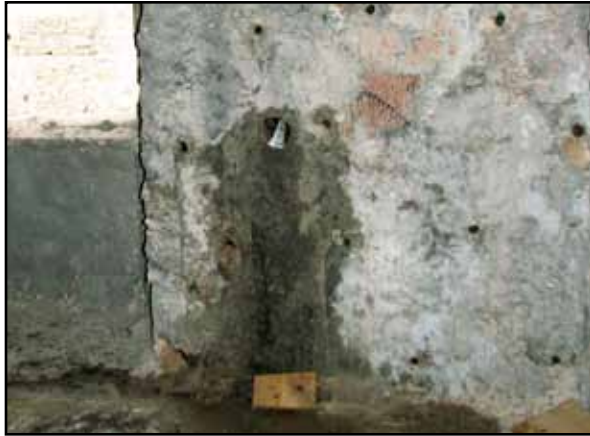
**Figure 4.27** Grouting an existing stone masonry wall in Slovenia - note uniformly distributed holes at the location where grout is to be injected (photo: M. Lutman)

Many voids exist in stone masonry walls, hence an appropriate method for strengthening the walls is by filling these voids by injecting cementitious grout. After hardening, the injected grout will bond the loose parts of the wall together into a solid structure. Cement-based grouting was first applied on a large scale in Italy and Slovenia after the 1976 Friuli, Italy, earthquake. The grout mix proportions may vary, but the common ingredients are Portland cement and pozzolana mixed with water. The grout is injected into the wall at low pressure through injection tubes and nozzles, which are built into the joints between the stones uniformly over the entire surface of the wall. For more details about this technique and experimental studies which confirmed its effectiveness, refer to To-

mazevic (1999) and Lutman and Tomazevic (2002). A stone masonry wall prepared for grouting is shown in Figure 4.27.

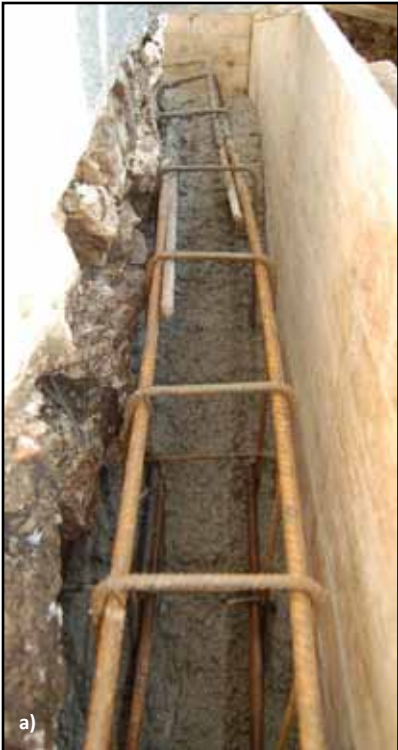
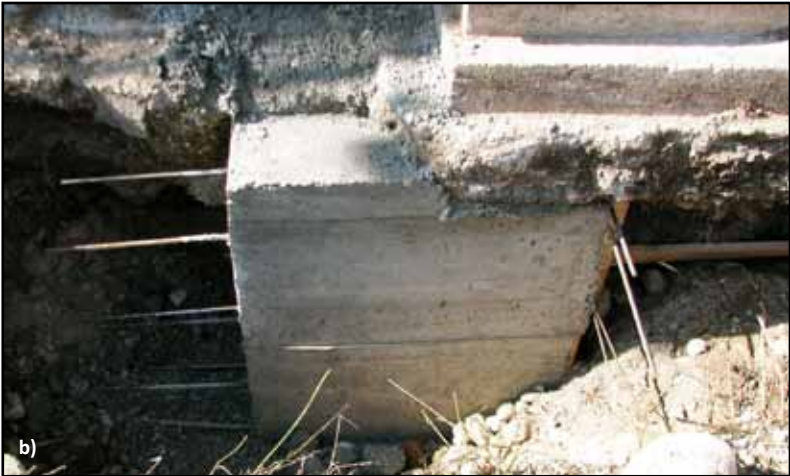
Figure 4.30 Strengthening a stone masonry foundation: a) reinforcement cage and formwork, and b) new reinforced concrete foundation under construction (photos: M. Lutman)
