A TUTORIAL: Improving the Seismic Performance of Stone Masonry Buildings

Jitendra Bothara • Svetlana Brzev

First Edition, April 2011

Publication Number WHE-2011-01

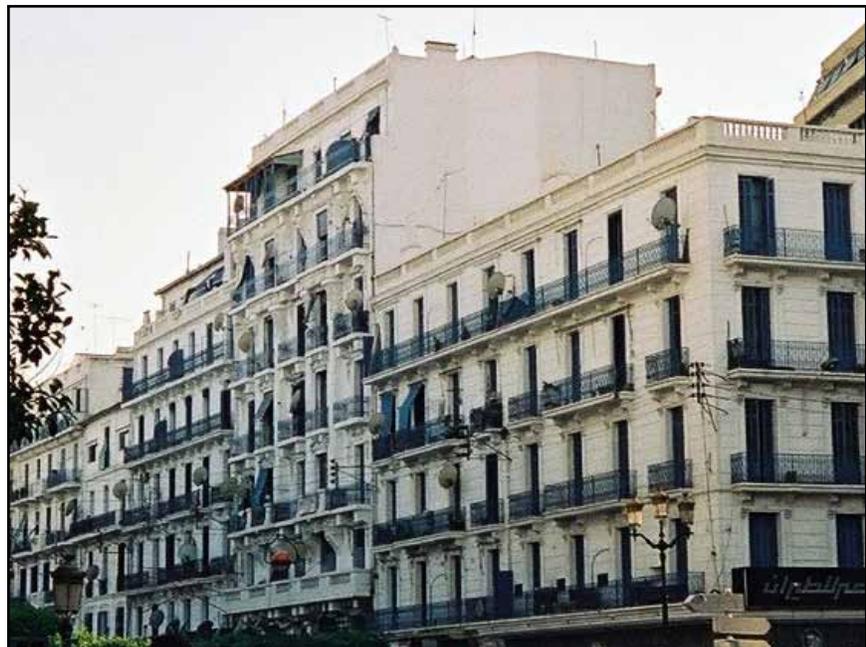
Figure 1.4 Six-story stone masonry building in Algiers, Algeria (photo: S. Brzev)

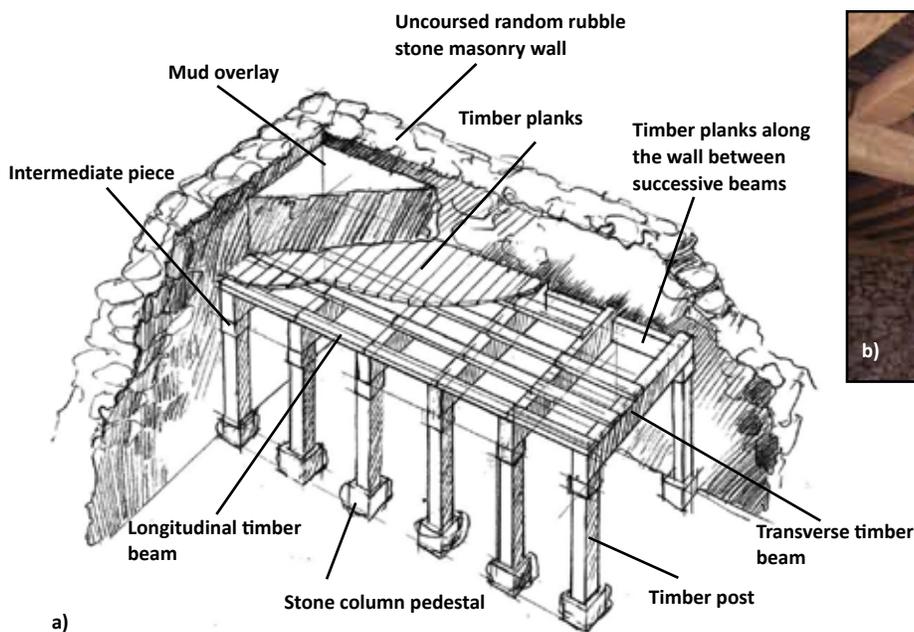
Figure 1.7 Dual gravity load-bearing system: a) a typical stone masonry building with exterior stone masonry walls and an interior timber frame in Maharashtra, India (source: GOM 1998), and b) a stone masonry building with dual system under construction in Pakistan (source: Bothara and Hıçylmaz 2008)

The key components of a typical stone masonry building include floor/roof systems, walls, and foundations. The walls are vertical elements which support the floors and/or roof, and enclose the building interior. In some cases, a dual gravity load-bearing system is used (Figure 1.7). This system

consists of a timber roof structure supported by timber columns and beams, and stone masonry walls at the exterior. In this case, the walls may not provide support to the floor/roof structure. This type of construction can be found in Maharashtra, India and in Pakistan. It performed poorly in past earthquakes due to the absence of wall-to-roof connections and walls collapsing outward (e.g., the 1993 Maharashtra earthquake, India).

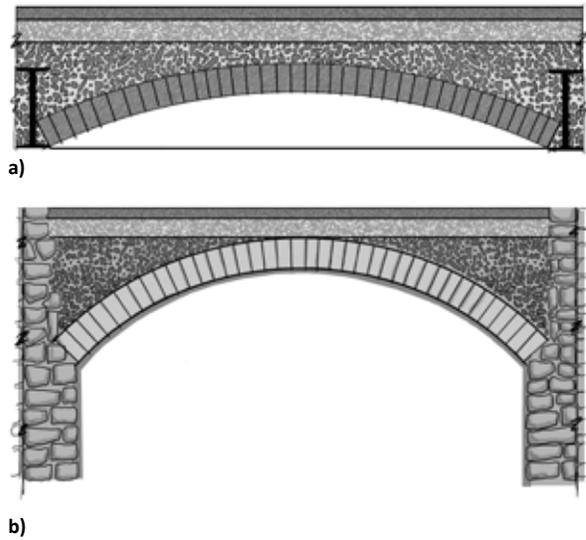
Figure 1.8 Brick masonry vaults: a) jack arch system, and b) brick masonry vault supported by stone walls (source: M. Lutman)

Brick or stone masonry vaults are typical floor/roof systems found in Mediterranean Europe and the Middle East. Figure 1.8a shows a typical early 20th century floor structure in Slovenia, in which iron beams support shallow brick masonry arches (this is known as a jack arch system), while Figure 1.8b shows a typical 19th century brick masonry vault in Slovenia. In multi-story buildings, jack arches are often found at the ground floor level, and timber joist floors at upper levels. Figure 1.9 shows examples of vaulted floor and roof structures from Italy.

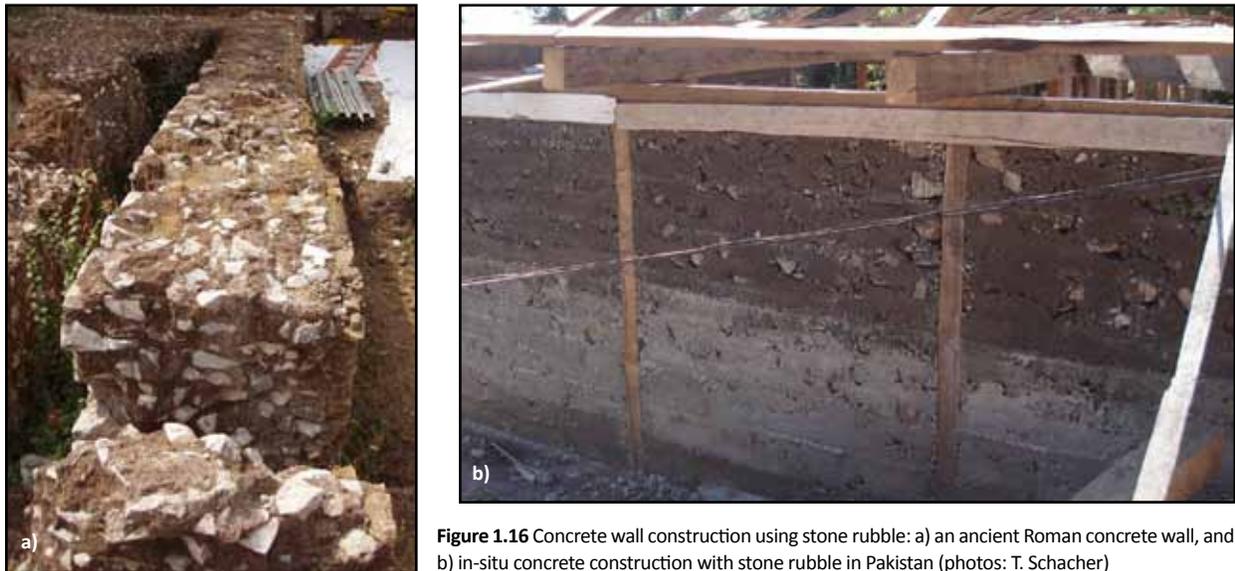
Figure 1.16 Concrete wall construction using stone rubble: a) an ancient Roman concrete wall, and b) in-situ concrete construction with stone rubble in Pakistan (photos: T. Schacher)

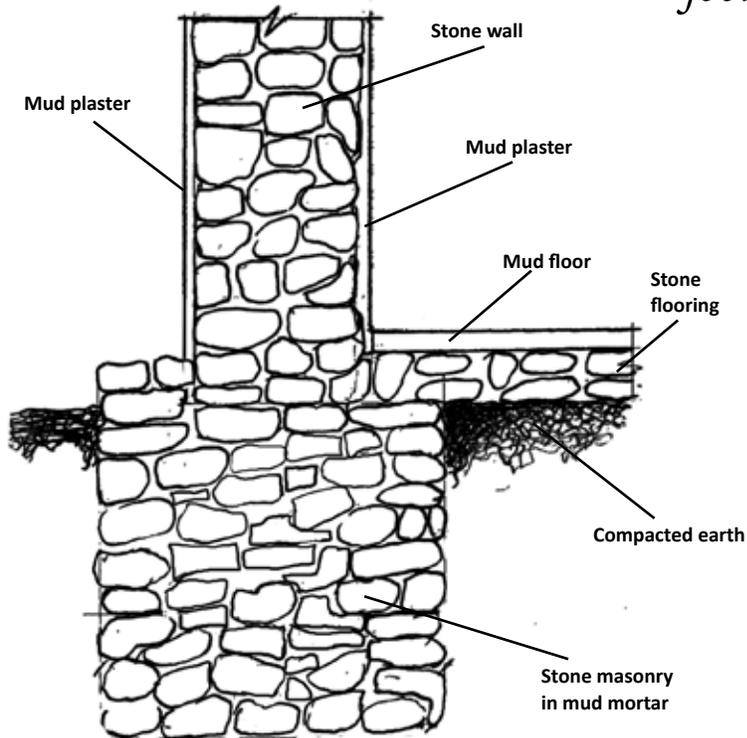
Figure 1.17 Typical stone masonry foundation in Nepal (source: WHE Report 74)

Foundations support the wall weight and provide an interface between the underlying soil and the building structure. In most cases, stone masonry walls are supported by continuous stone masonry strip footings (Figure 1.17). In some cases, footings do not exist at all (Figure 1.18).

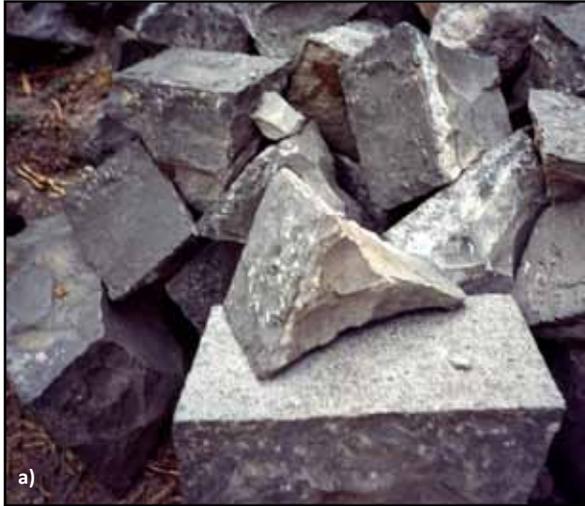
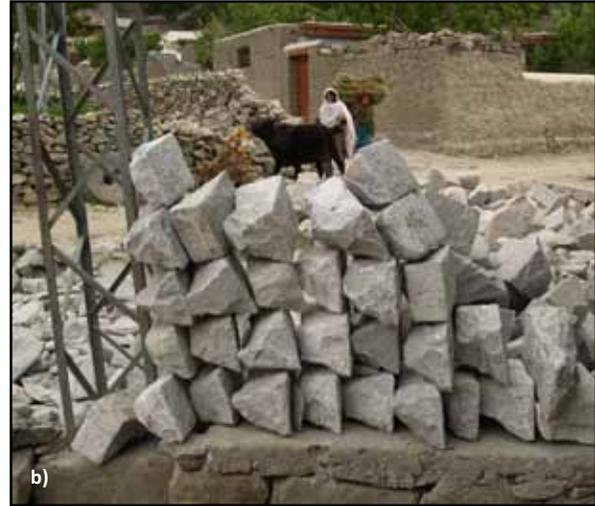
Figure 1.21 Semi-dressed stones ready for wall construction: a) wedged stones in Maharashtra, India (photo: S. Brzev), and b) shaped stones in Pakistan (photo: T. Schacher)

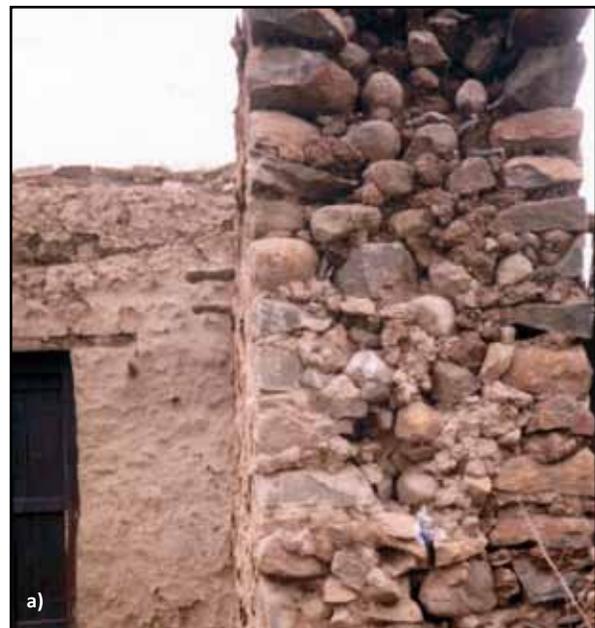
Figure 1.22 Typical uncoursed random rubble stone walls: a) an uncoursed random rubble stone wall in Maharashtra, India, showing exterior wythes and stone rubble in mud mortar in between (photo: S. Brzev) and b) plan view of a stone wall under construction in Nepal (note stone rubble between the wall wythes) (photo: Smart Shelter Foundation)

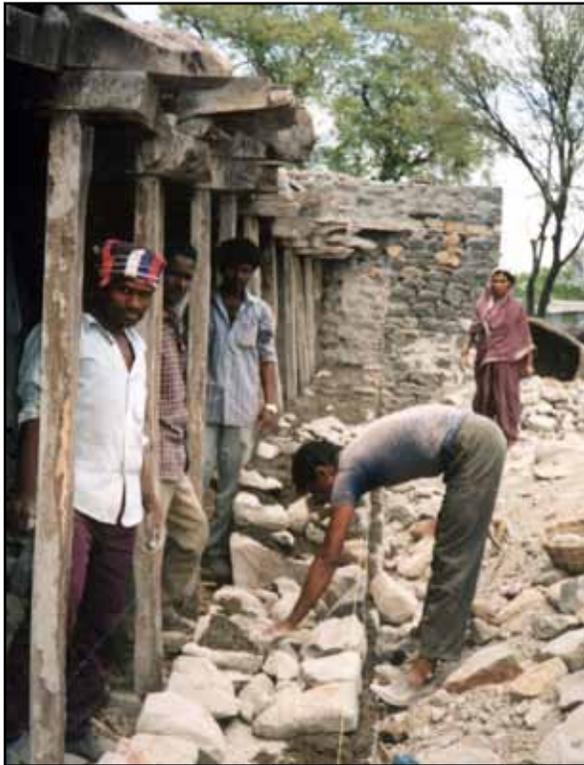
Figure 1.23 Construction of an uncoursed random rubble stone wall in Maharashtra, India (photo: S. Brzev)

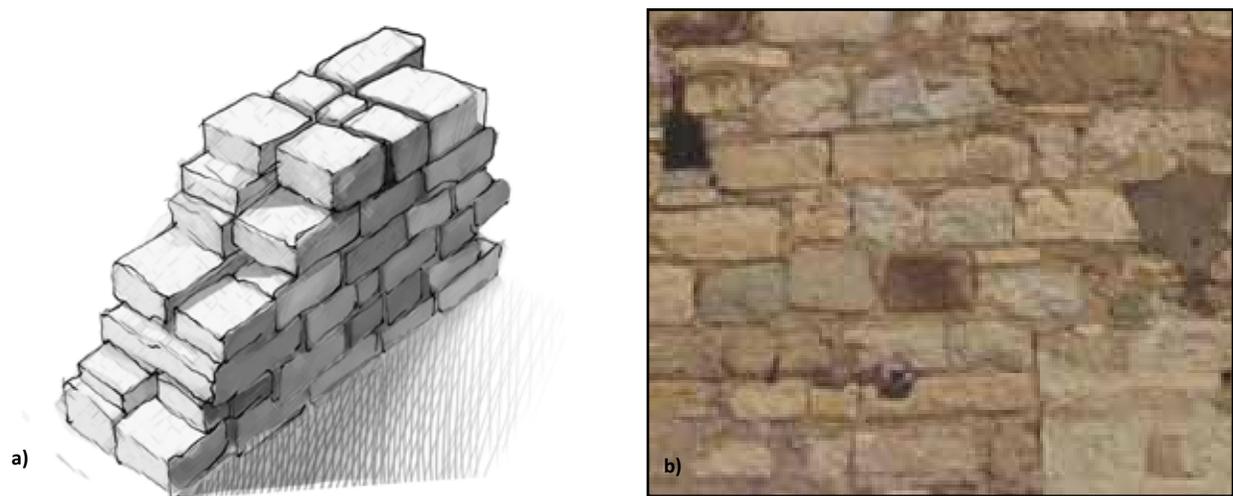
Figure 1.31 Dressed stone masonry: a) an isometric view of a typical wall, and b) an exterior of a wall in Umbria, Italy (source: Maffei et al. 2006)

Dressed stone masonry is constructed using stones of regular shape that look like solid blocks, as shown in Figure 1.31. A stone with a rectangular or square face is also called ashlar, hence the name ashlar masonry (Shadmon 1996). Dressed stone masonry can be found in Europe. A few examples from Italy and Switzerland are shown in Figures 1.31 and 1.32. It should be noted that some types of stone are easier to shape than the others. For example, the widespread

use of dressed stone masonry in Italy is due to the availability of calcareous stones and tuffs (rocks formed from volcanic ash), which are relatively easy to shape. Mortar in dressed stone masonry walls is usually of poor quality, however the seismic resistance is superior compared to other types of stone masonry due to frictional forces between adjacent stones. The thickness of dressed stone masonry walls is in the range of 300 to 600 mm.

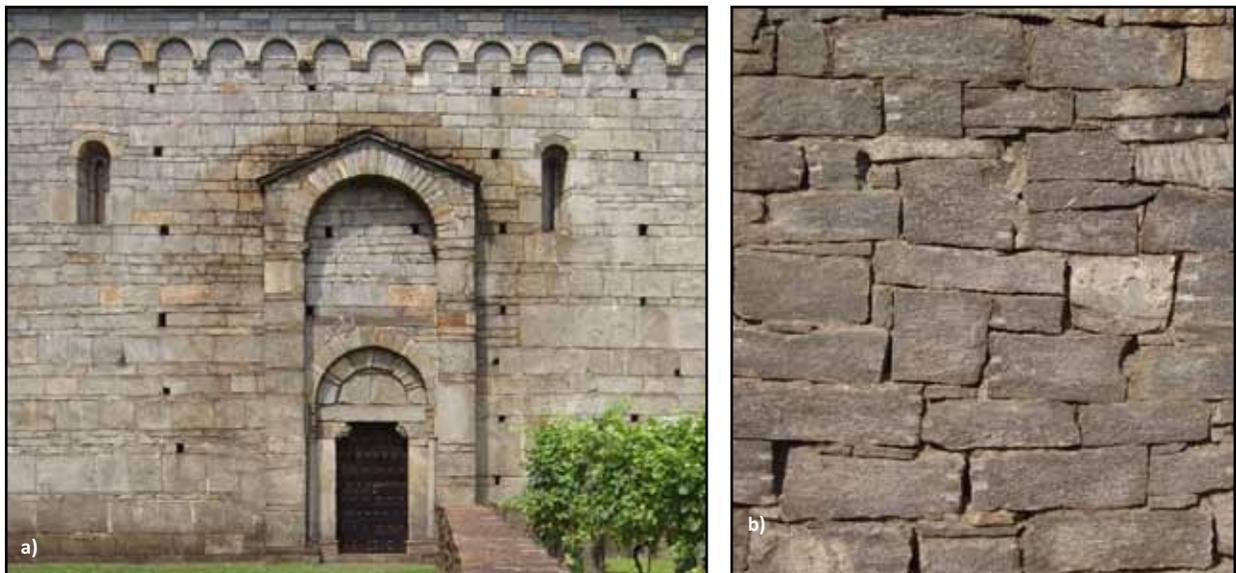
Figure 1.32 Dressed stone masonry construction in Southern Switzerland: a) a typical building in Giornico, and b) a detail of the exterior (photos: T. Schacher)

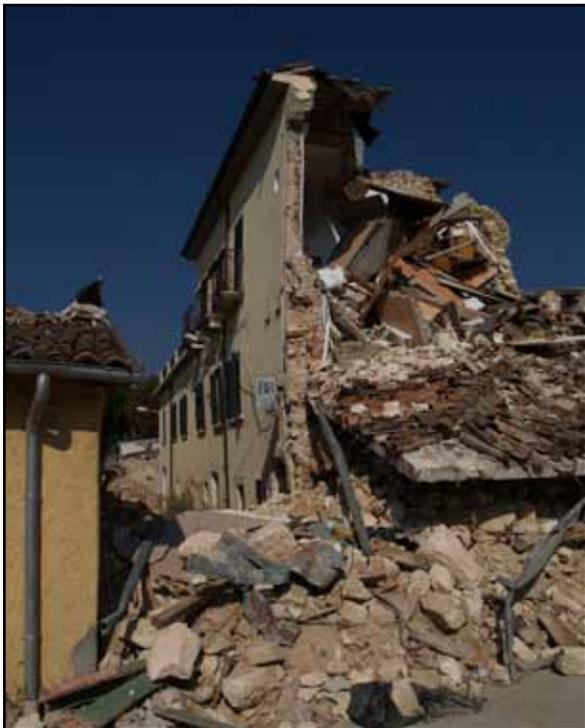
Figure 2.1 Extensive damage to stone masonry buildings in the 2009 L'Aquila, Italy, earthquake (photo: T. Schacher)

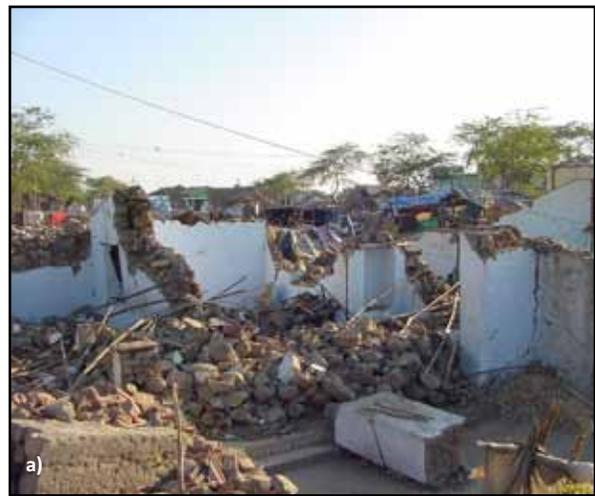
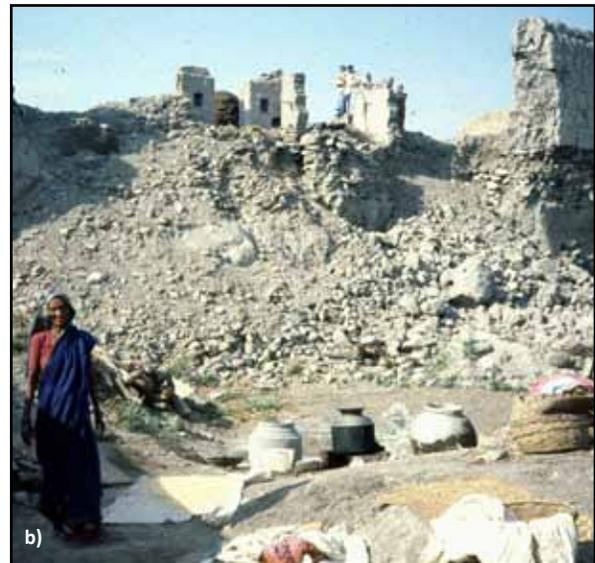
Figure 2.2 Extensive damage to stone masonry buildings in Indian earthquakes: a) the 2001 Bhuj, Gujarat, earthquake (photo: C.V.R. Murty), and b) the 1993 Maharashtra earthquake (photo: S. Brzev)

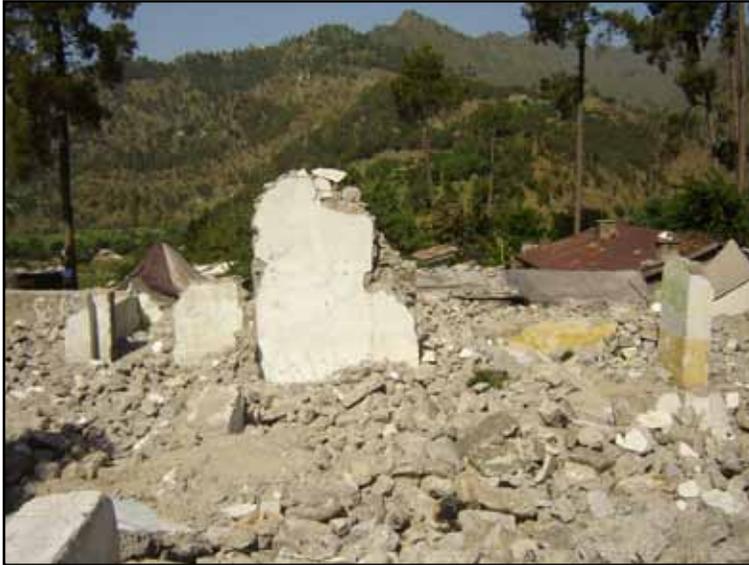
Figure 2.3 Collapse of stone masonry buildings, 2009 Bhutan earthquake (photo: K. Vatsa)

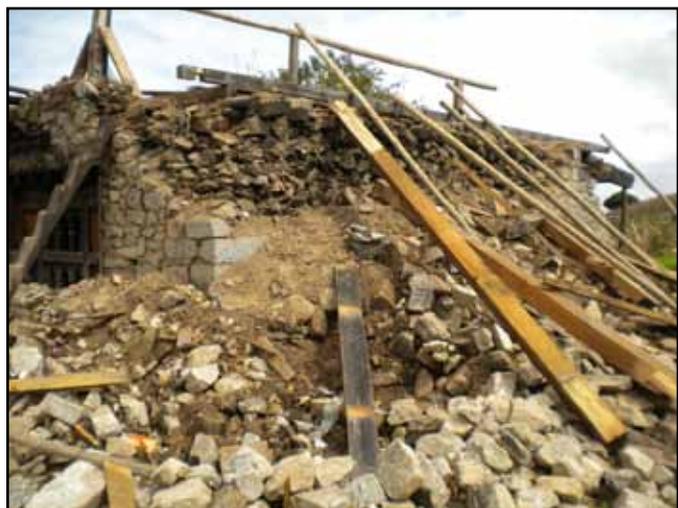
Figure 2.4 Collapsed stone masonry buildings, 2009 Bhutan earthquake (photo: K. Vatsa)

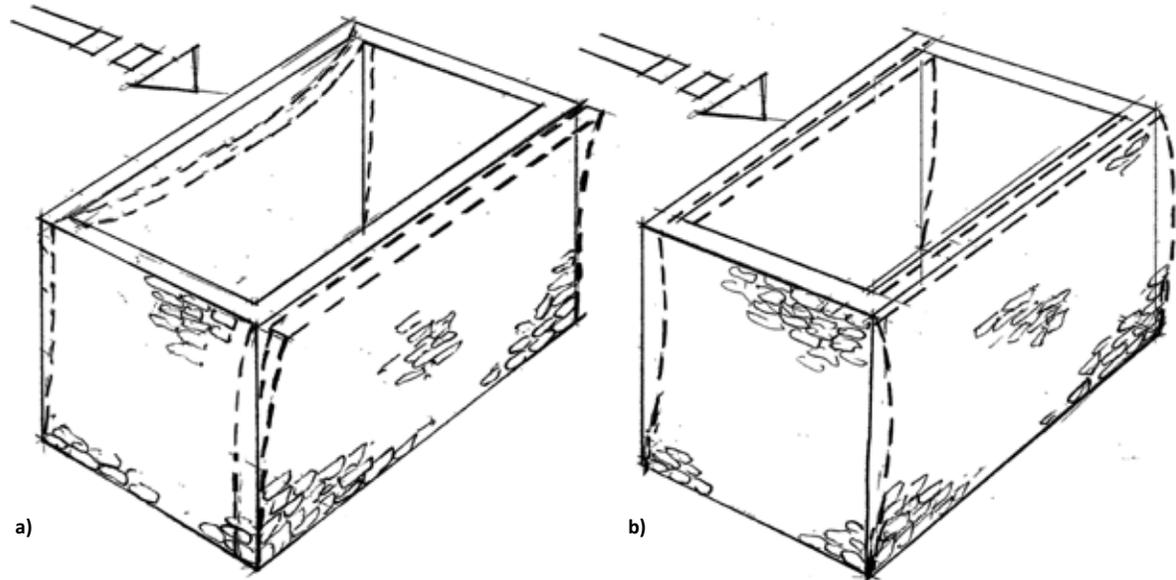
Figure 2.5 Masonry building during earthquake shaking: a) loosely connected walls without slab at the roof level, and b) a building with well-connected walls and a roof slab (source: Tomazevic 1999)

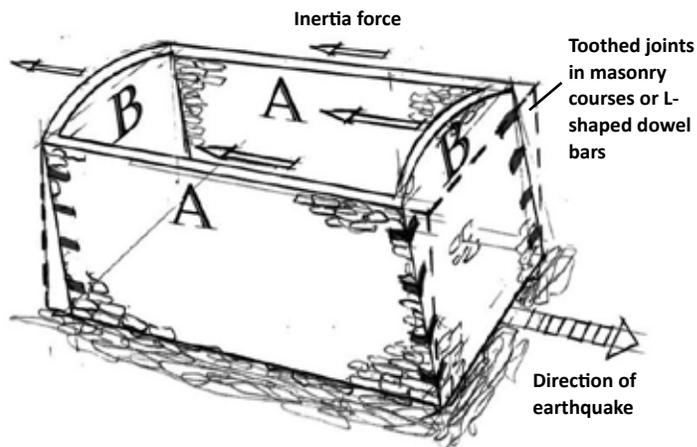
Figure 2.6 Wall connections are critical to the box-like action of a building: Walls A (loaded in the strong direction) support Walls B (loaded in the weak direction) (source: Murty 2005)

Wall intersections are particularly vulnerable to earthquake effects due to significant tensile and shear stresses developed when seismic forces are transferred from walls B (transverse walls) to walls A (shear walls), as illustrated in Figure 2.6. When wall connections are inadequate or absent, vertical cracks may develop or separation may take place at wall intersections. These damage patterns have been observed in past earthquakes, as shown in Figures 2.7 to 2.9. In some cases, intersecting walls are built using different materials (a combination of brick or block and stone masonry), and are more susceptible to damage compared to other walls, as shown in Figure 2.38.

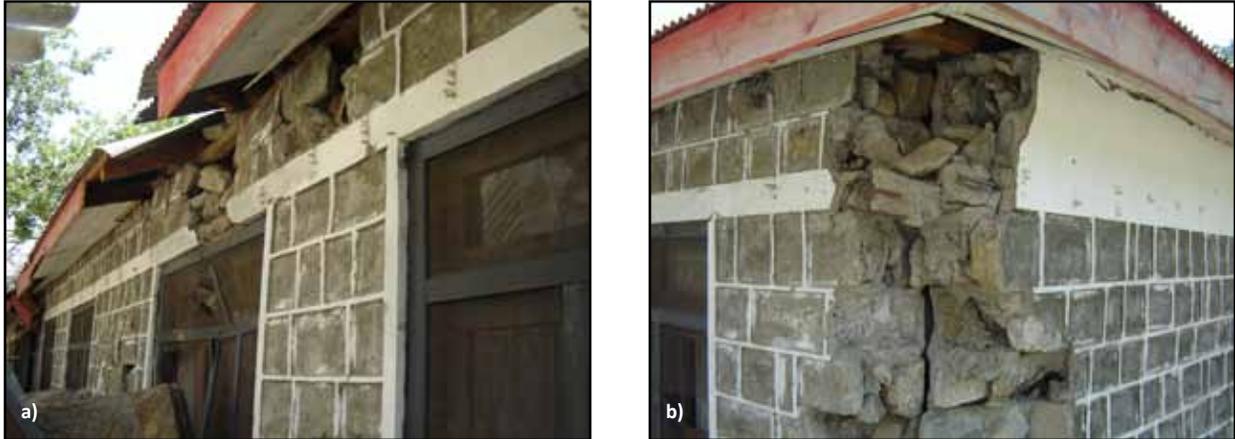
Figure 2.11 A stone masonry building with an RC lintel band that survived the 2005 Kashmir earthquake in Pakistan: a) the building suffered only moderate damage in the top portion, and b) separation at the wall intersection took place in spite of the band (note inadequate anchorage of the band reinforcement) (photos: Builders Without Borders)

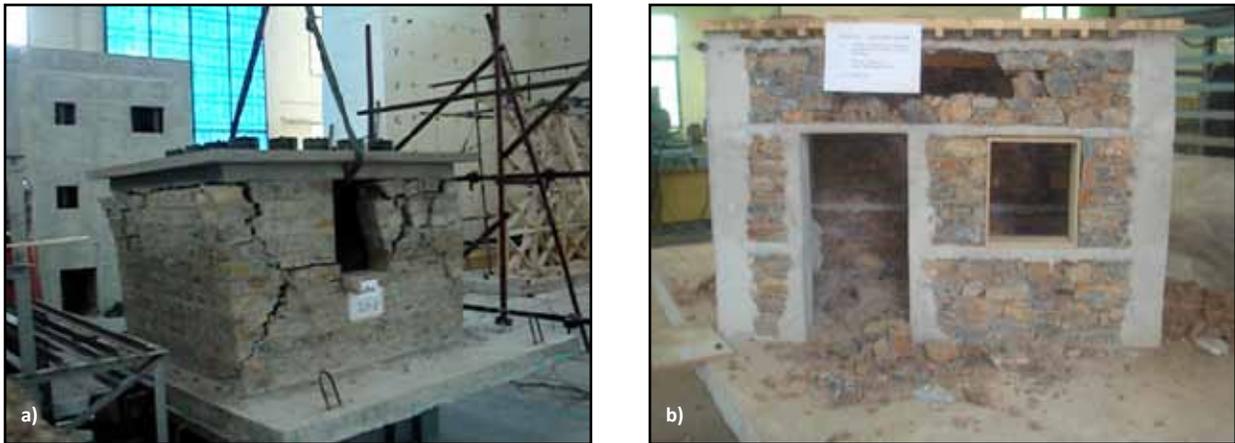
Figure 2.12 Damaged models at the end of the test: a) failure of model SM1, and b) model SM3 at the end of the experiment (source: Ali et al. 2010)

displacement capacity. However, they did not improve the overall capacity of the structure, as the model faced moderate damages at a PGA of 0.16 g and major damages at a PGA of 0.26 g. Model SM3 showed an excellent response, and maintained its integrity until the base acceleration (PGA) of 0.27 g was reached. Model SM1, with semi-dressed stone walls in cement mortar, showed worse performance than model SM2, which had uncoursed rubble walls in mud mortar. It was concluded that bands provided at several levels are effective in maintaining the integrity of a building because these elements divide the walls into smaller portions. Figure 2.12 shows models SM1 and SM3 at the end of the test.

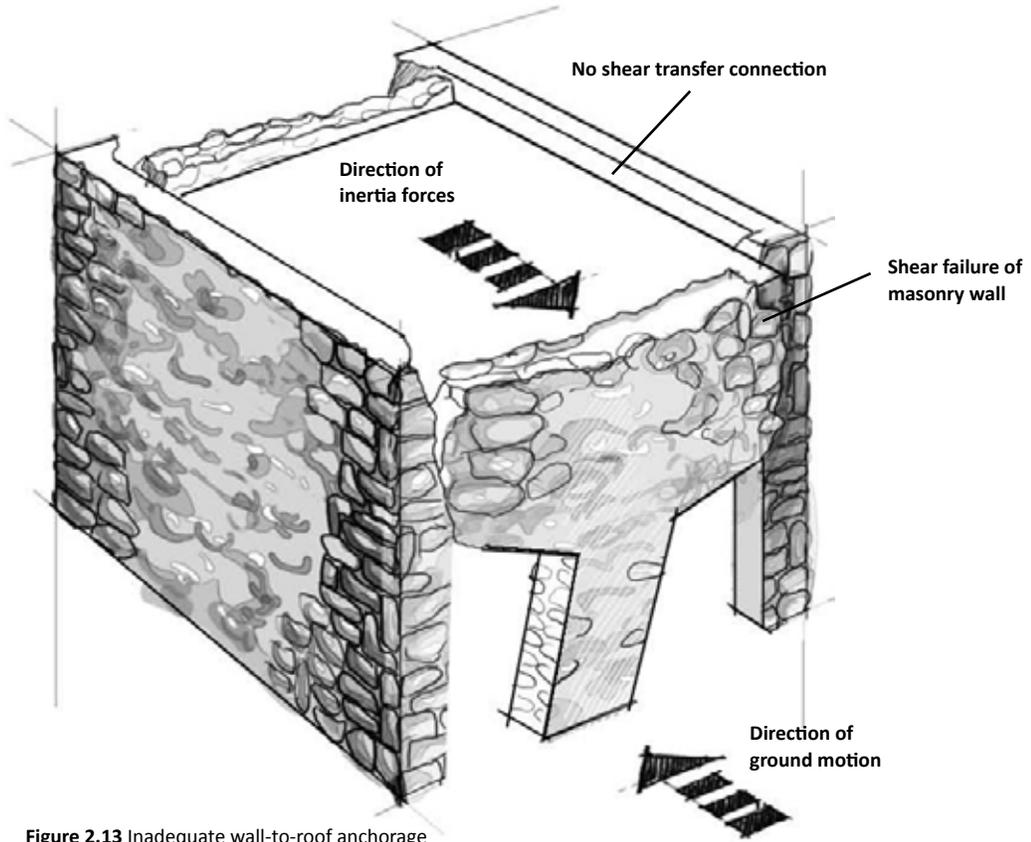
Figure 2.13 Inadequate wall-to-roof anchorage

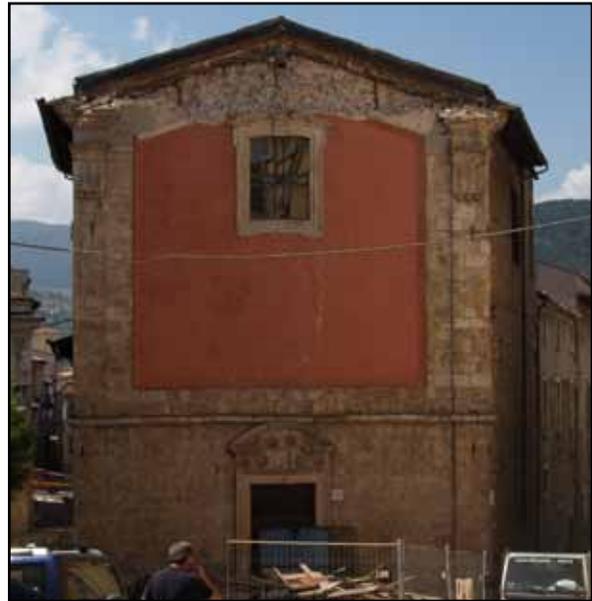
Figure 2.16 A building with roof-to-wall anchors survived the 2009 L'Aquila, Italy, earthquake (photos: T. Schacher)

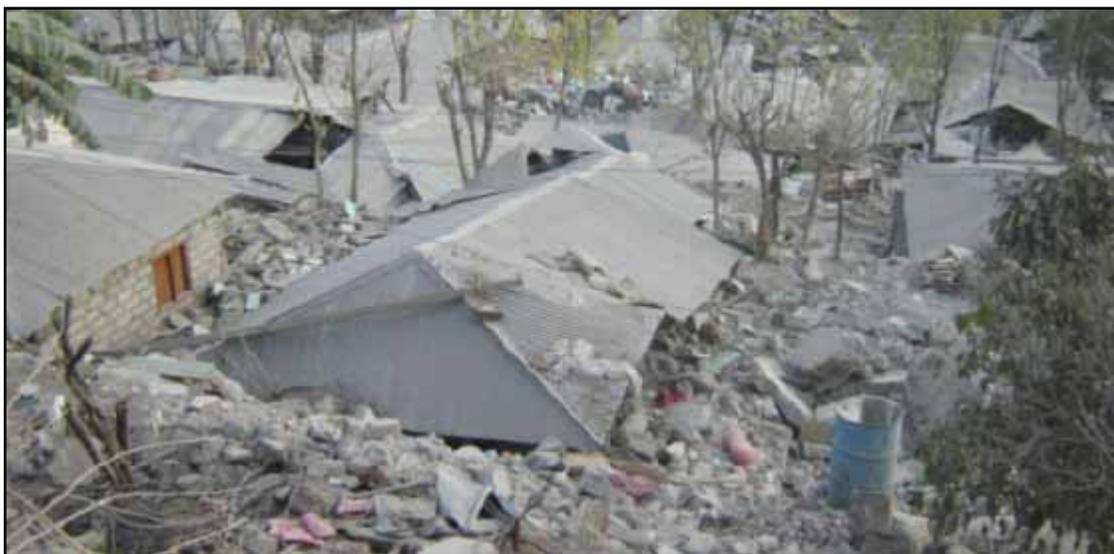
Figure 2.17 Collapse of stone masonry buildings with hipped roofs in the 2005 Kashmir, Pakistan, earthquake (source: Bothara and Hiçyılmaz 2008)

the 2005 Kashmir, Pakistan, earthquake. These buildings have a few important seismic deficiencies, such as an absence of effective ties or ring beams (bands) at the eaves level (beneath the roof), inadequate wall-to-roof anchorage, and an absence of through-stones in the walls. Buildings of this type showed poor performance in the earthquake due

to the collapse of stone masonry walls, as shown in Figure 2.17. It should be noted that the seismic performance of hipped roofs in the earthquake was excellent in terms of maintaining their integrity and shape. After the earthquake, people were able to lift the roof of their collapsed house and rebuild the walls (Bothara and Hiçyılmaz 2008).

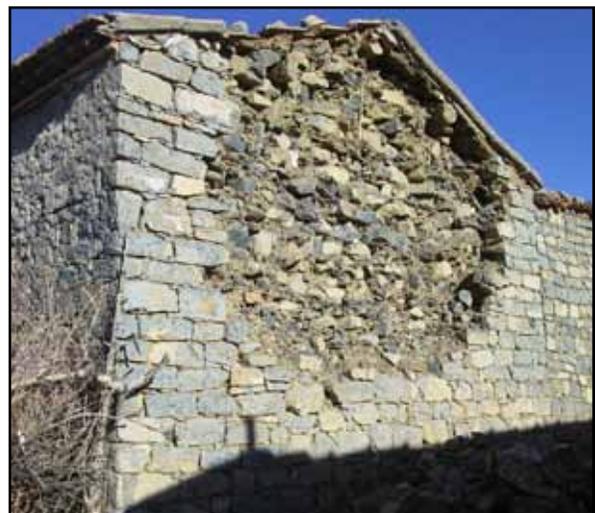
Figure 2.22 Delamination of a stone masonry wall in the 2000 Beni-Ouartilane, Algeria, earthquake (photo: M. Farsi)

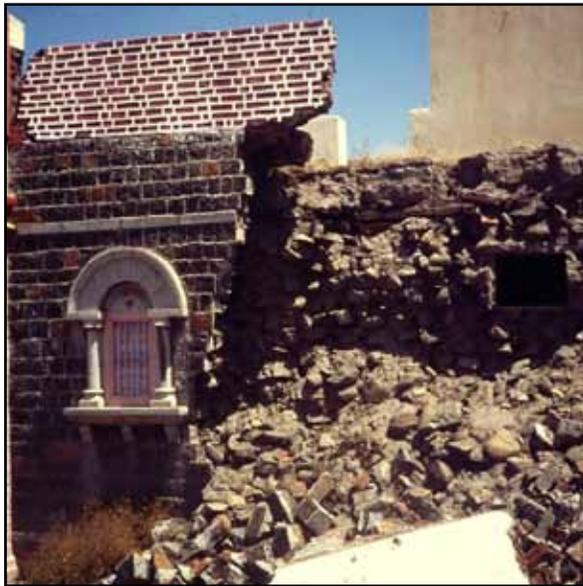
Figure 2.23 Delamination was a common damage pattern observed in the 1993 Maharashtra, India, earthquake (photos: S. Brzev)

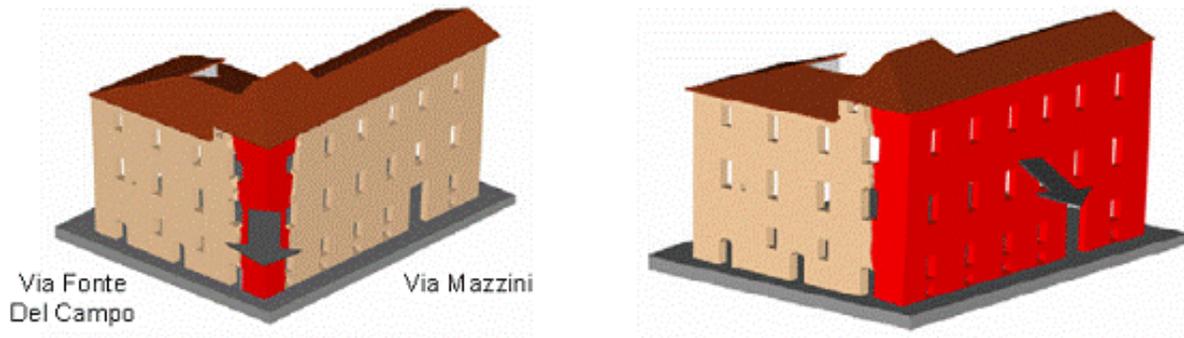
Figure 2.26 Rendered images of a building damaged in the 2002 Molise (Italy) earthquake: a) the stone masonry construction is damaged at the corner resulting in a loss of gravity support; b) a façade falls away from the floor and roof diaphragms (source: Maffei et al. 2006)

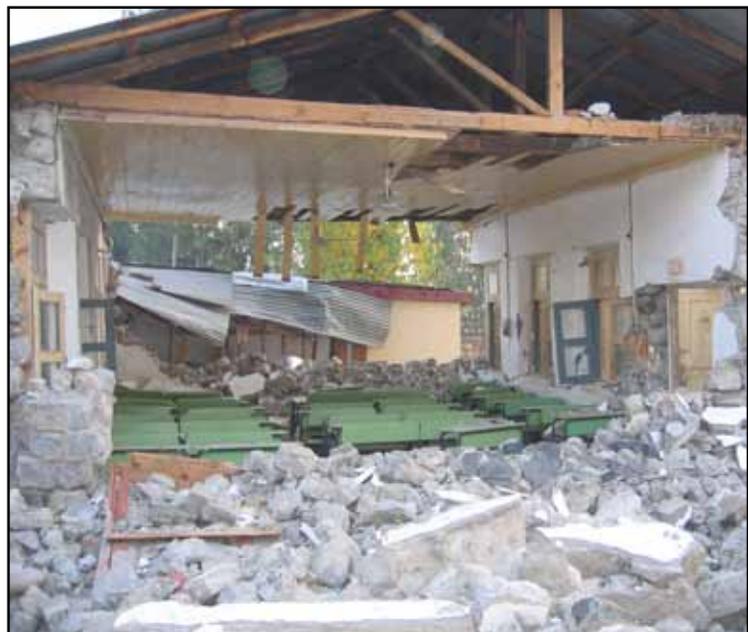
Figure 2.28 Out-of-plane collapse of two parallel walls, NWFP Pakistan (photo: SDC)

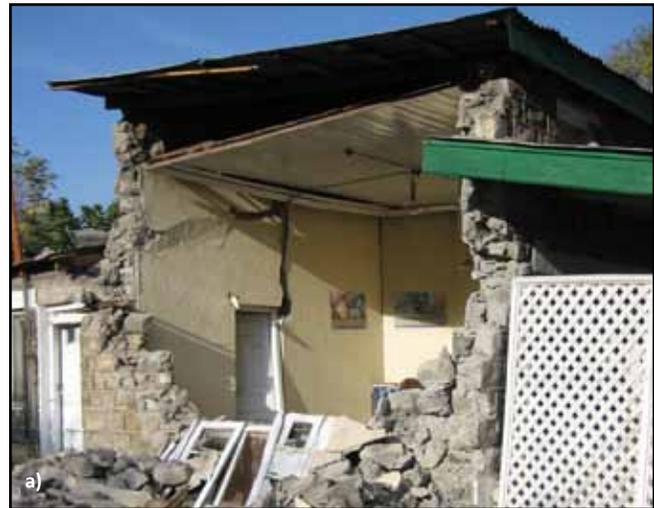
Figure 2.30 Out-of-plane collapse of stone masonry walls in buildings with flexible roofs and inadequate wall-to-roof connections: a) the 2005 Kashmir, Pakistan, earthquake (photo: M. Tomazevic); b) the 2003 Boumerdes, Algeria, earthquake (photo: M. Farsi)

Out-of-plane wall collapse is common in buildings with flexible roofs and floors, and where wall-to-roof connections are inadequate, as shown in Figure 2.30.

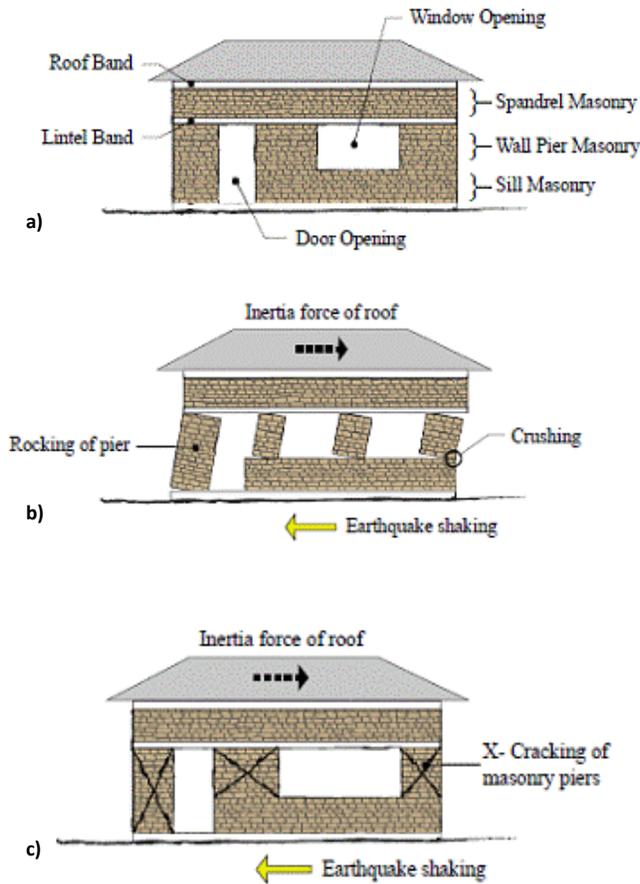
Figure 2.33 In-plane damage of stone masonry walls: a) typical wall with openings; b) rocking failure, and c) diagonal shear cracking (adapted from: Murty 2005)

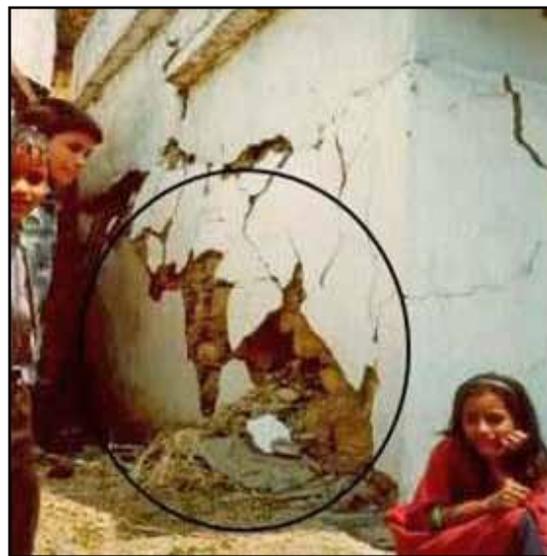
Figure 2.35 Localized wall failure caused by irregular stones (source: WHE Report 74)

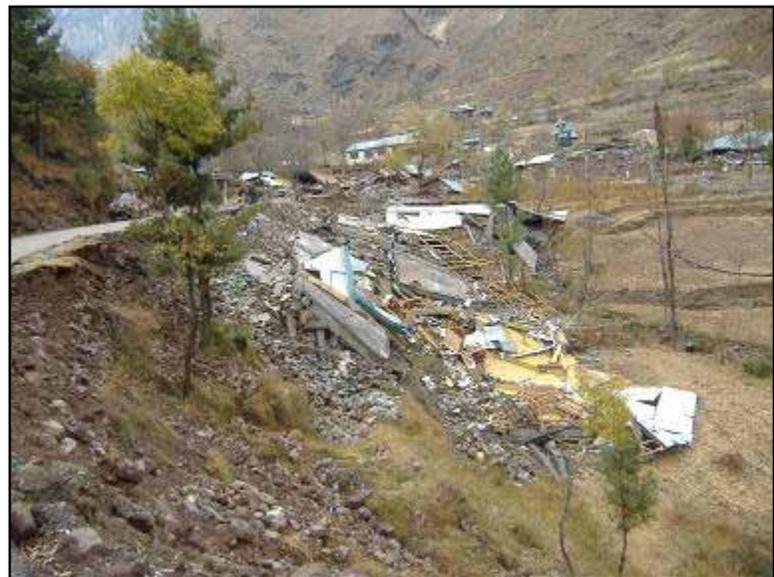
Figure 3.1 A collapsed building on a steep slope after the 2005 Kashmir earthquake, Pakistan (source: Bothara and Hıçyılmaz 2008)

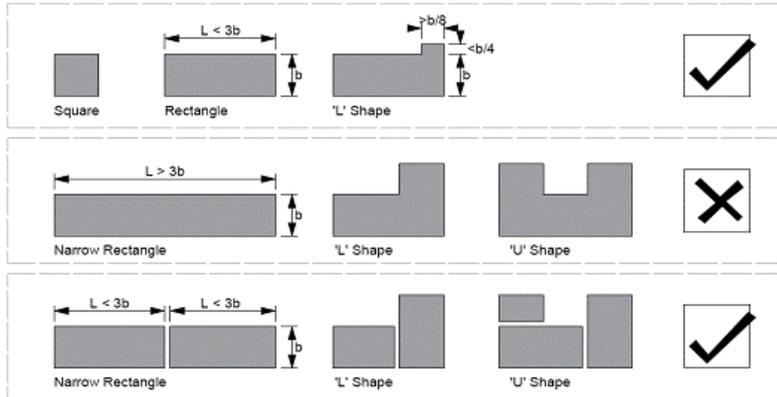
Figure 3.4 Building configurations: DOs and DON'Ts (adapted from: IAEE 2004)

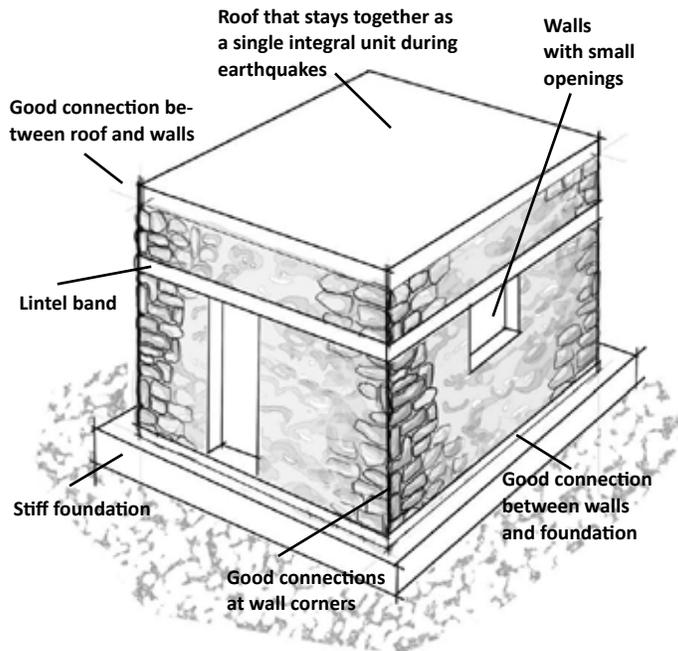
Figure 3.6 Key requirements for ensuring box action in a stone masonry building (adapted from: Murty 2005)

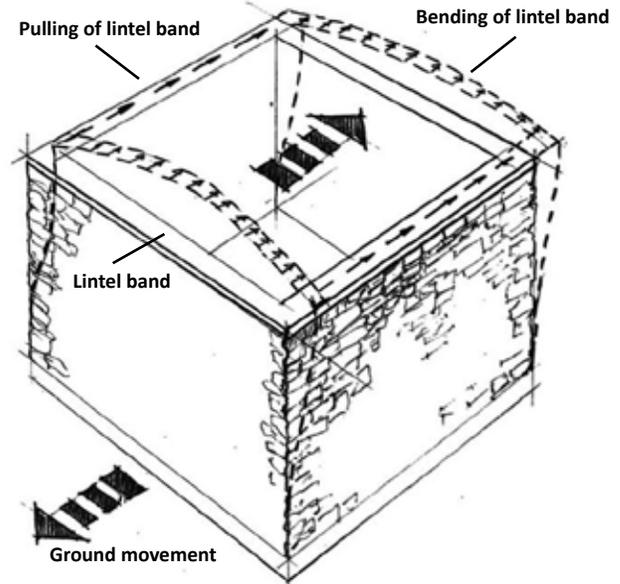
Figure 3.8 Pulling and bending of a lintel band in a stone masonry building (adapted from: Murty 2005)

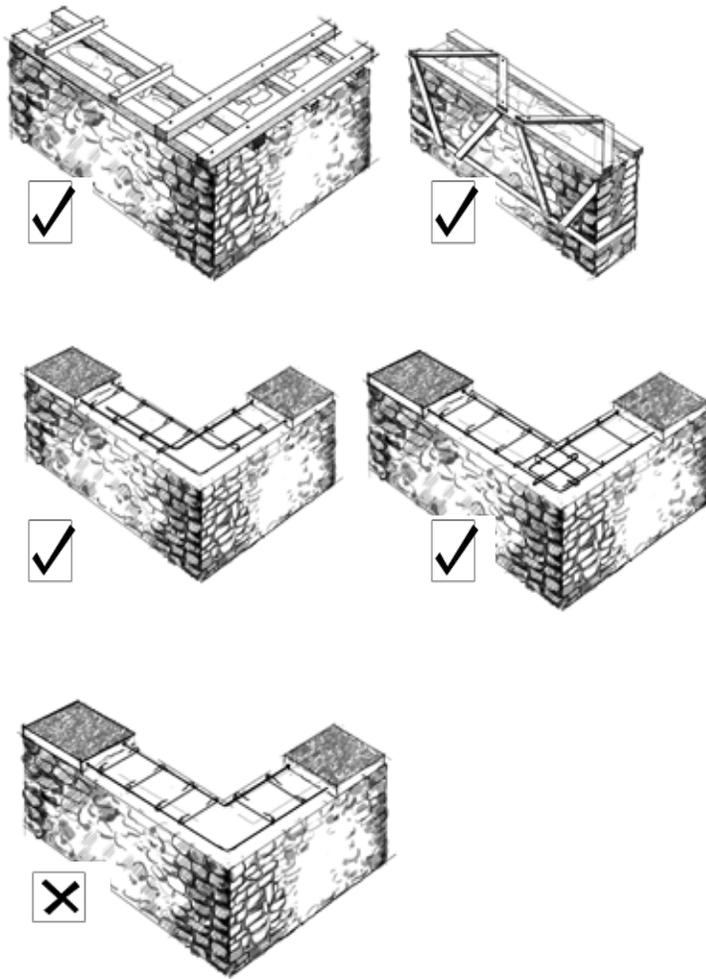
Figure 3.14 Recommended detailing of timber and RC bands (adapted from: T. Schacher and C.V.R. Murty)

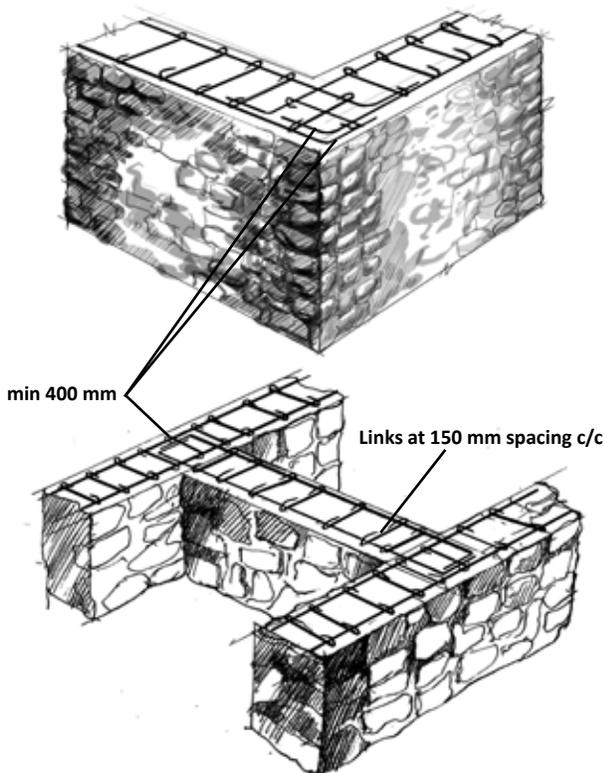
Figures 3.16 Reinforcement layout in RC bands (adapted from: GOM 1998)

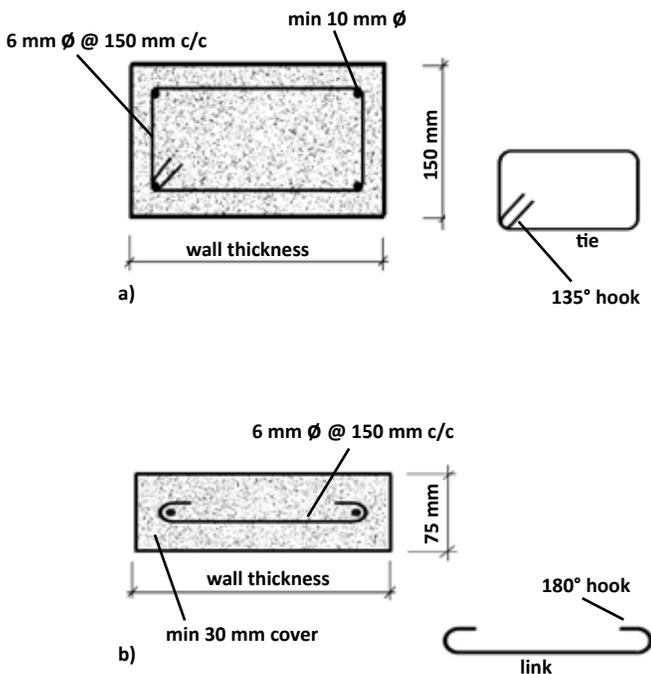
Figure 3.17 RC band cross-section: a) a band with four bars and ties, and b) a band with two bars and links

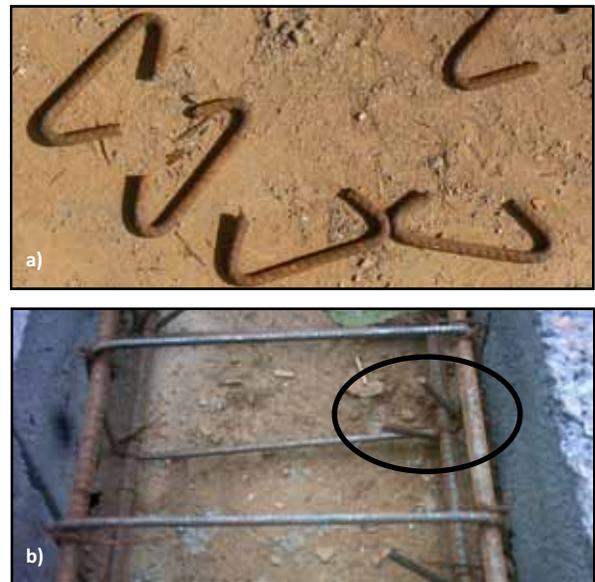
Figure 3.18 Inadequate bending of reinforcement in RC bands: a) links, and b) ties (photos: Smart Shelter Foundation)

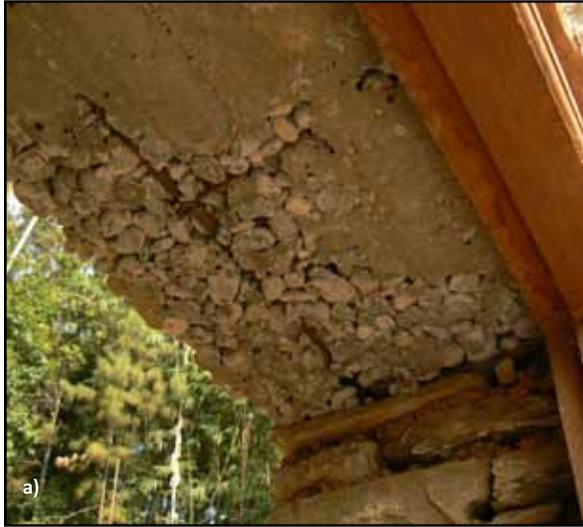
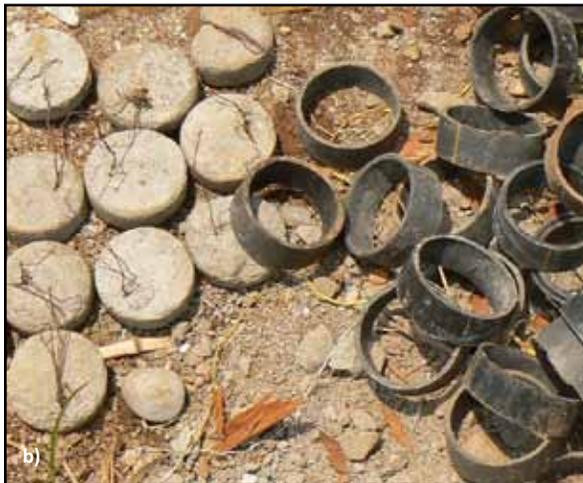
Figure 3.19 Concrete cover in RC bands: a) exposed bars due to inadequate cover, b) concrete spacers made from PVC pipes, and c) RC band under construction showing use of concrete spacers (photos: Smart Shelter Foundation)

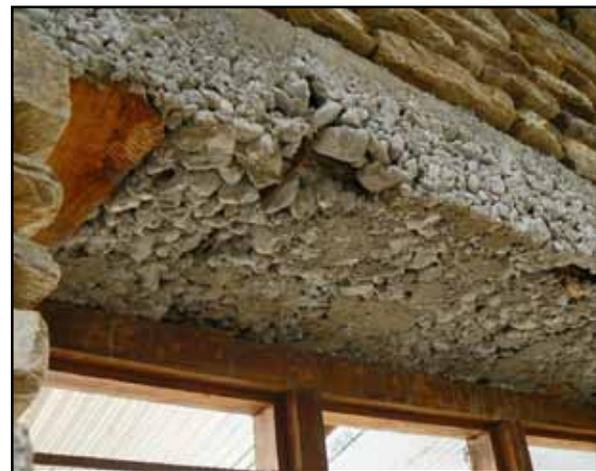
Figure 3.20 Poor concrete construction quality in an RC lintel band (photo: Smart Shelter Foundation)

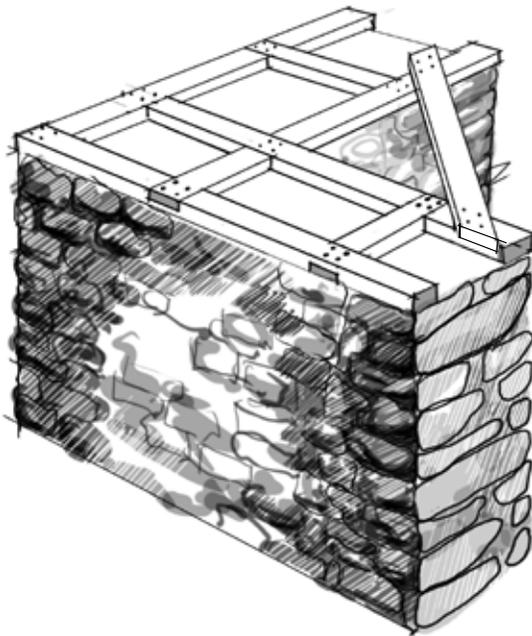
Figure 3.21 Timber band with a knee-brace at the corner

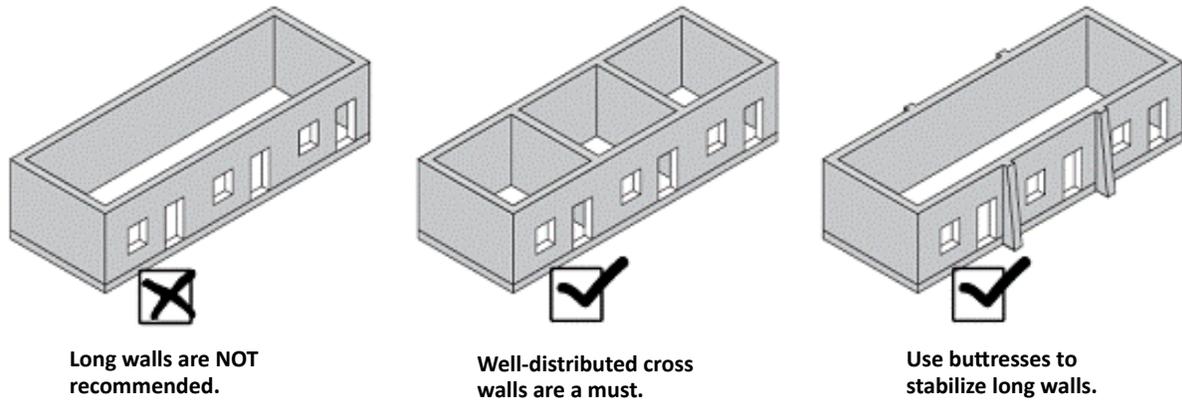
Figure 3.24 Recommendations related to the wall length (source: Bothara et al. 2002)
