A TUTORIAL: Improving the Seismic Performance of Stone Masonry Buildings

Jitendra Bothara • Svetlana Brzev

First Edition, April 2011

Publication Number WHE-2011-01

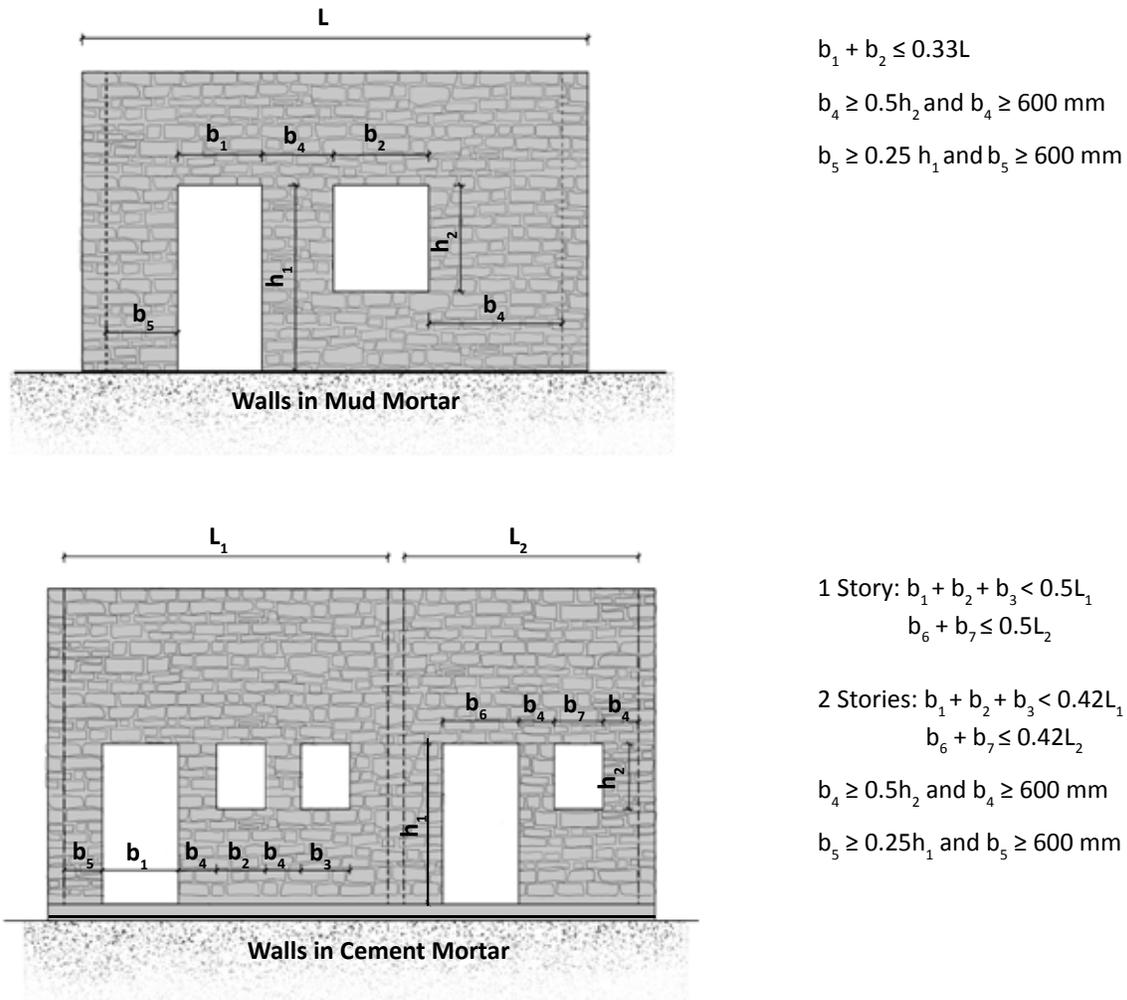
Figure 3.26 Recommended location and size of openings for stone masonry walls (source: IAEE 2004)

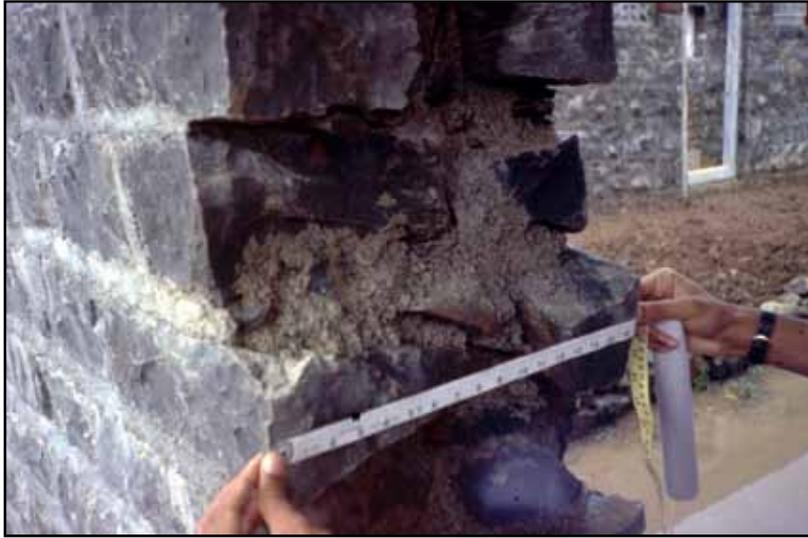
Figure 3.27 Examples of stone masonry in cement mortar with a wall thickness limited to 450 mm (note through-stones) (photos: S. Brzev)

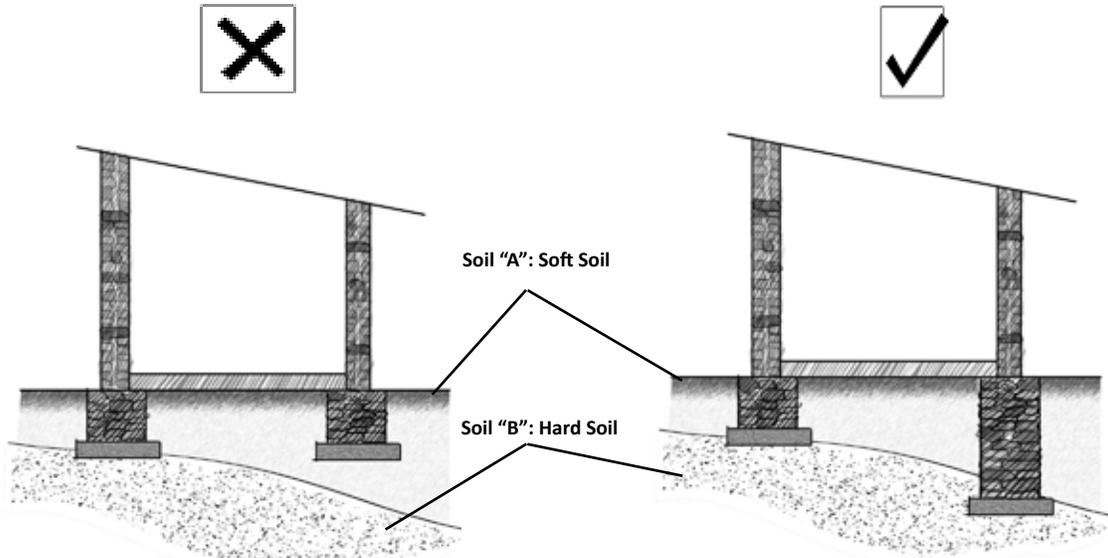
Figure 3.37 Different foundation depths are required for building sites with variable soil properties (source: GOM 1998)

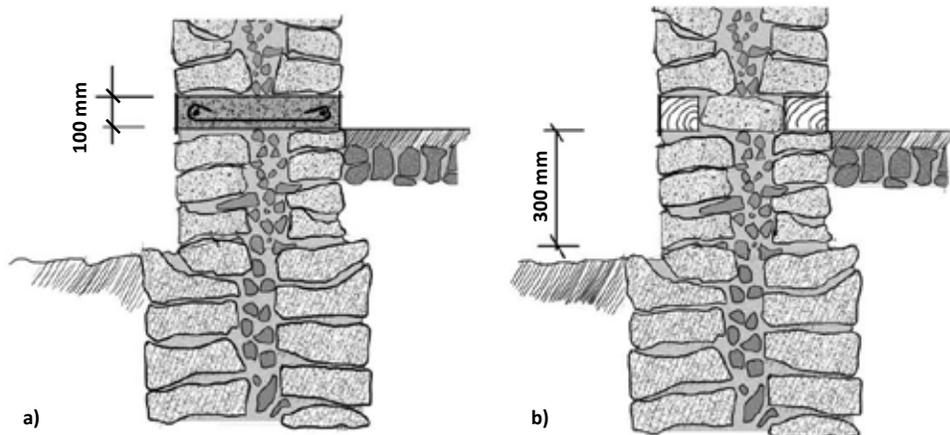
Figure 3.38 Stone masonry foundation with plinth bands: a) RC band, and b) timber band

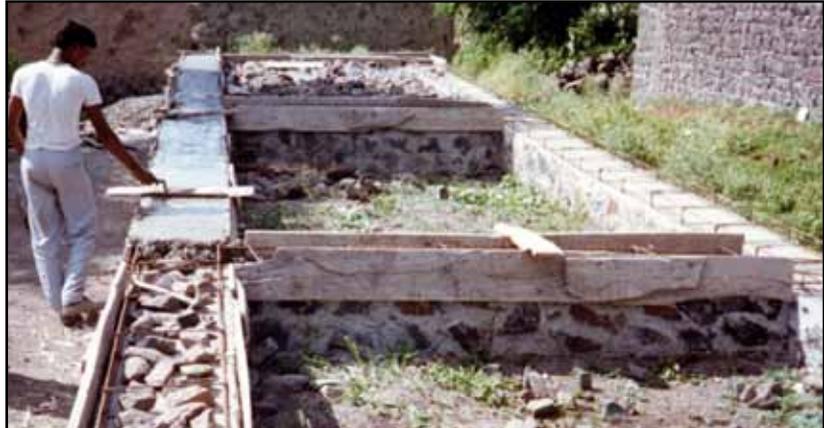
Figure 3.39 Construction of an RC plinth band using large stone rubble (also known as "stone-crete") (photo: S. Brzev)

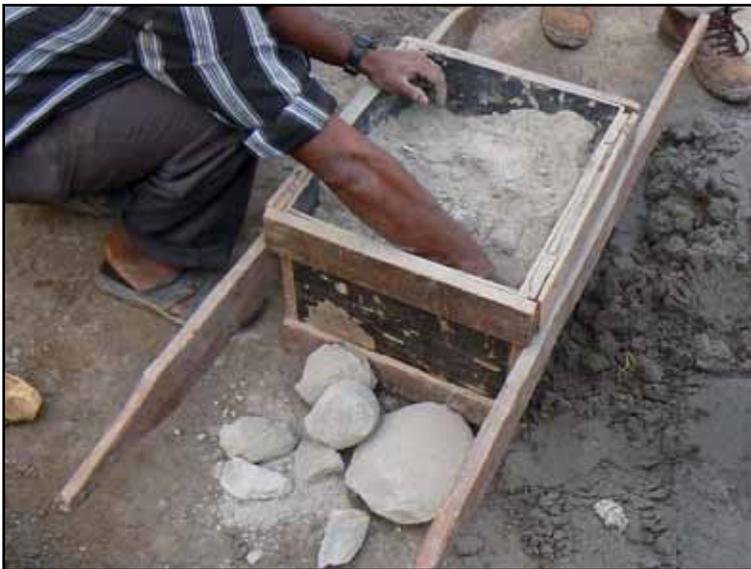
Figure 3.43 Cement with large lumps should not be used for construction (photo: Smart Shelter Foundation)

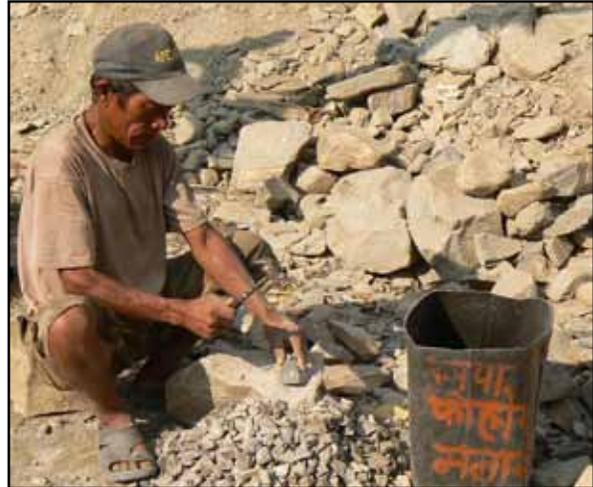
Figure 3.44 Stones can be cut to produce aggregates for concrete construction—an example from Nepal (photo: Smart Shelter Foundation)

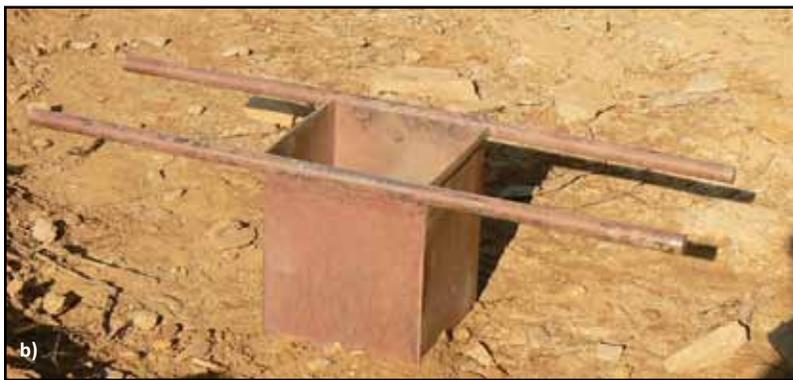
Figure 3.45 Measuring concrete materials: a) proportioning concrete ingredients using a measuring box, and b) a measuring box (photos: Smart Shelter Foundation)

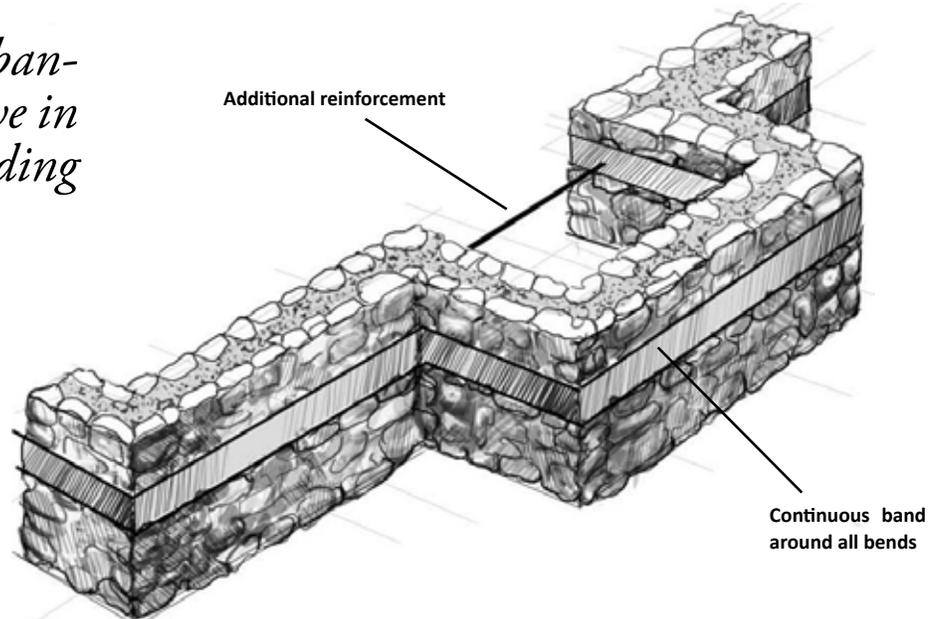
Figure 4.9 Continuing a bandage in re-entrant walls (source: R. Desai)

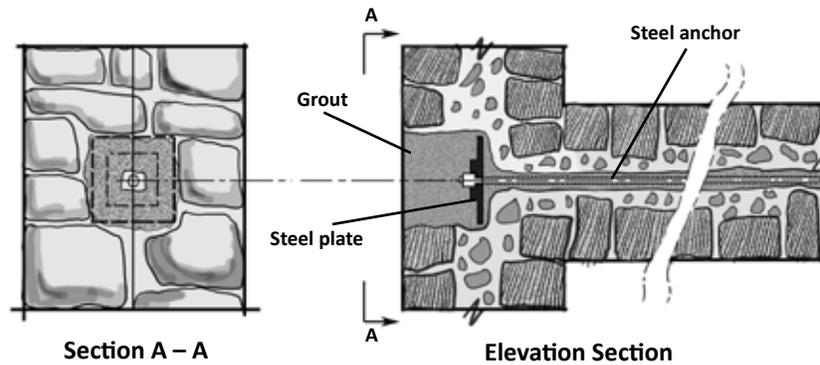
Figure 4.12 Installation of post-tensioned steel anchors to enhance connections between the intersecting walls (source: Maffei et al. 2006)

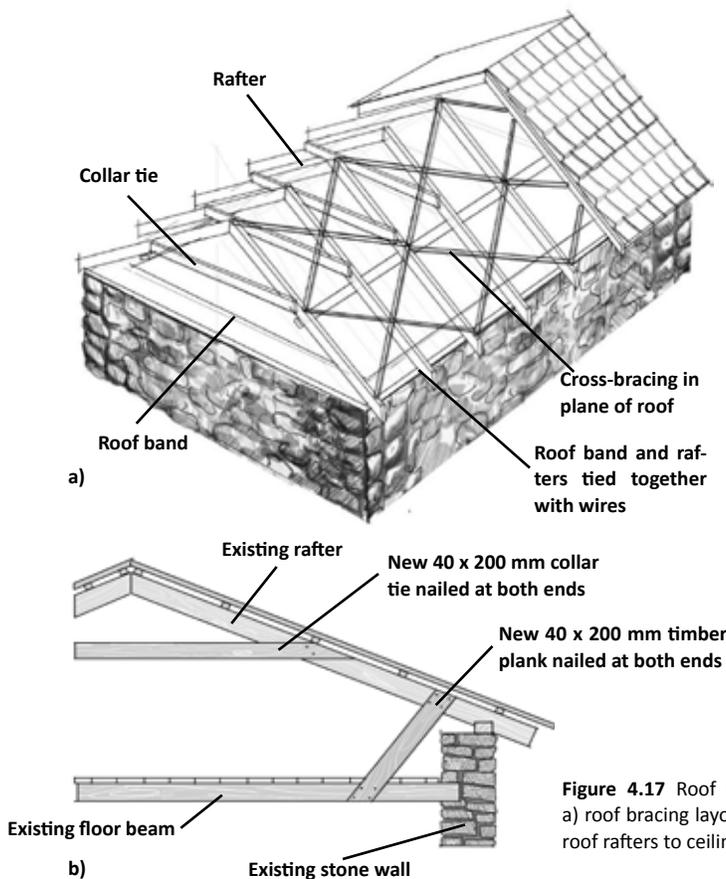
Figure 4.17 Roof bracing details: a) roof bracing layout, and b) tying roof rafters to ceiling joists

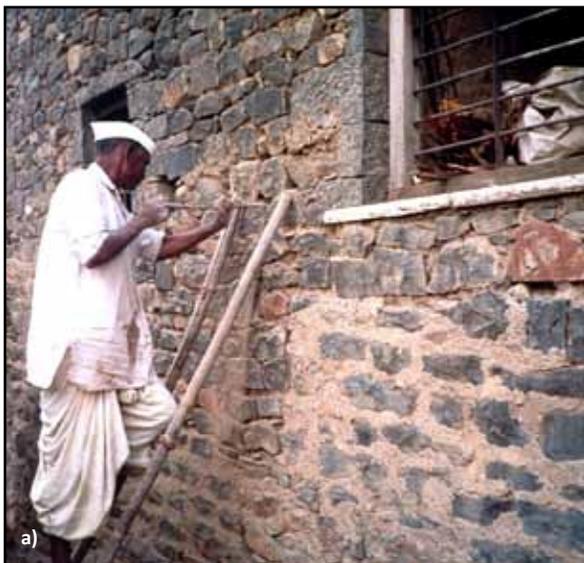
Figure 4.19 Examples of through-stone installation in Maharashtra, India: a) removing stone from the existing wall, and b) surface of a through-stone covered with a plaster (photos: S. Brzev)

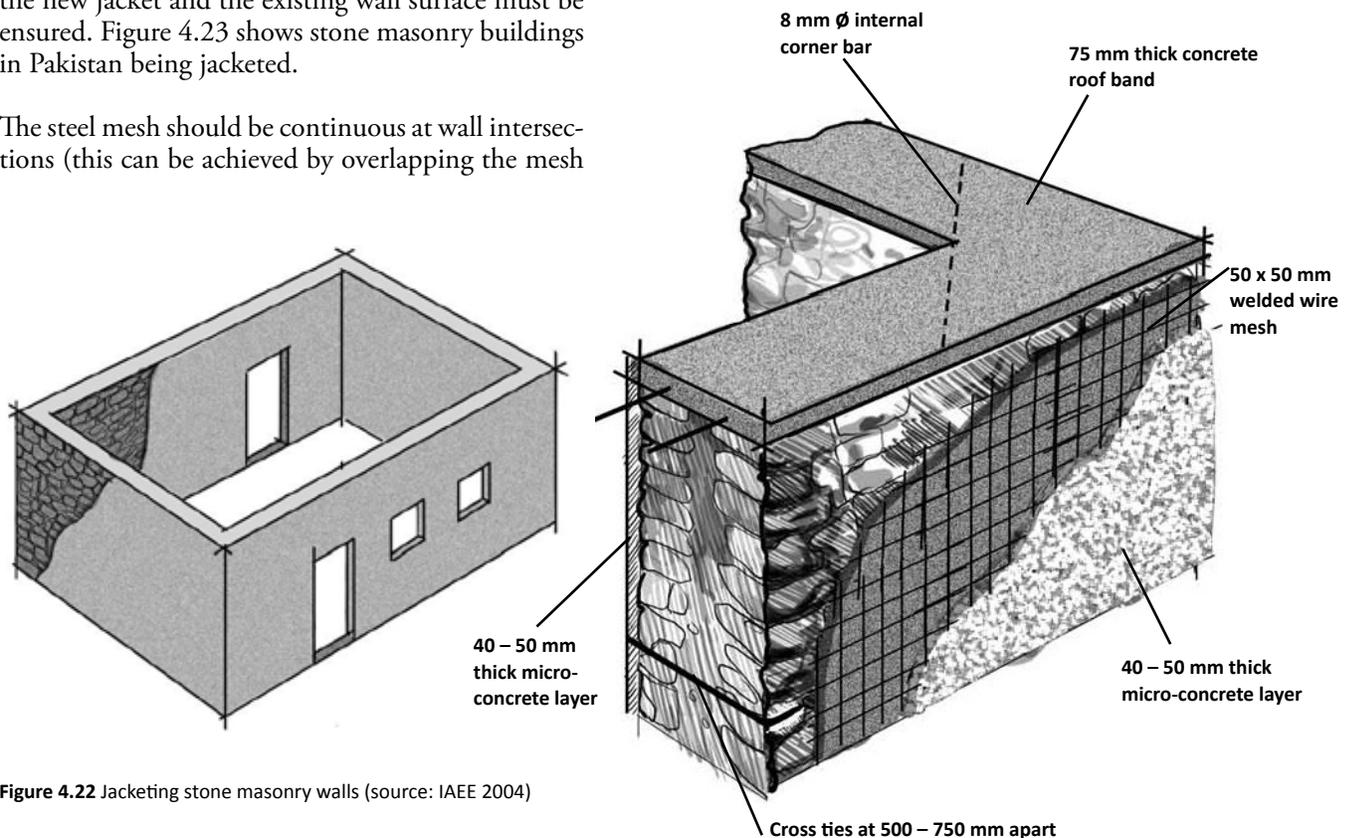
Figure 4.22 Jacketing stone masonry walls (source: IAEE 2004)

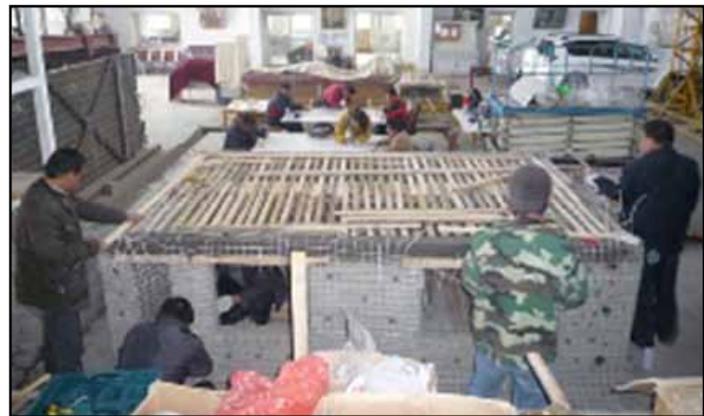
Figure 4.26 Testing polypropylene bands at IEM in Harbin, China (photo: W. Feng)

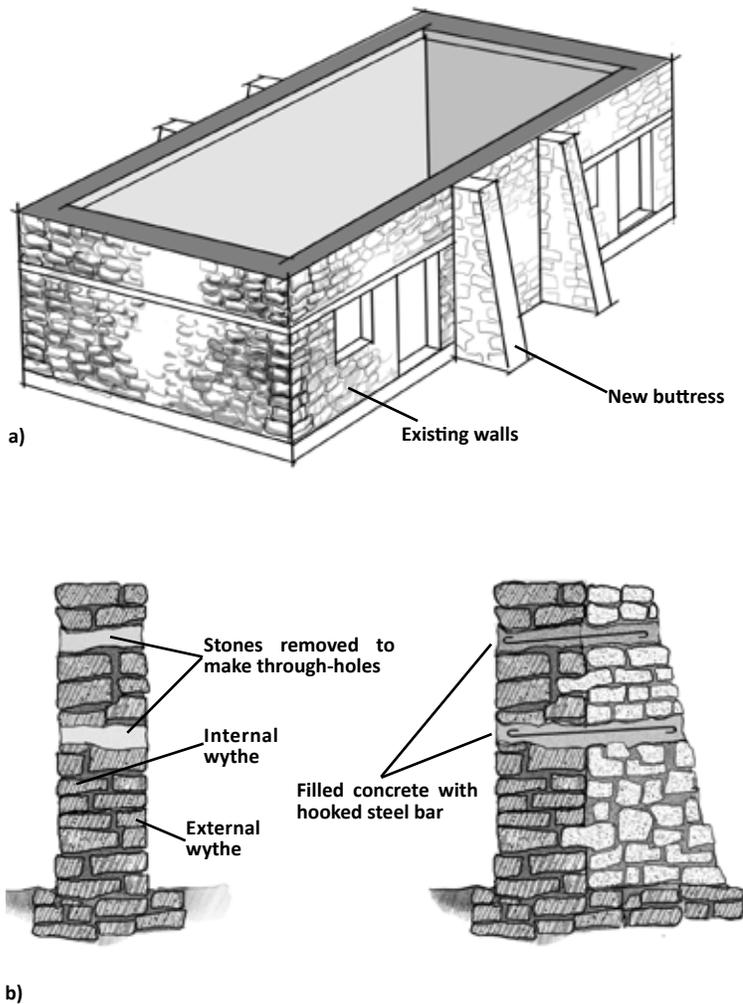
Figure 4.28 Strengthening an existing stone wall with buttresses

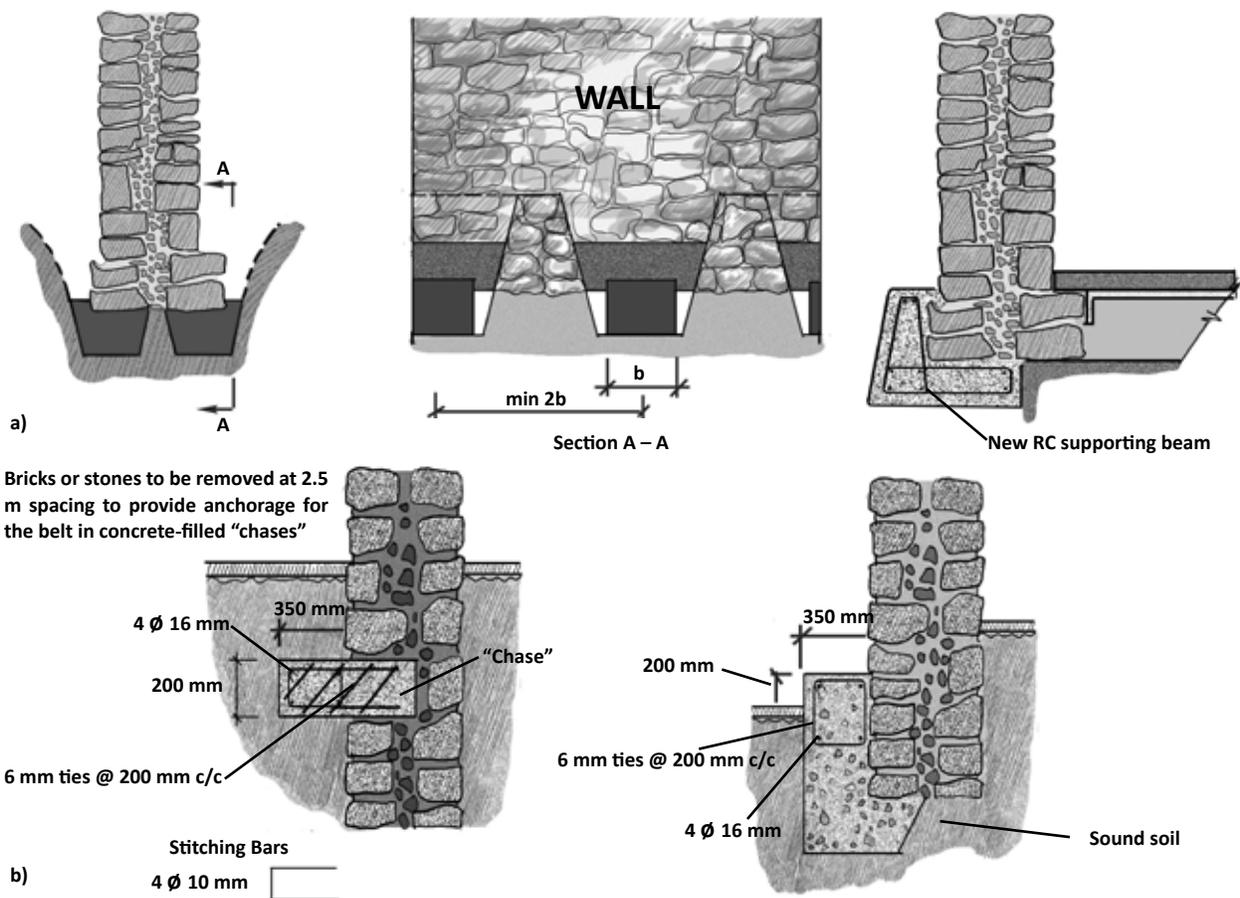
Figure 4.29 Strengthening existing foundations: a) underpinning the foundation, and b) external RC belt (adapted from: GOM 1998 and UNIDO 1983)

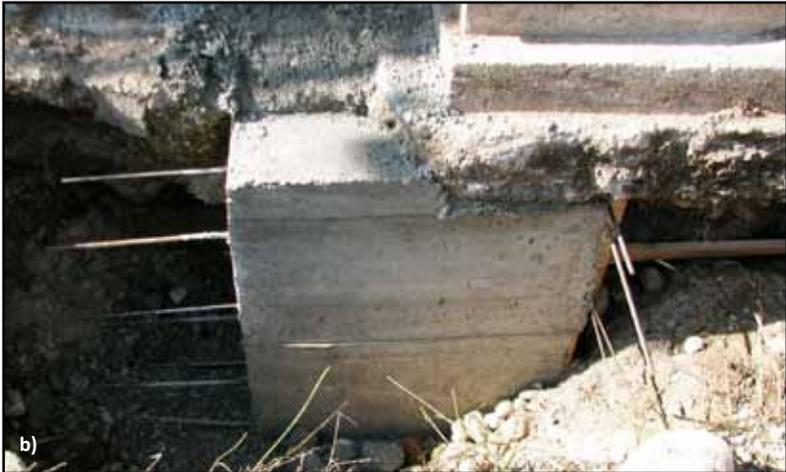
Figure 4.30 Strengthening a stone masonry foundation: a) reinforcement cage and formwork, and b) new reinforced concrete foundation under construction (photos: M. Lutman)
