World Housing Encyclopedia

HOUSING REPORT

Reinforced Concrete Moment Frame Building without Seismic Details

Report #	111
Report Date	14-09-2004
Country	USA
Housing Type	RC Moment Frame Building
Housing Sub-Type	RC Moment Frame Building : Designed for gravity loads only, with URM infills
Author(s)	Heidi Faison, Craig D. Comartin, Kenneth Elwood
Reviewer(s)	Mahmoud M. Hachem, Ayhan Irfanoglu

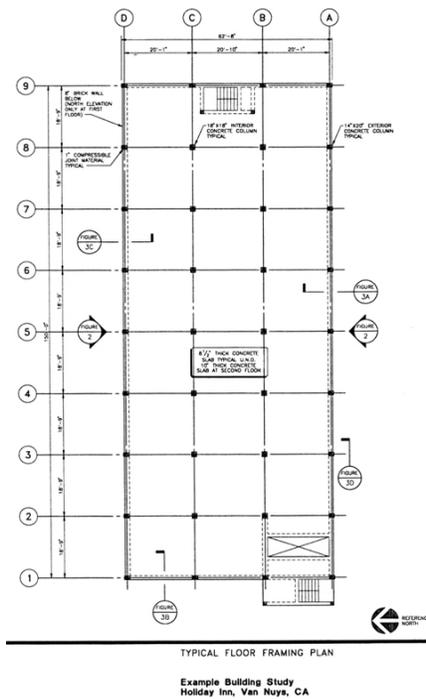
Figure 1: Typical Building Plan (Holiday Inn, Van Nuys, CA) [1]

resisted by a combination of the interior column-slab frames and the exterior column-spandrel beam frames (Figures 1 - 3). Damage primarily consisted of shear failure of the columns and subsequent buckling of column vertical reinforcing between the ties where added confinement provided by the concrete cover was no longer available due to spalling (Figures 22 & 23). Minor to moderate shear cracks were observed in many beam-column joints at the lower stories. Several spandrel beams showed minor spalling as well as flexural cracks at the bottom of the beams, suggesting possible yielding of the bottom reinforcement. The building was red-tagged after the event and temporary shoring was placed in some bays where the vertical load carrying capacity was compromised. The Champaign Tower in Santa Monica, CA was a 15-story concrete building with nonductile moment frames in one-direction and shear walls in the other. Balcony parapets shortened the column spans, which induced short column effects on many columns in the lower stories as shown by the X-shaped shear cracking (Figures 24 & 25). Extensive coupling beam shear failures were evident in the building direction that had shear walls to resist the seismic loads. The Barrington Medical building was a 6-story, L-shaped reinforced concrete building built in the late 1960's. The lateral system included perimeter frames, shear walls along the interior core and shear walls at the perimeter. Shear cracking in the perimeter frame columns comprised most of the structural earthquake damage and undermined the column strength enough at some levels that the windows buckled due to a decreased column/story height (Figure 26).

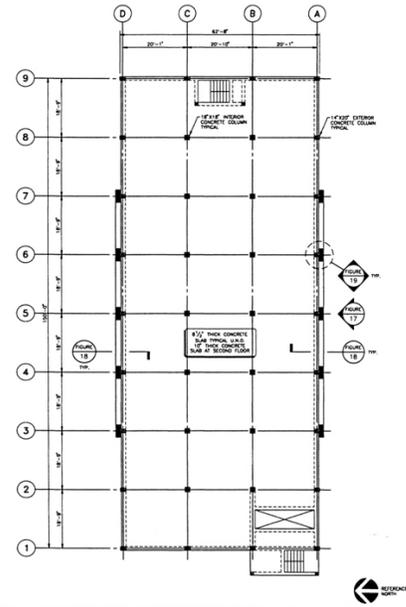
Figure 30: Plan of retrofit design for Holiday Inn, Van Nuys, CA. [1]

Many of these strengthening techniques have been applied to institutional buildings (i.e. universities) throughout California. The Holiday Inn in Van Nuys, CA which was damaged in the 1994 Northridge earthquake was retrofitted after the earthquake to repair the structure and improve its future earthquake performance. The method used for this structure was to insert new lateral load resisting elements to take the full seismic loads. New moment frames were added to the exterior of the building that were integrated with the existing frames (Figures 30 - 33). Although several of the buildings explained and documented in this report are hotels and office buildings, they have many similarities with non-ductile concrete apartment housing construction. Hotels, offices and typical housing structures have similar low story heights to maximize the number of floors throughout the height of the building. All of these uses also require the placement of many windows and openings throughout the structure. Large apartment buildings, offices and hotels may have a soft story at the lower level if there is a ground floor lobby or commercial space. Because of these similarities in building form, the seismic performance of these buildings is comparable. The hospitals used in this report document the reasons why the codes were changed so drastically in the 1970's. The failures in these hospitals also demonstrate deficiencies in design that commonly are seen in all moment frame buildings built before 1976.

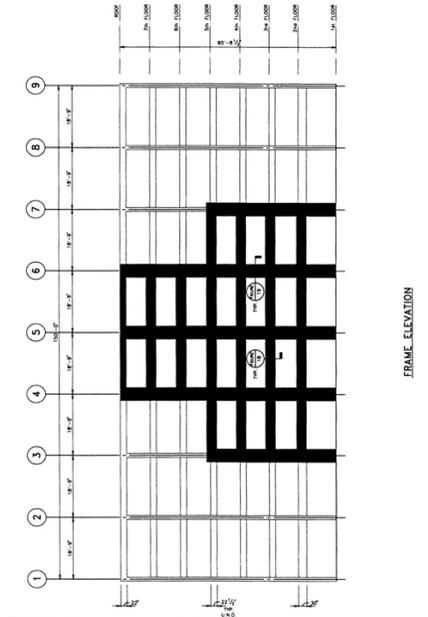
Figure 31: Elevation of retrofit design for Holiday Inn, Van Nuys, CA showing new moment frames to be added. [1]

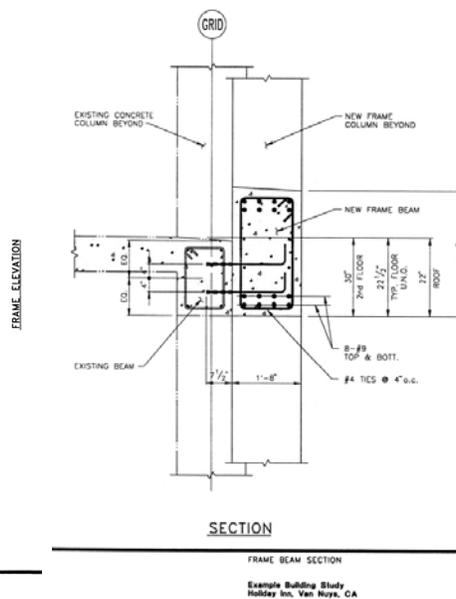
Figure 32: Detail of retrofit design for Holiday Inn, Van Nuys, CA showing connection of new moment frame beam to old moment frame beam. [1]

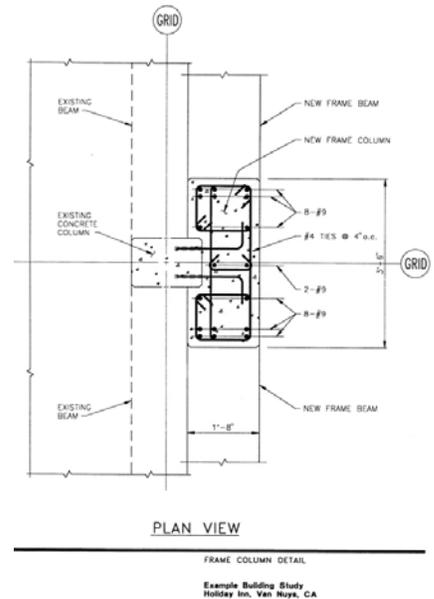
Figure 33: Detail of retrofit design for Holiday Inn, Van Nuys, CA showing connection of new moment frame column to old moment frame column. [1]
