World Housing Encyclopedia

HOUSING REPORT

Reinforced concrete frame structure with diagonal bracing and brick infill walls

Report #	71
Report Date	05-06-2002
Country	ROMANIA
Housing Type	RC Moment Frame Building
Housing Sub-Type	RC Moment Frame Building : Designed for seismic effects, with URM infills
Author(s)	Maria D. Bostenaru, Ilie Sandu
Reviewer(s)	Vanja Alendar

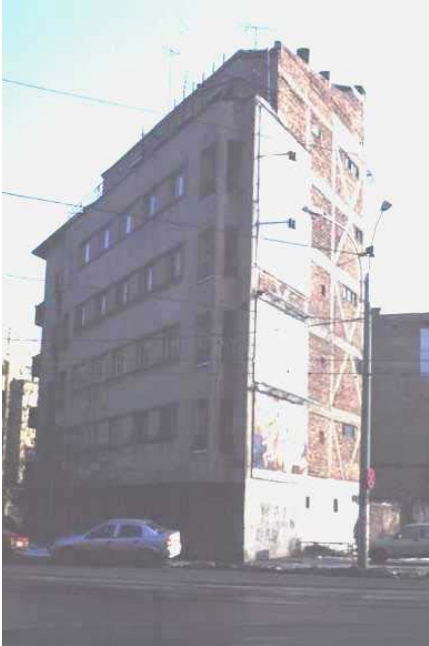
Figure 1A: Typical Building

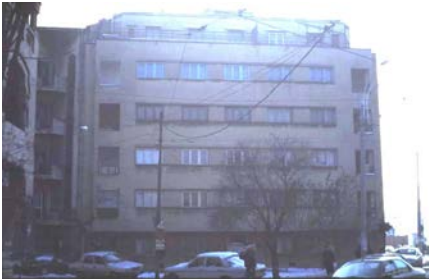
Figure 1B: Typical Building

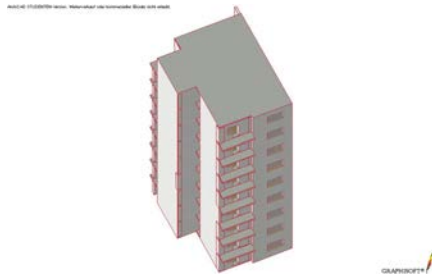
Figure 2C: Perspective Drawing Showing Exterior of the Building

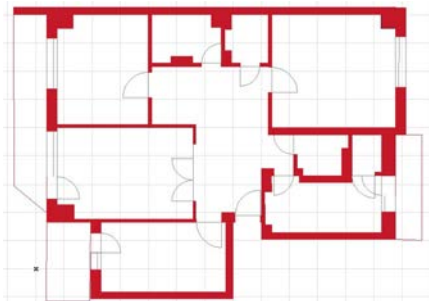
Figure 3A: Plan of a Typical Building

The dwellings have been modified after the 1978 retrofit, however the modifications vary from building to building and it is hard to generalize. The building plan presented in this contribution was recorded based on the actual condition in November 2001. Neither the original (as constructed) building plan nor the plans existing at the time of the 1977 earthquake are available. It is known that, in general, the new inhabitants after 1948 made their own modifications, and did not follow the regulations concerning the building space. Modifications of the building interior arrangement and in the structural elements were made as a part of the retrofit following the 1977 earthquake. Details of the modifications are not available.

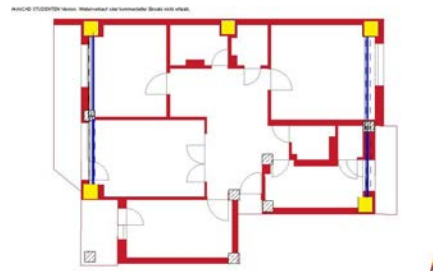
Figure 3B: Plan of a Typical Building (after the retrofit)- the jacketed columns are yellow - colored

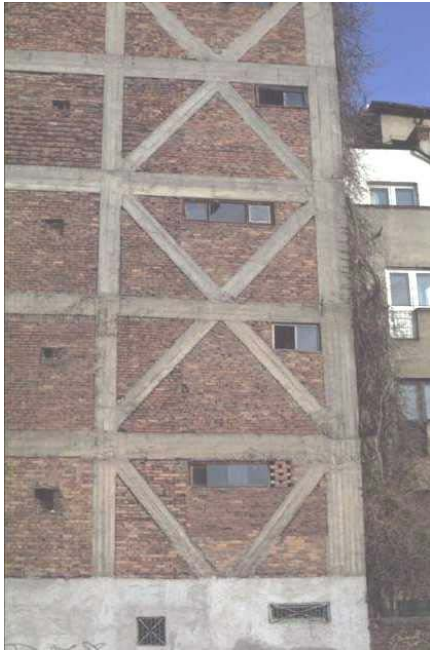
Figure 4A: Critical Structural Details - Frame with Diagonal Braces and Masonry Infill

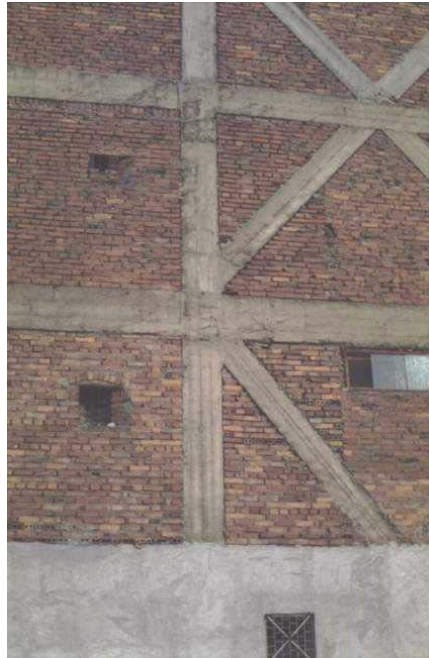
Figure 4B: Critical Structural Details - Frame with Diagonal Bracings and Masonry Infill

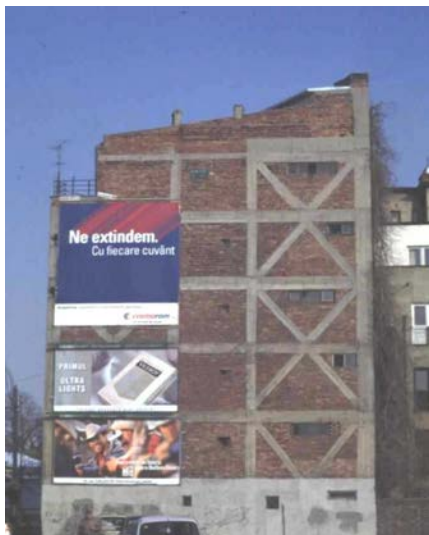
Figure 8A: Another example of a Typical Building (triangular plan, suffered minor damage in the 1977 earthquake)
