World Housing Encyclopedia

HOUSING REPORT

One family one storey house, also called "wagon house"

Report #	85
Report Date	13-11-2002
Country	ROMANIA
Housing Type	Unreinforced Masonry Building
Housing Sub-Type	Unreinforced Masonry Building : Brick masonry in lime/cement mortar
Author(s)	Maria D. Bostenaru, Ilie Sandu
Reviewer(s)	Marjana Lutman

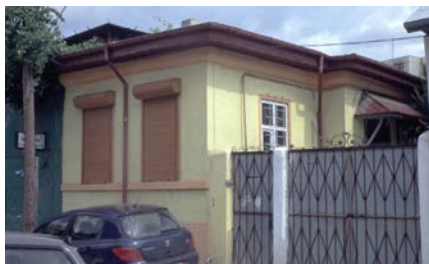
Figure 1: Typical building (from Bostenaru, 2004, TAFEL VII)

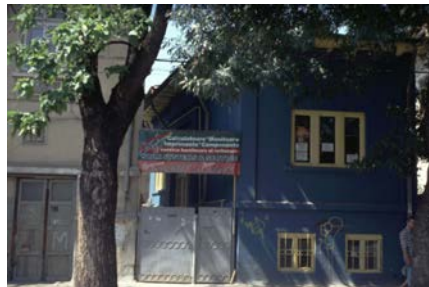
Figure 2: Variant of the building with high basement.

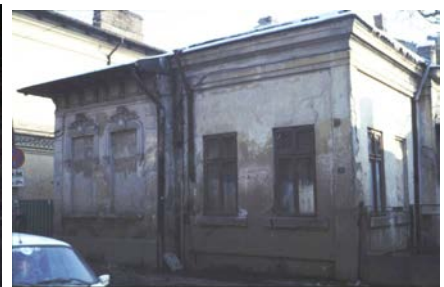
Figure 3: Coupled buildings

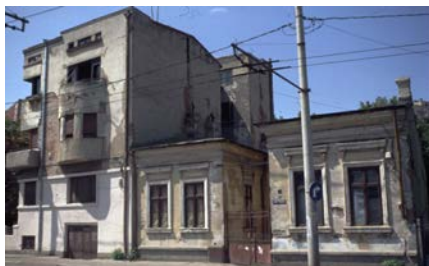
Figure 4: Buildings of this type not coupled, but in vis-a-vis.

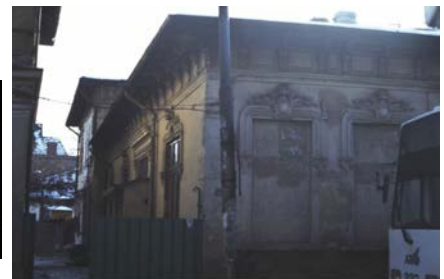
Figure 6: Structural modifications: partial upper floor and closed windows to the street.

Typical changes in time are additional floors over the existing ones (especially taking in consideration the thickness of the walls, considered to be able to carry one floor more, see fig. 6) or additions of "wings", typically one room more with vestibule (fig. 5). Some of these can be used as office, study room, artists workshop and similar. A typical

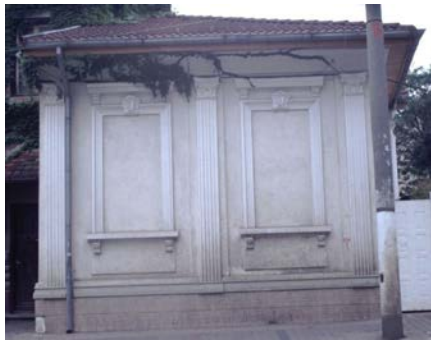
Figure 7: Structural modification: Facade with walled-up windows.

modification includes filling the windows to the street with masonry infill (fig. 7-9). This has been also performed at the model building considered for this report.

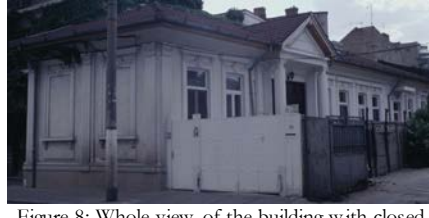
Figure 8: Whole view of the building with closed windows to the street (from Bostenaru, 2004, Abb. 2-4 on P. 24)

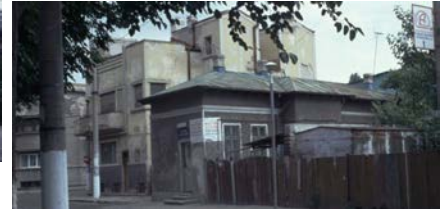
Figure 9: Structural modification: one closed facade window and one changed to door opening.

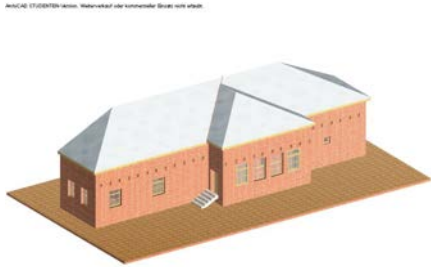
Figure 10: Axonometric view

rectangular (see fig. 11 and 26 for possible recesses). Figure 10 shows a typical building in axonometric view. 5-10 openings, depending on the number of rooms (see fig. 23 and 24 for their layout). ~20% For the building taken as model for this report (late building of this type): A typical window in the longitudinal wall to the courtyard is 1.44sqm in size. There are smaller ones for secondary rooms, of 0.36sqm or 0.9sqm. Bigger windows are 1.2mx1.9m (2.28sqm), to the vestibule. To be noted is that all windows to main rooms are 1.2m wide. A typical door is 0.8mx2.1m (1.68sqm). Smaller doors to the secondary rooms are 0.7mx2.1m (1.47sqm), and also door openings for double doors of 1.4mx2.1m (2.94sqm). The entrance door is wider (0.9m), but same height. In older buildings the windows were all like those to the vestibule (fig. 20) in this one. The back longitudinal wall is usually solid without openings, as it is situated on the cadastral unit boundary, where it is expected that the adjacent semidetached twin unit will be built.

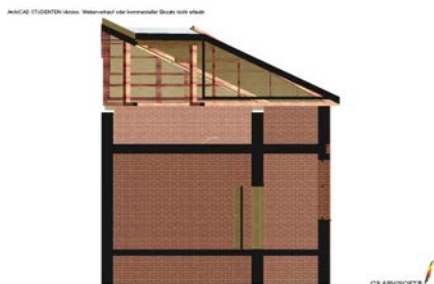
Figure 18: Transversal section

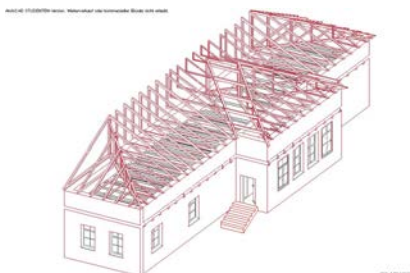
Figure 22: Axonometric view showing the roof

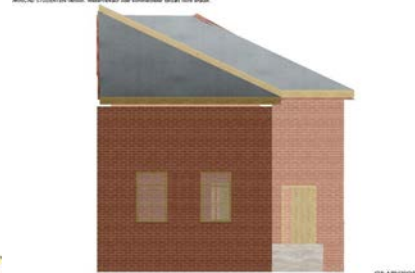
Figure 23: View to street

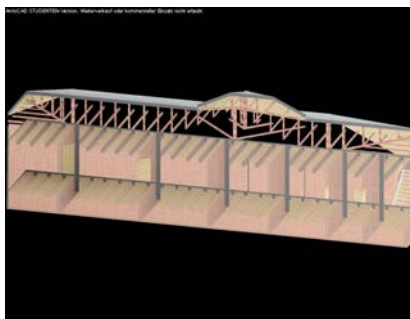
Figure 25: 3D section with rendering (from Bostenaru, 2004, TAFEL VII)

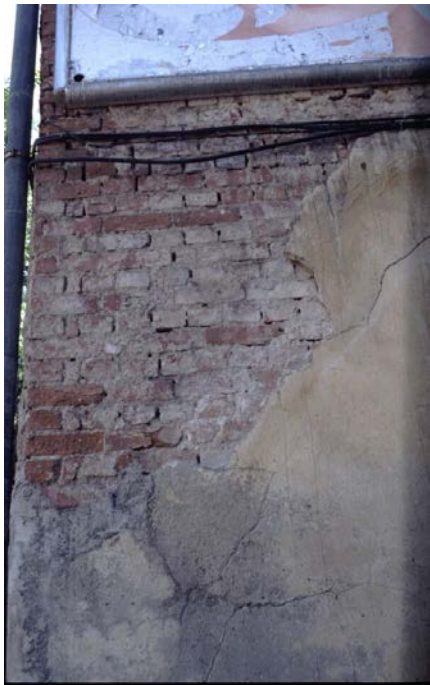
Figure 27: Masonry detail (from Bostenaru, 2004, TAFEL VII)

Construction process adapted for a building from 1904, from a figure by Dinescu in Simetria (2000): Digging the ground and reinforced concrete foundation (reinforced concrete already, like in the model building considered for this form) - 2 positions; Making day brick masonry wall works - one position; Wood works - two positions; Wood works for the roof - one position; Metal works for the roof (the covering) - three positions; Interior plastering - two positions; Exterior plastering - two positions; Floors - one position; Filling between the joists - three positions; Stone stairs at the vestibule - one position; Wood works for windows and doors - two positions; Fir tree mobile staircase - one position; Toilette with everything - one position; Basalt tubes - one position; "terracota" ovens - one position; Decorative plastering - one position; Iron cover - one position. For retrofit: According to the UAIM methodology cracks under 2mm in masonry walls cannot be injected during retrofit works as this implies availability of materials and equipment hard to be found today in Romania. The construction of this type of housing takes place incrementally over time. Typically, the building is originally not designed for its final constructed size. Changes in time may be cause of later damages. Such ones are: geometry changes: widening of openings, removal or addition of walls or floors (fig. 9); stiffness changes through dosing up windows (fig. 6-9); material degradation (fig. 28, 32, 33); load changes: addition of floors without approval, use change (fig. 6); missing maintenance: especially related to water damages (ex. from rain, missing facade plaster, as visible in figures 27 and 28 for walls and floors); previous damages from earthquakes or fire (fig. 30-33).

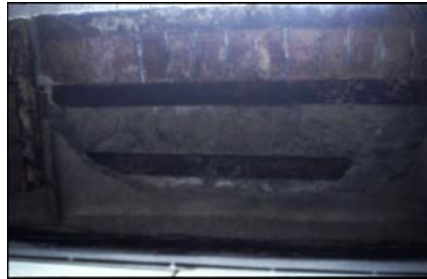
Figure 28: Photo of a brick and metal joists floor structure.

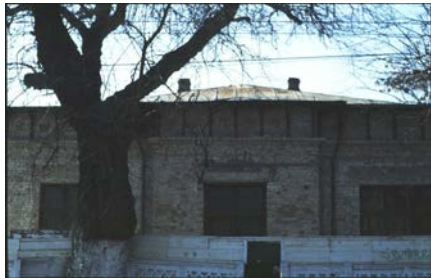
Figure 30: Damage over opening (from Bostenaru, 2004, TAFEL VII)

Openings	Not always respecting the actual prescriptions regarding the dimensions and the areas of openings in walls. Piers (between windows) of reduced sections compared to the loads to be supported. Lintels are usually brick vaults, timber or metal joists.		In some buildings: X shaped cracks above the openings; Z shaped cracks on the "parapet" (under the window); cracks in the lintels over the entry door (fig. 30); cracks in the piers of the facade.

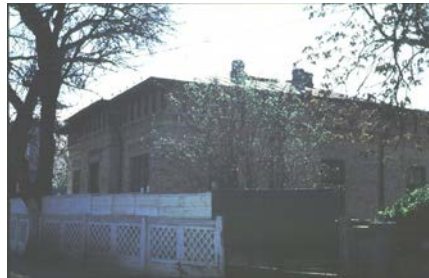
Figure 31: Damage at corner

Structural Element	Seismic Deficiency	Earthquake Resilient Features	Earthquake Damage Patterns
Wall	The disposition of walls sometimes does not respect rules concerning uniform distribution of mass and stiffness. Brickwork can be extensively worn out (poor maintenance, decay) No reinforced concrete vertical posts. Height differences to adjacent buildings possible. Use of mortars with moderate strength.	Good quality (hydraulic) lime mortar. Because of the wall-roof connection, which do not assure the spatial co-operation of the structures, the appeared asymmetries don't cause significant general torsion effects under the action of seismic forces.	Some cracks in the plaster Vulnerability to pounding In some buildings: diagonal cracks on the facades and on the party wall. Corner damage (see figure 31)
Foundations	Foundations are clay brick masonry as well, and rarely stone masonry or concrete.		no data

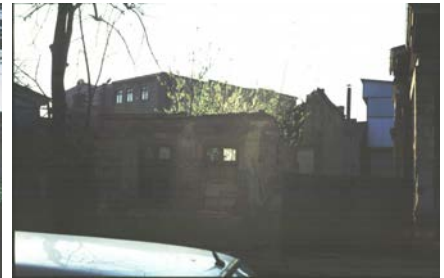
Figure 32: Ruins of such a building

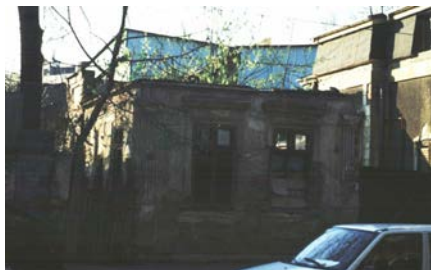
Figure 33: Ruins of walls of a building of this type

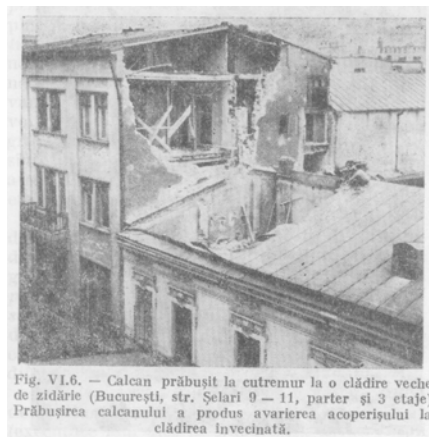
Fig. VI.6. — Calcan prăbușit la entremur la o clădire veche de zidărie (București, str. Șelari 9 — 11, parter și 3 etaje) Prăbușirea calcanului a produs avarierea acoperișului la clădirea învecinată.

Figure 34: Fallen party wall in neighbouring masonry building, damaging the roof of a building of this type (see Balan, 1980: figure VI.6. on page 234)

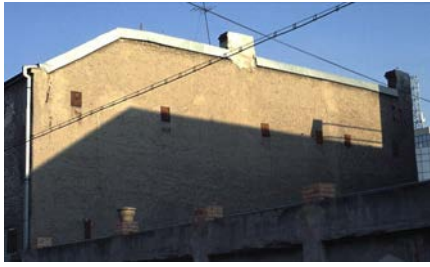
Figure 41: Reinforcement with tension strut, in Romanian "tirant" (from Bostenaru, 2004, TAFEL VII)

out of plane walls after earthquake (reparation work)	Replace collapsed portions of old walls with new masonry walls: 1. loads to be carried usually by the walls are hold off and directed to the sustainable subsoil (with bolts); 2. knock off of the old wall; 3. building of a new wall; 4. reloading of the wall (disassembling the support). (after Bourlotos, 2001)
Low capacity of wall-to-wall and wall-to-floor joints and/or damage along these joints	Anchoring two neighbouring walls or floors to walls by means of metal tension struts (in Romanian "tirant"): 1. dismanteling plastering; 2. breaking holes through the wall; 3. anchor head for the strut; 4. fixing of the solidisation metal plates; 5. making and mounting of the screw dispoitiv for screwing in; 6. mounting of the protection tube for guiding the tyrants through the walls; 7. making and mounting the metal strut; 8. filling in the holes; 9. remaking plastering. (see fig. 41 and after INCERC, 2000)

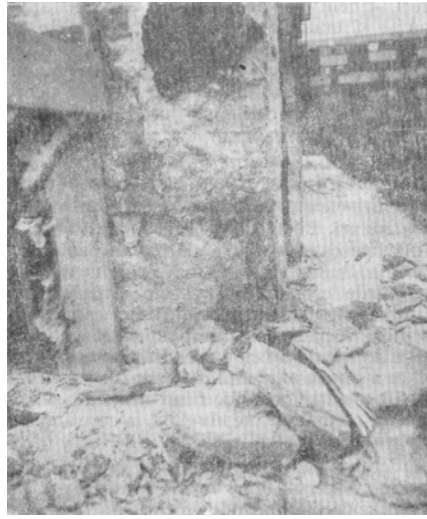
Figure 42: Damages at a vertical post at the corner of a midrise masonry building in the 1977 earthquake. (from Balan, 1980: figure VI.28.b. on page 253)

The model building wasn't damaged significantly. However, Balan (1980) documents failure of reinforced concrete posts at masonry buildings (P. 376), so this type of damage should be taken into account also for reinforced buildings. Thus also the potential reinforcement elements, like vertical posts, can be damaged in Vrancea earthquakes, as shown in figure 42.
