## HOUSING REPORT

# Historic, braced frame timber buildings with masonry infill ('Pombalino' buildings)

Report #	92
Report Date	08-05-2003
Country	PORTUGAL
Housing Type	Others
Housing Sub-Type	Others: Hybrid System
Author(s)	Rafaela Cardoso, Mario Lopes, Rita Bento, Dina D'Ayala
Reviewer(s)	Paulo B. Lourenco

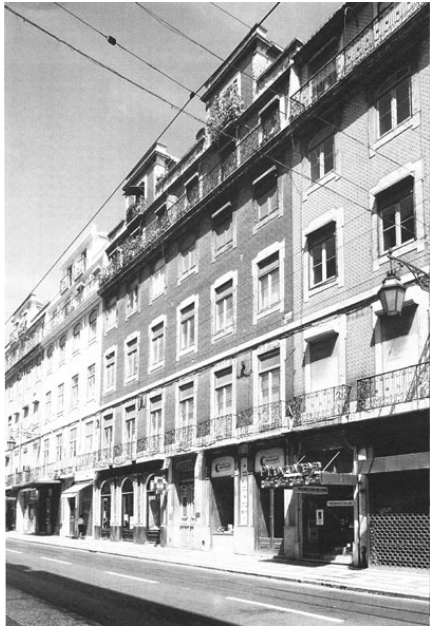
Figure 1: Typical Building (Santos, 2000)

Pombalino buildings (see Figures 1, 2, 3 and 4) are historic masonry buildings that can be identified by the presence of a three-dimensional timber structure (named "gaiola pombalina"), which is enclosed in internal masonry walls above the first floor. The roofs are built with

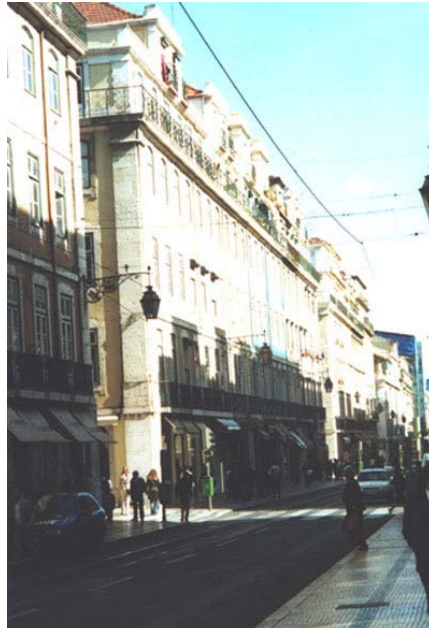
Figure 2: Typical building from a block of buildings

These buildings are typically found in flat terrain. They share common walls with adjacent buildings. Pombalino buildings belong to a block of buildings (see Figures 2 and 3) and they have common walls with adjacent buildings. Common walls are perpendicular to the facades of both buildings. The distance between blocks of buildings varies from 10 meters to 5 meters, corresponding to a street's transverse dimension. Street width depends on its importance (a main street is larger than a secondary one)

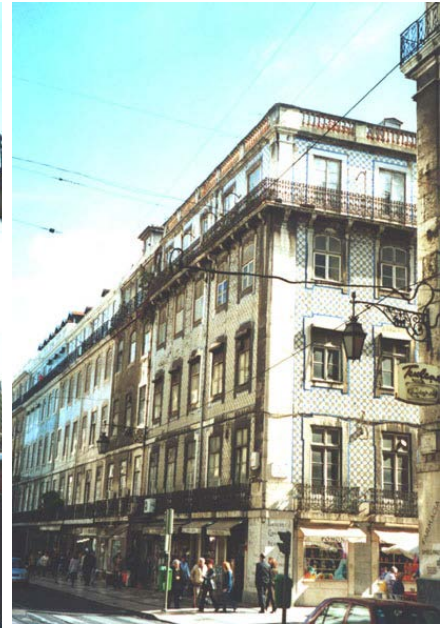
Figure 3: Typical building from a block of buildings

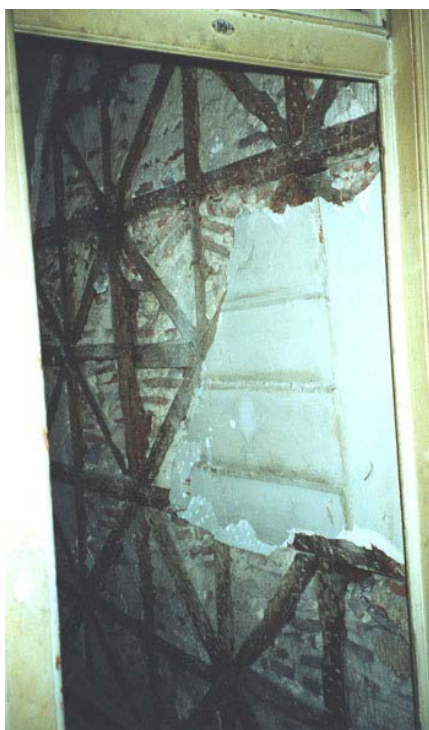
Figure 9: Timber structure enclosed in interior masonry wall

The lateral load-resisting system is stone masonry walls. Masonry walls and a three-dimensional wood frame structure (gaiola) above the first floor, double braced with diagonal timber elements (see Figures 8, 9 and 10), form the lateral load-resisting system. The timber elements are notched together or connected by iron or metal ties, according to historical information about the construction techniques. The results of experimental tests performed on Pombalino panels, and of tests performed on masonry panels without diagonal bracing (Alvarez, 2000 and Lopes, 1986) showed that the gaiola exhibits ductile behavior and allows some energy dissipation. Connections between the timber elements, which sometimes include metallic (iron) elements, probably contribute to the observed ductile behavior. These results may be extrapolated to the performance of the entire structure. According to the construction process (first the entire gaiola was built, then the masonry infill and the exterior walls), there are reasons to believe that interior timber frames are connected to floor elements but these connections must be better characterized. The connections of interior timber frames between stories must also be better characterized.

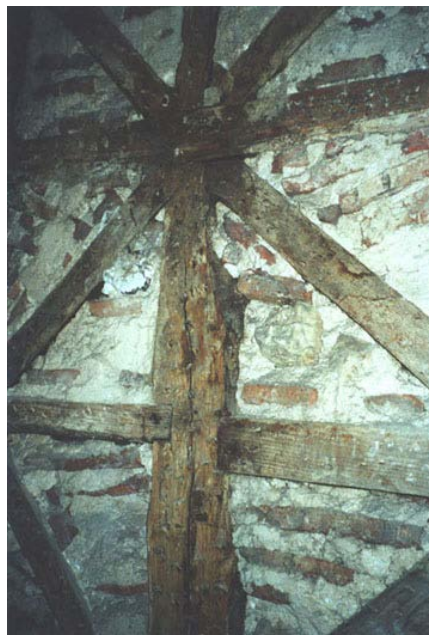
Figure 10: Timber structure enclosed in interior masonry wall (detail)
