World Housing Encyclopedia

HOUSING REPORT

Vivienda de Bahareque

| Housing Sub-Type | Timber Building : Walls with bamboo/reed mesh and post (Wattle and Daub) |

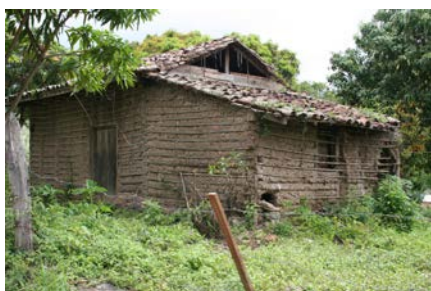
Figure 1. Typical bahareque building for rural areas.

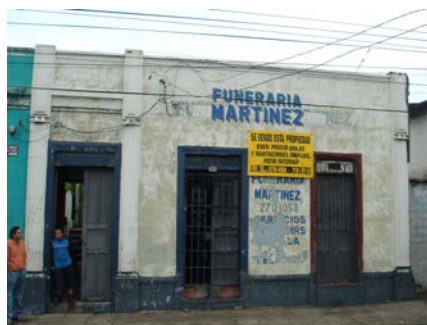
Figure 3. Typical bahareque buildings in rural areas.

Even though the basic construction technique is the same, there are differences between bahareque buildings found in urban and rural areas. Those found in urban areas are more stable and have more substantial construction, complete with (adobe-based or lime-based) plaster, and whitewash or paint (Figure 4), while those in rural regions appear to be temporary shacks reflecting a lower income level (Figure 3).

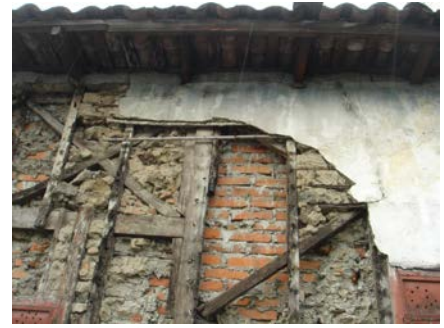
Figure 10. Modification of a bahareque house by an additional wall at the inside made of masonry bricks (Santa Tecla).

In some cases, outer walls of bahareque buildings are supplemented by masonry walls added inside the structure (Figure 10). The most frequent modification of bahareque buildings is replacing the heavy day roof tiles with metal sheeting such as corrugated iron or aluminum plates.

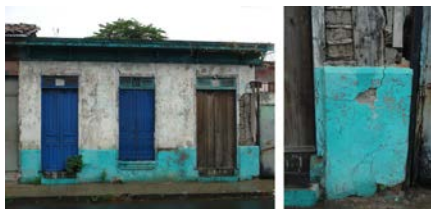
Figure 14. Bahareque building in an urban area with a pedestal made of clay bricks.

In rural areas, bahareque houses generally possess no foundation or only a strip footing of field stones or bricks. Here, the vertical timber elements are simply set firmly into the ground at the corners which in many reported cases is not sufficient. In urban areas, foundations are built as bases (pedestals) consisting of field stones, day bricks or concrete into which the vertical posts are inserted (Figure 14).

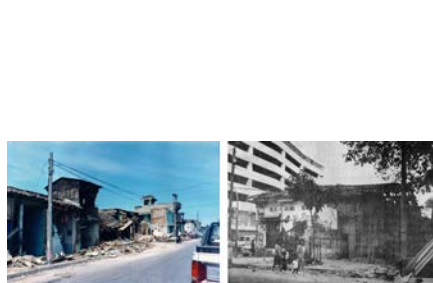
Figure 17. Damaged bahareque dwellings after the San Salvador earthquake on October 10, 1986 (left: San Jacinto neighborhood; right: after Kuroiwa, 1987). [Click to enlarge figures].

1986, October 10 (UTC: 17:49 h): Based on Harlow et al. (1993) the earthquake killed an estimated 1,500 people, injured 7,000 to 10,000 others, and left more than 100,000 people homeless (Olsen, 1987). The earthquake occurred on a shallow fault beneath the city of San Salvador at 11:49 a.m. local time and was assigned a surface-wave magnitude (Ms) of 5.4 by the U.S. National Earthquake Information Center. Whilst Anderson (1987) stated that new bahareque construction holds up well, on the average, under earthquake ground shaking. But failure of this building system during the earthquake, as well as failure of adobe construction, was extensive in the southern sector of San Salvador. This included the neighborhoods of Santa Anita, Modelo, and San Jacinto (near the Presidential Palace). Based on experiences in past Central American earthquakes, collapse of bahareque dwellings is often due to failure of the structural timber caused by rot or damage by insects. Figure 17 illustrates some damages to bahareque dwellings caused by the 1986 event.

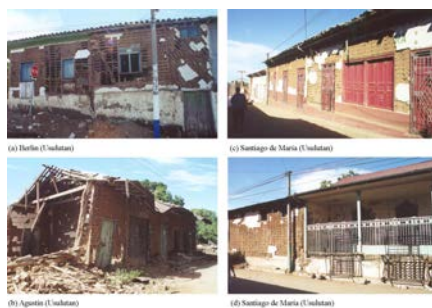
Figure 18. Structural damage to bahareque dwellings caused by the earthquake on January 13, 2001.

2001, January 13 (17: 33 UTC) earthquake: The epicenter was located 100 km southwest of the city San Miguel in the subduction zone offshore from El Salvador. The depth of the mainshock was 39 km (NEIS). According to the Seismological Center of Central America (CASC) the maximum ground shaking intensity in the coastal area of El Salvador (near the epicenter) was $I(MMI) = VIII$, in most cities of El Salvador $I(MMI) = VII$ (Sawada et al., 2001; Yoshimura and Kuroki, 2001). Bommer et al. (2002) suggest that $I(MMI)$ intensities throughout the southern half of the country were between VI and VII with local pockets of higher intensity between VII and VIII. Examples of damaged bahareque houses within different villages of the region Usulután are given in Figure 18.

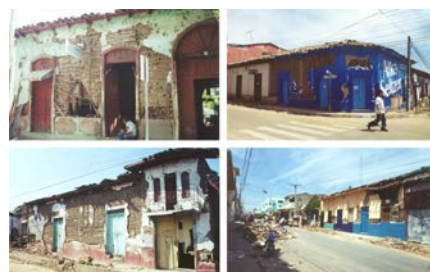
Figure 19. Structural damage to bahareque dwellings in the city of San Vicente caused by the earthquake on February 13, 2001.

2001, February 13 (14:22 UTC) earthquake: It is reported that this event, with an epicenter close to the town of San Juan Tepezontes, caused maximum shaking intensities of VII-VIII (MMI) in the area from Lake Ilopango in the west to San Vicente in the east, and VI in San Salvador. However, a more recent study revealed that the maximum intensities did not exceed VII (Bommer et al., 2002). Figure 19 illustrates some damaged bahareque houses located in the city of San Vicente.
