# World Housing Encyclopedia

### Vivienda de Adobe (adobe brick houses)

Report #	144
Report Date	11-06-2007
Country	GUATEMALA
Housing Type	Adobe / Earthen House
Housing Sub-Type	Adobe / Earthen House : Adobe block walls
Author(s)	Dominik Lang, Lisa Holliday, Omar G. Flores Beleton
Reviewer(s)	Marcial Blondet

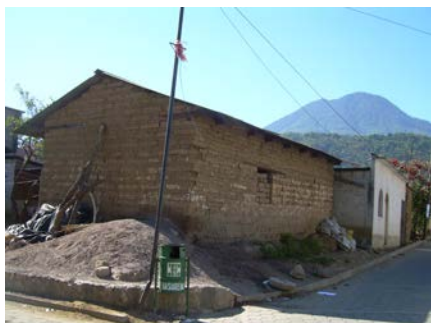
Figure 1. Typical adobe building for rural areas (San Juan La Laguna). [Click to enlarge figures]

half of these buildings (54.3 %) were located in rural settlements, while the rest (45.7 %) was located in urban areas, e.g. Guatemala City (Marroquin and Gándara, 1976). Surprisingly, the percentage of adobe buildings at that time was higher in urban areas than in rural regions. Today, circumstances have changed and adobe structures prevail in rural areas while only remainders of this traditional construction technique can be found in the cities. Based on a more recent statistical survey in the municipality of Guatemala City conducted by ASIES (2003), around 4 % of the building stock is either adobe or bahareque buildings. The latter not being covered in the present report. Throughout the report, a distinction is made between adobe buildings in rural (Figure 1) and urban (Figure 2) areas. This distinction affects some of the building parameters and features herein.

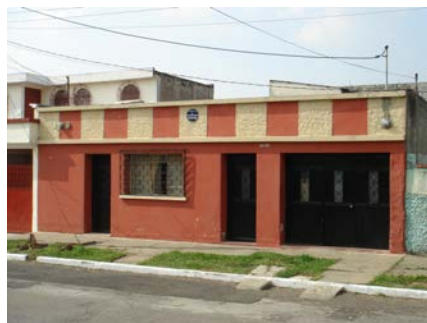
Figure 2. Typical adobe building for urban areas (Guatemala City, Zona 11).

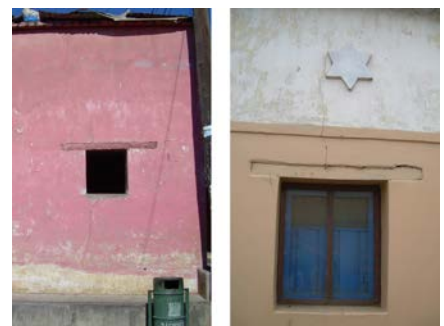
Figure 6. Window lintels consisting of wooden trusses.

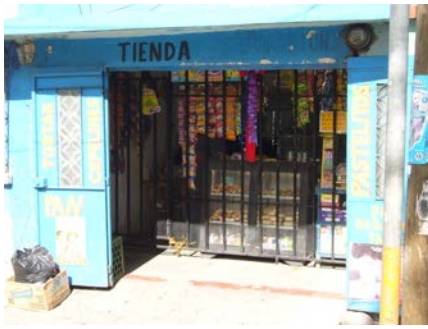
Figure 7. Heavily locked doors and windows by lattices in Guatemala City.

The main function of this building typology is single-family house. Besides residential use by one single family, adobe houses often accommodate small shops (retail trade) or handicraft businesses especially in urban areas. In a typical building of this type, there are no elevators and no fire-protected exit staircases. The buildings have at least one entrance door on the front facade and one at the back entering a patio. In urban areas it is also common for these structures to have two doors located on the front facade (Figures 2 and 15). In urban areas where the crime rate is higher, the doors and windows (means of escape) are heavily locked by bars, rendering a quick escape from the building in case of an earthquake impossible (Figure 7).

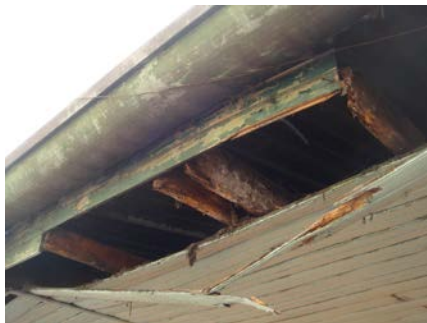
Figure 9. Rotten beams of the wooden roof construction.

Roof and floors	- missing friction-locked connection to the walls- large dead loads due to heavy roof tiles (inverted pendulum)- missing diaphragm- material deterioration of wooden (or metal) trusses due to weathering effects (Figure 9)	NA	- total and partial collapse of roof construction

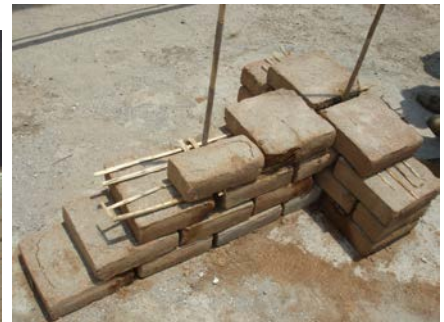
Figure 10. Principle of internal wall reinforcement with bamboo (Universidad de El Salvador UES, 2007).

Seismic Deficiency	Description of Seismic Strengthening provisions used
insufficient wall strength	internal horizontal and/or vertical reinforcement, e.g. bamboo, steel bars (Figure 10)
insufficient wall strength	addition of a ring beam made of logs, lumber or reinforced concrete (Figure 11)
insufficient wall strength	addition of corner posts or wooden diagonal corner bracings (Figure 12)
insufficient wall strength	strengthening of wall corners by wall buttresses (Figure 13)
humidity in walls	water barrier at the wall base
heavy roof	use of (corrugated) iron sheeting
