HOUSING REPORT

Timber-reinforced Stone Masonry (Koti Banal Architecture) of Uttarakhand and Himachal Pradesh, Northern India

Report #	150
Report Date	05-05-2008
Country	INDIA
Housing Type	Others
Housing Sub-Type	Others: Hybrid System
Author(s)	Piyooch Rautela, Girish Chandra Joshi, Yogendra Singh, Dominik Lang
Reviewer(s)	Tom Schacher

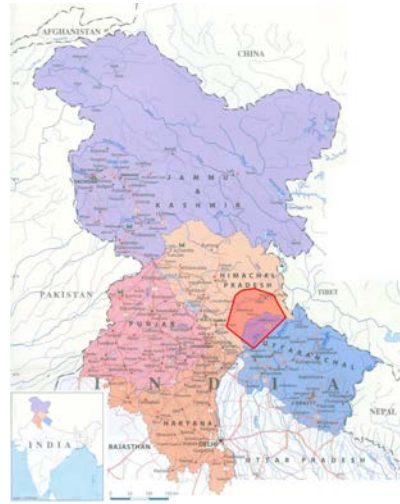
Figure 2. Map illustrating the respective region in Himalayan India where Koti Banal buildings are found.

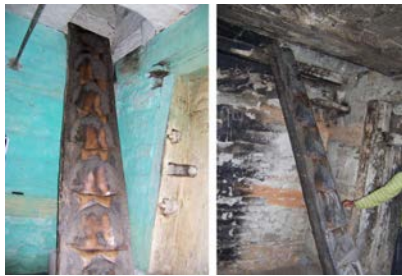
Figure 15. Ladders made of a single trunk used for access to upper floors.

floor level above the foundation platform. The access to upper floors is solely provided by wooden ladders made of a single wooden trunk (Figure 15). The reasons for not providing a second means of escape could not be completely identified. However, due to their massive walls, some of the buildings have also been used as fortress against enemy attacks of e.g. the British Gurkha army. The Gurkhas lay siege of the building for several weeks, but could not enter into it. According to tales from the local people, narrow connection tunnels to close rivers still exist which were used to supply the people with potable water. Today, the fact that no second means of escape is foreseen does not represent any particularity in India since this is generally not provided in daily construction practice.

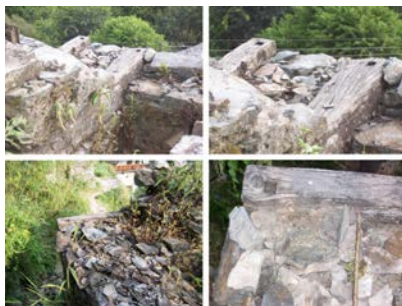
Figure 18. Detailing of the connection means at the wall corner. The horizontally placed wooden logs are connected by rectangular-shaped wooden pins. (Photographs show the rectangular holes foreseen at the log ends.)

The lateral load-resisting system is others (described below). The system of horizontally pairs of wooden logs which are connected to each other by wooden shear pins/tenons (Figure 18) act like a wooden frame which is braced by well-dressed flat stones in between the logs increasing the bearing and lateral capacity of the construction. This especially in the lower parts of the walls where the wooden frame is continuous in three dimensions and the stones do not carry any loads. The stones between the logs are mostly assembled without any grout or mortar thus enabling a certain level of flexibility and allowing lateral deflections of the building without damage effects. The bottommost wooden logs are embedded within the base platform. Outer walls parallel to the floor beams are supported in out-of plane action by vertical shear keys over several storeys (Figure 13).

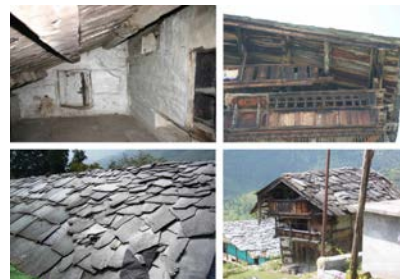
Figure 19. Detailing of the wooden roof construction and the roofing by large slate tiles.

Wood planks resting on wooden joists supported by beams or walls: The floors consist of wooden beams and planks (Figure 12). Since no cross/inclined planks are used, it is expected to act as flexible diaphragm. The floor beams are shear pinned with the wall logs and thus provide support to the walls orthogonal to the beams, in out-of-plane action. Wood planks or beams that support slate tiles: The roof construction consists of a wooden frame which is expected to act as a flexible diaphragm. It is further furnished with large slate tiles (Figure 19).
