# World Housing Encyclopedia

# Reinforced concrete frame structure with diagonal bracing and brick infill walls

<b>Report #</b>	71
<b>Report Date</b>	05-06-2002
<b>Country</b>	ROMANIA
<b>Housing Type</b>	RC Moment Frame Building
<b>Housing Sub-Type</b>	RC Moment Frame Building : Designed for seismic effects, with URM infills
<b>Author(s)</b>	Maria D. Bostenaru, Ilie Sandu
<b>Reviewer(s)</b>	Vanja Alendar

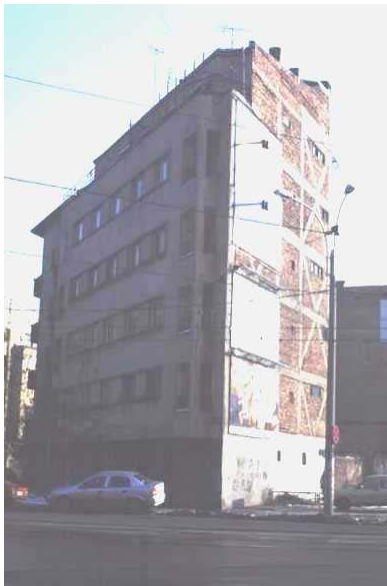
Figure 1A: Typical Building

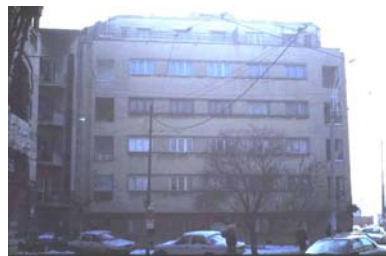
Figure 1B: Typical Building

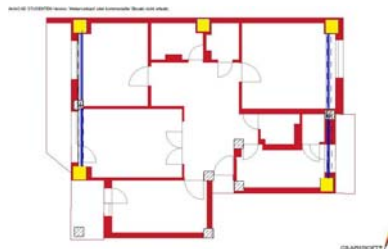
Figure 3B: Plan of a Typical Building (after the retrofit)- the jacketed columns are yellow-colored

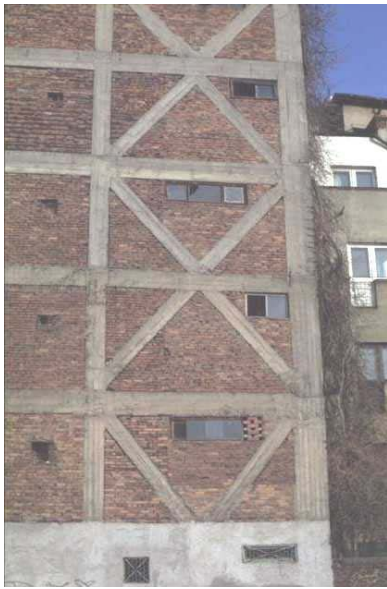
Figure 4A: Critical Structural Details - Frame with Diagonal Braces and Masonry Infill

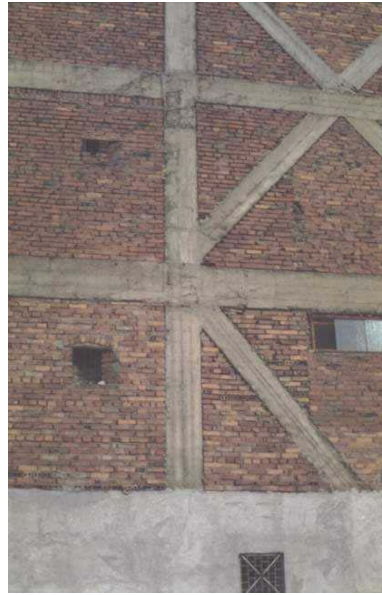
Figure 4B: Critical Structural Details - Frame with Diagonal Braces and Masonry Infill

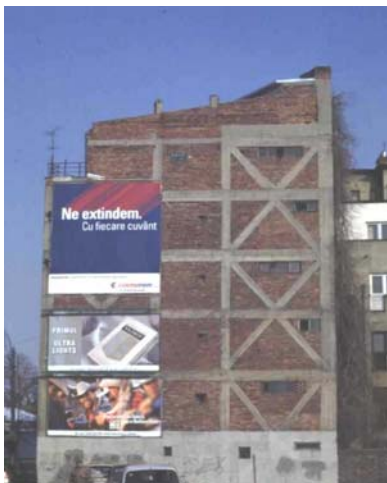
Figure 8A: Another example of a Typical Building (triangular plan, suffered minor damage in the 1977 earthquake)
