# World Housing Encyclopedia

## HOUSING REPORT

### Rubble-stone masonry house

<b>Report #</b>	58
<b>Report Date</b>	05-06-2002
<b>Country</b>	SLOVENIA
<b>Housing Type</b>	Stone Masonry House
<b>Housing Sub-Type</b>	Stone Masonry House : Rubble stone without/with mud/lime/cement mortar
<b>Author(s)</b>	Marjana Lutman, Miha Tomazevic
<b>Reviewer(s)</b>	Svetlana N. Brzev

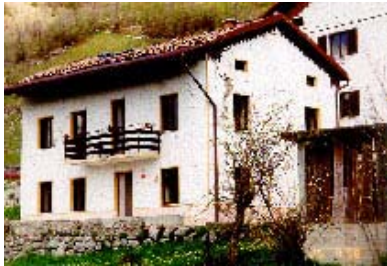
Figure 1A: Typical Building

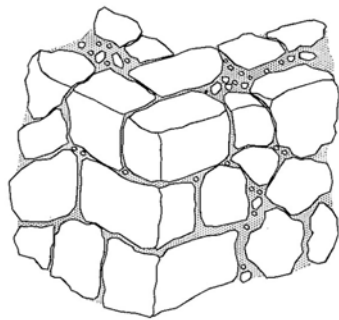
PARTLY CUT STONES AT CORNERS

Figure 4A: Critical Structural Details - wall intersection

The lateral load-resisting system is others (described below). The lateral load-resisting system consists of exterior and interior stone walls. The walls are generally uniformly distributed in both orthogonal directions, and the building plan is generally regular. In general, with a few exceptions, the walls are not connected by means of wooden or iron ties. The thickness of walls varies from 40 to 70 cm, with spacing ranging from 3.0 m to 6.0 m. The walls are supported by foundation walls (strip foundations) made out of rubble masonry or there are no footings at all. Lateral load transfer to bearing walls is accomplished through roof and floor structures. The weakest links in this structural type are usually: weak inner infill between exterior wythes of masonry, vertical joints between walls, and connections between roof /floors and walls.

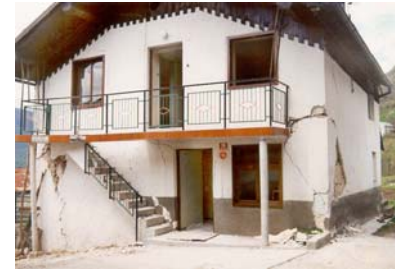
Figure 5A: an Illustration of Key Seismic Deficiencies - lack of structural integrity results in wall dislocation and corner damage

Structural Element	Seismic Deficiency	Earthquake Resilient Features	Earthquake Damage Patterns
Wall	The walls are built with two exterior wythes using larger stones with a stone rubble infill in poor mud mortar with a small amount of lime. In general, there are many voids in the middle portion and the connecting stones (through		Cracking; heavy damage of structural walls. Delamination and disintegration of masonry. Dislocation of walls and vertical

stones) are rare. This type of masonry is characterized with low tensile strength. The walls are not tied by means of steel or wooden ties.		cracks at corners; partial collapse of wall corners.
Frame (columns, beams)	Not applicable.		
Roof and floors	Timber floor joists are supported only by the interior wall wythe and are not attached to the exterior wythe.	Timber floor and roof structures are not heavy.	Horizontal cracks along the wall-to-floor joints.
Other

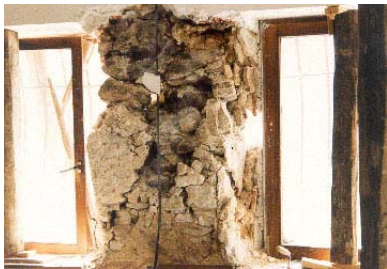
Figure 5B: Seismic deficiency: pier failure

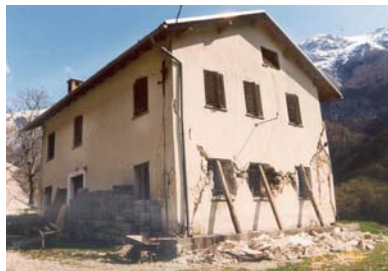
Figure 6A: a Photograph Illustrating Typical Earthquake Damage in the 1998 Bovec earthquake

The epicenters of the main shock on May 6, 1976 (M= 6.5 , focal depth 20-30 km) and the strongest aftershock on September 15, 1976 (M=5.9) were in Friuli, Italy, 20.5 km from the border between Italy and Slovenia. In Italy 965 people died and an enormous damage was caused. In Slovenia, the maximum intensity was VIII EMS. Out of 6,175 damaged buildings, 1,709 had to be demolished and 4,467 were retrofitted. The strongest earthquake with the epicenter in Slovenia in the 20th century occurred on April 12, 1998. The epicenter was approx. 6.3 km South-East from the town of Bovec, and the focal depth was between 15 and 18 km. No building collapses were reported, however out of 952 inspected buildings, 337 were found to be unsafe, out of which 123 beyond repair. The effectiveness of strengthening methods applied in 1976 was analyzed. Typical patterns of earthquake damage to traditional stone-masonry houses are: - Cracks along the joints between walls and floors; - Vertical cracks at the corners and wall intersections, separation of walls, collapse of gables; - Cracks in structural walls, falling out of masonry at lintels, closed openings and in corner zones; - Heavy damage to walls, partial collapse of corners, delimitation and disintegration of masonry.

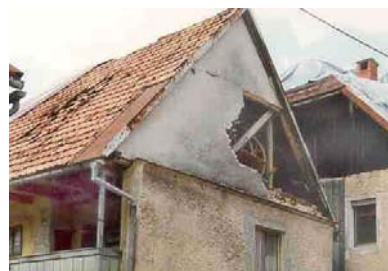
Figure 6B: Out-of-plane gable collapse

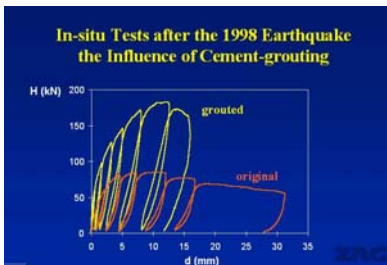
Figure 7D: Seismic strengthening by injection grouting: strengthened vs. unstrengthened specimen

What was the performance of retrofitted buildings of this type in subsequent earthquakes? Many buildings have been adequately repaired and strengthened after the 1976 Friuli earthquake. The walls were grouted, the old timber floor structures were replaced with new reinforced concrete slabs in many cases and houses were completely tied. The effectiveness of these measures was confirmed during the 1998 Bovec earthquake. Adequately repaired and strengthened structures suffered almost no damage in the earthquake.

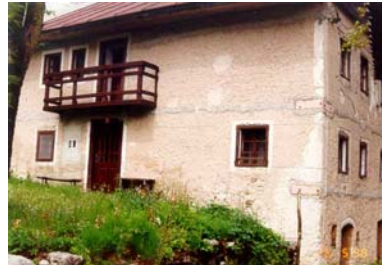
Figure 7E: A building strengthened after the 1976 Friuli earthquake remained undamaged in the 1998 Bovec earthquake
