# TIMBER CONSTRUCTION

*Chris Arnold, Building Systems Development, USA*

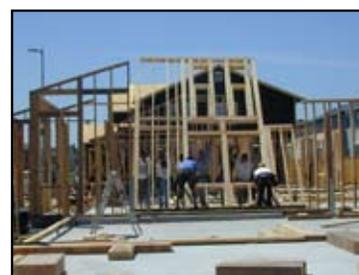
Figure 7: Typical one-story wood-frame construction (WHE Report 90)

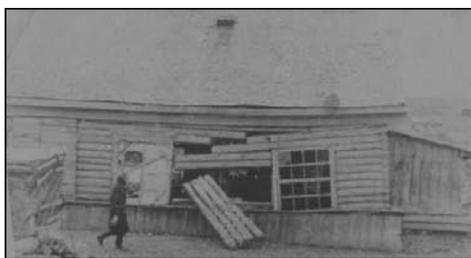
Figure 11: A photograph illustrating typical earthquake damage from the 1958 Kamchatka earthquake (WHE Report 56)

Horizontal timber buildings in the Russian Federation have performed moderately well in past earthquakes (Figure 11).

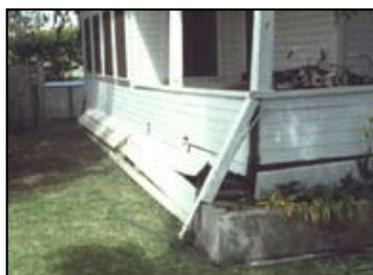
Figure 12: Damage caused by unbraced cripple walls. Note that the house has shifted about 1 foot (30 cm) off its foundation (WHE Report 90, USA)

The most common deficiency for buildings in the USA is unbraced cripple walls (WHE Report 90, USA). A cripple wall is a low stud wall sometimes used between the top of the foundation and the underside of the first floor. The collapse of a cripple wall or damage to it from an earthquake are generally not life-threatening but expensive to repair (Figure 12).

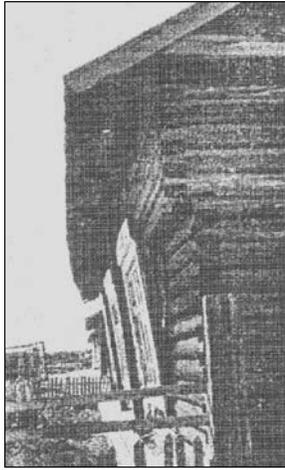
Figure 13: Wall damage in the 1958 Kamchatka earthquake (WHE Report 56)

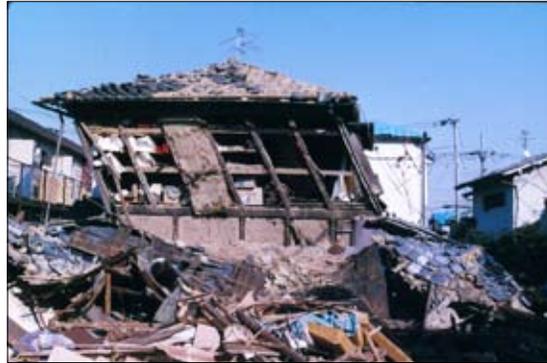
Figure 14: Damage caused by heavy roof construction in Japan from 1995 Kobe earthquake (WHE Report 86)

A deficiency likely to be found in Japanese structures is that of very heavy roofing materials (Figure 14). The traditional heavy tiles often lead to the collapse of buildings as seen in the 1995 Kobe earthquake (WHE Report 86, Japan).
