GEM Building Taxonomy Report

EMCA-5

InTUIT

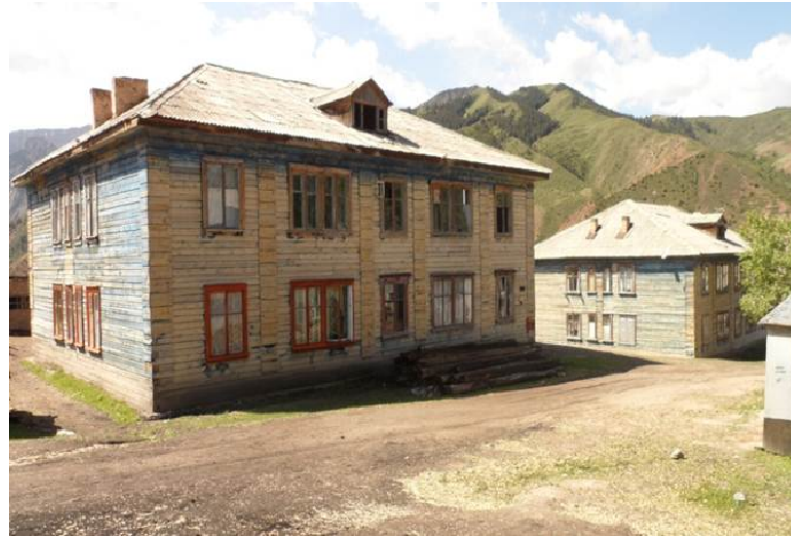
DX /W+WLI /LWAL /DY /W+WLI /LWAL /YAPP:1900 /HEX:2+HFEX:6+HD:15 /RES+RES1 /BPD /PLFR /IRRE /EWW /RSH3+RMT4+RWO+RWO1+RWCP /FW+FW1+FWCP /FOSN

Wood

Wall

Shallow foundation, with no lateral capacity

Pitched and hipped

Roof-wall diaphragm connection present
