GEM Building Taxonomy Report

Multistorey masonry building Maria BOSTENARU DAN

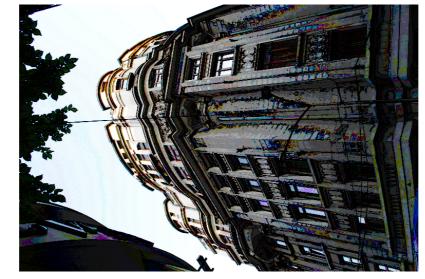
This type of building constituted the first middle rise multifamily house in the capital of Romania. The vertical system is of masonry walls, while the horizontal one is out of metal joists supporting also solid clay brick floors.
