World Housing Encyclopedia

HOUSING REPORT

Street front building with arcade at the first floor (contemporary construction)

Report #	62
Report Date	05-06-2002
Country	TAIWAN
Housing Type	RC Moment Frame Building
Housing Sub-Type	RC Moment Frame Building : Designed for gravity loads only, with URM infills
Author(s)	George C. Yao, M. S. Sheu
Reviewer(s)	Craig D. Comartin

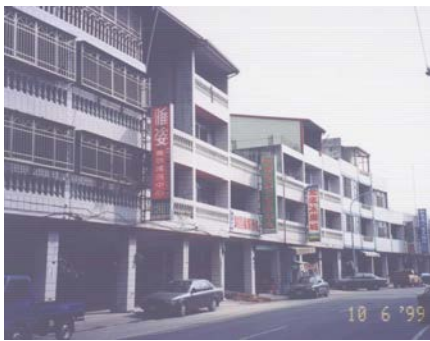
Figure 1A: Typical Building

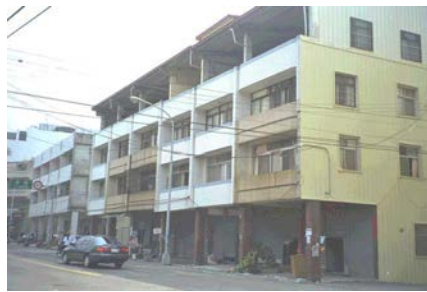
Figure 1B: Typical Building (Source: EERI 2001)

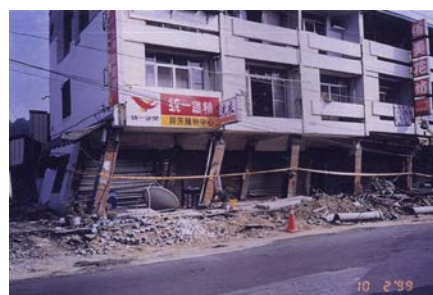
Figure 6A: A Photograph Illustrating Typical Earthquake Damage

No major deficiencies		
	The open front at the bottom story is the most obvious configuration irregularity characteristic for this construction type. This feature creates undesirable soft-story and torsional effects, as illustrated in Figure 5A. (Source: EERI 2001)		Extensive damages and building collapses due to the large demands on the bottom story columns caused by soft story and torsional effects (see Figures 6A, 6B, 6C, 6D, 6E, 6F)

Although many buildings of this construction type sustained significant damage in the 1999 Chi Chi earthquake, most of them performed satisfactorily. Earthquake damages are illustrated in Figures 6A, 6B, 6C, 6D, 6E, and 6F. The main causes for damage observed after the earthquake are (EERI, 2001): 1) Poor configuration attributable to the open front combined with inadequate column lateral reinforcement (ties). The large displacement demands from the soft-story and torsional effects often damaged the plastic hinge regions of the columns at the open front. All damaged columns were observed to have non-ductile confinement reinforcement details consisting of widely spaced horizontal hoops, more than 300 mm apart, and 90 degree hooks. Usually, the lack of confinement reinforcement in the plastic hinge regions resulted in brittle failure. In some cases, hinge rotation caused buildings to permanently lean out of plumb. In other cases, buildings with no signs of earthquake damage remained standing next to the seemingly identical buildings that sustained the total collapse of entire bottom stories. 2) There was also widespread damage to the unreinforced brick partitions and perimeter walls. Although partitions are usually considered nonstructural elements, the collapse of or damage to unreinforced brick partitions represents a significant falling hazards, and it forced many people out of their homes. 3) Performance of this construction type in the earthquake was significantly influenced by the infill wall layout. Because brick infills significantly influence the structural characteristics and yet are not considered in the design, the seismic performance of this building type is highly unpredictable.

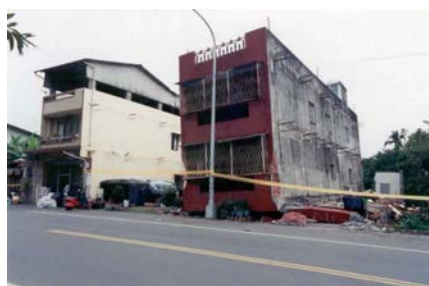
Figure 6B: Earthquake damage-Collapsed Three-story building in the 1999 Chi Chi earthquake (Source: EERI 2001)

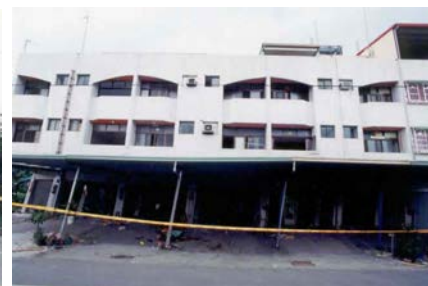
Figure 6C: Earthquake Damage - Partial Collapse of a Three-story building in the 1999 Chi Chi Earthquake (Source: EERI 2001)

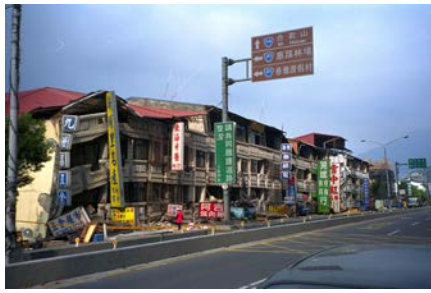
Figure 6D: Earthquake Damage - Pancake Collapse of an Entire City Block in the 1999 Chi Chi earthquake (Source: EERI 2001)

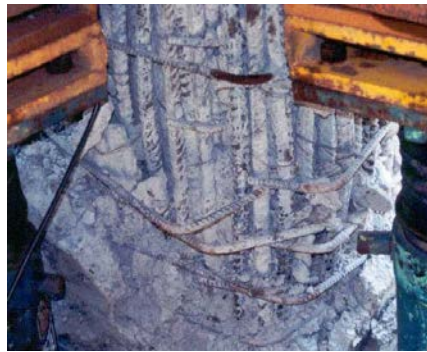
Figure 6E: Earthquake Damage - Opening of 90 degree column hooks in the 1999 Chi Chi earthquake (Source: EERI 2001)

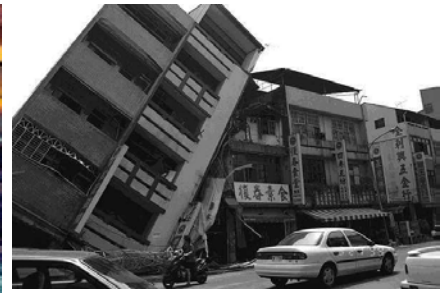
Figure 6F: Collapse of a Concrete Frame Building in the 1999 Chi Chi Earthquake (Source: EERI 2001)
