# World Housing Encyclopedia

### A single-family, two-storey house with brick walls and timber floors

Report #	84
Report Date	21-10-2002
Country	ROMANIA
Housing Type	Unreinforced Masonry Building
Housing Sub-Type	Unreinforced Masonry Building : Brick masonry in mud/lime mortar
Author(s)	Maria D. Bostenaru, Ilie Sandu
Reviewer(s)	Dina D'Ayala

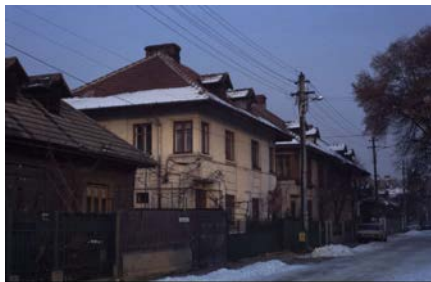
Figure 1: Typical building

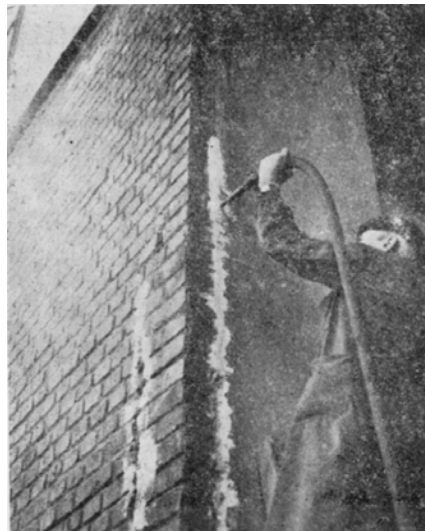
Figure 25: Wall repair by injecting cement paste

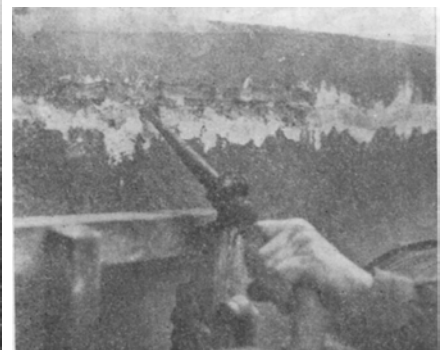
Figure 26: Wall repair by injecting cement paste with compressed air

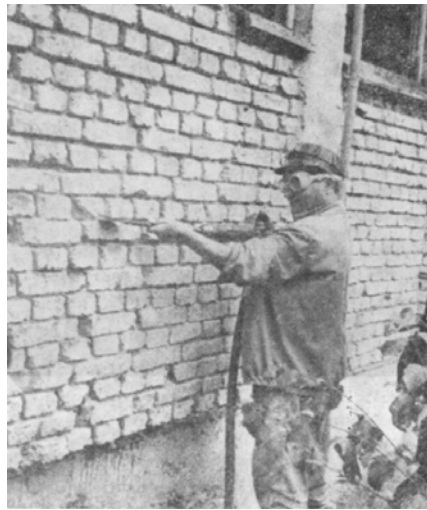
Figure 28: Torcrete method - step 1: cleaning of the wall surface with compressed air

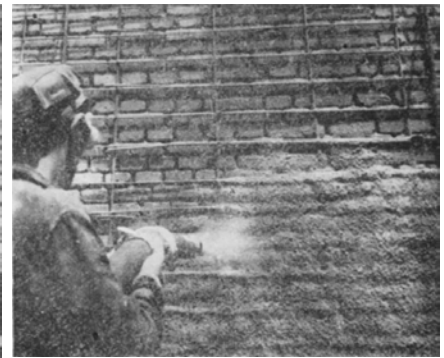
Figure 29: "Torcrete" retrofit : application of torcrete overlay on the steel net attached to the wall
