# World Housing Encyclopedia

## HOUSING REPORT

### Traditional adobe house without seismic features

Report #	89
Report Date	07-03-2003
Country	ARGENTINA
Housing Type	Adobe / Earthen House
Housing Sub-Type	Adobe / Earthen House : Adobe block walls
Author(s)	Virginia I. Rodriguez, Maria I. Yacante, Sergio Reiloba
Reviewer(s)	Sergio Alcocer

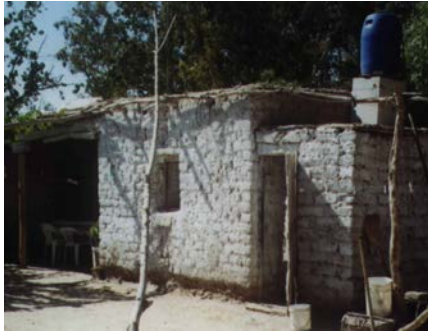
Figure 1: Typical Building

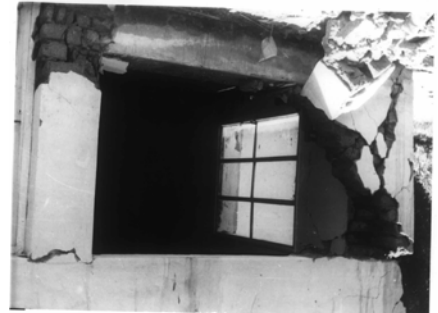
Figure 6: Damage in the 1977 Cauce Earthquake

The first earthquake known in the area was in 1894, it was called "The Argentinean Earthquake." All the buildings at that time were of this construction type. 100% of this construction type collapsed in the most affected area, while in the areas which were far from the epicenter, cracks on walls and the total or partial collapse of cornices were observed. During the 1944 earthquake, 90% of the buildings of this construction type collapsed completely or suffered severe damage. The same happened with this adobe house without seismic provisions during the earthquakes of 1952 and 1977.

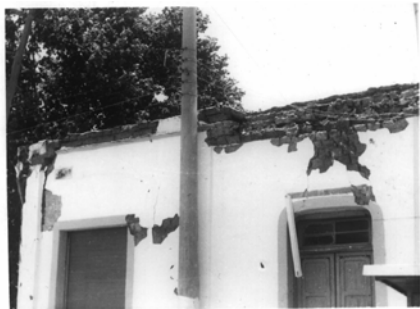
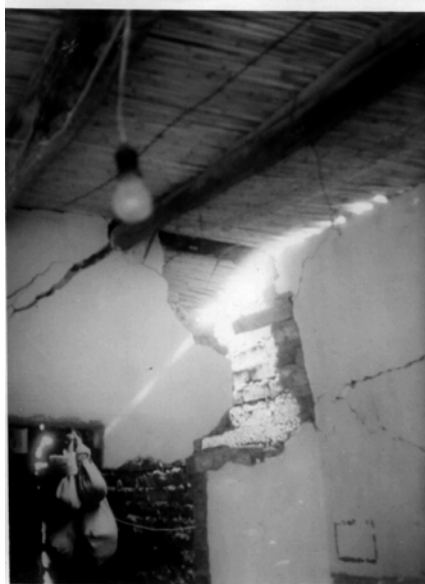
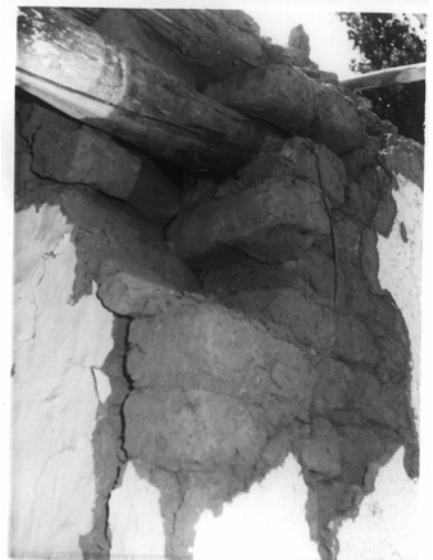
Figure 7: Damage in the 1977 Caucete Earthquake    Figure 8: Damage in the 1977 Caucete Earthquake    Figure 9: Damage in the 1977 Caucete Earthquake
